The Study on the Damage of the Rear-Axle Shaft in a KIA Truck

Marek Wozniak¹, Gustavo Ozuna², Krzysztof Siczek^{1*}

Keywords: truck, rear axle-shaft, failure

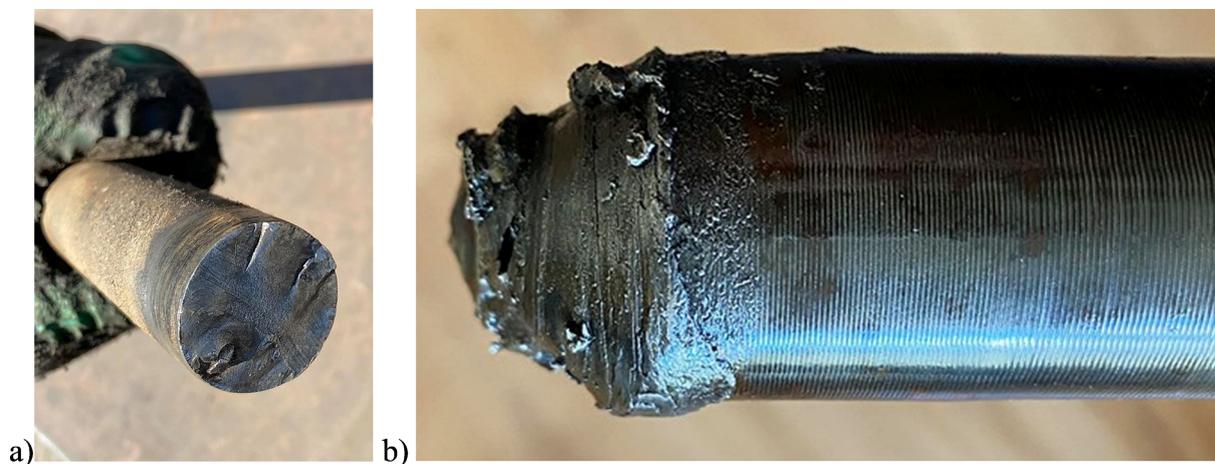
Figure 9 presented the parts of the broken rear-axle shaft of a KIA K2700 truck. The cross-section of the left part (Fig. 9a) revealed the traces characteristic of the presence of fatigue crack in the form of a focus of that crack, probably initiated by the post-hardened heterogeneity of the structure at the border of the core and surface layer, or by the presence of non-metallic inclusions. In addition, the traces in the mentioned cross-section indicated the occurrence of separation of materials as a result of tearing. However, it

resulted from a complex state of stresses (torsion and tensile) rather than from the torsion or bending moment itself. On the outer surface of the rear-axle shaft, there were also traces of rubbing the outer surface against the inner surface of the rear-axle casting. The part on the right (Fig. 9b) revealed the traces of rubbing between a fragment of the outer surface of the rear axle-shaft against the inner surface of the rear-axle casting. The aforementioned fragment was located near the place of rupture and breakage of the rear-axle shaft. In addition, the traces of the occurrence of separation of materials as a result of tearing were clearly visible.

Fig. 9. Two parts of the broken rear half-shaft of a KIA K2700 truck. a) part from the side of the rear-axle housing, b) part from the side of the truck dual wheel.

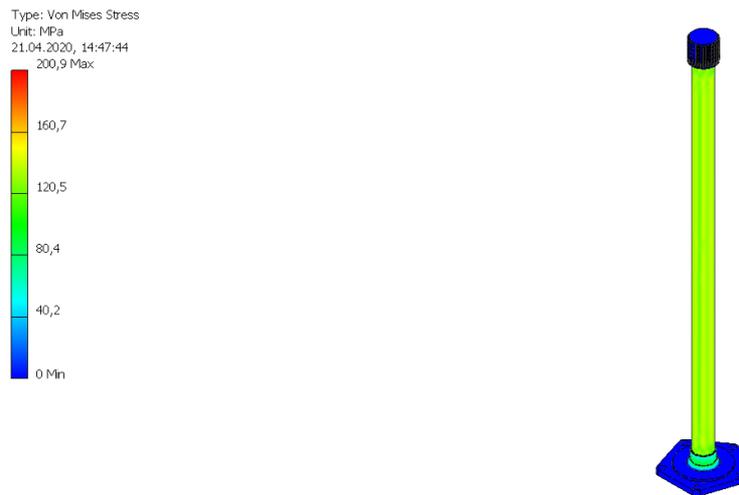
The obtained values of the von Mises stresses in the material of the rear-axle shaft where the bending torque M_x was equal to 0 MPa was showed in Figure 10. It was visible that the von Mises stresses were below the value of $k_{fatigue}$.

Fig. 10. The von Misses stresses in material of the rear-axle shaft where the bending torque M_x was equal to 0 MPa.

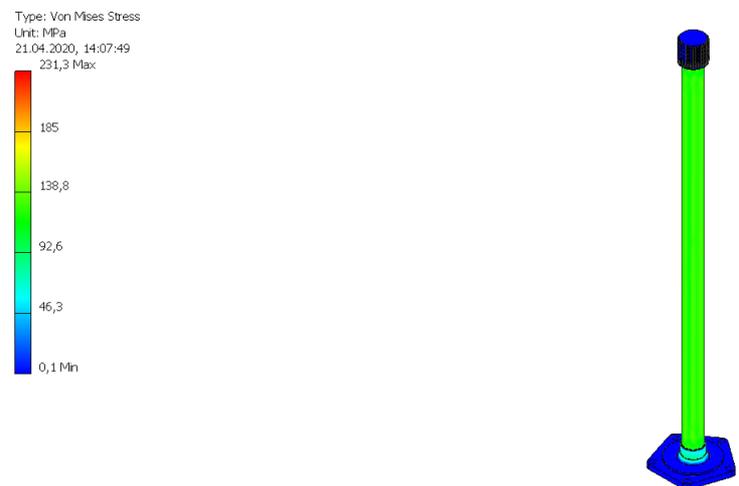
Figure 11 presented the values of the von Mises stresses obtained where the torque M_x was equal to 140 MPa. It was visible that the von Mises stresses reached the value of $k_{fatigue}$.

Fig. 11. The von Misses stresses obtained where the bending torque M_x was equal to 140 MPa. It was visible that the von Misses stresses reached the value of $K_{fatigue}$.

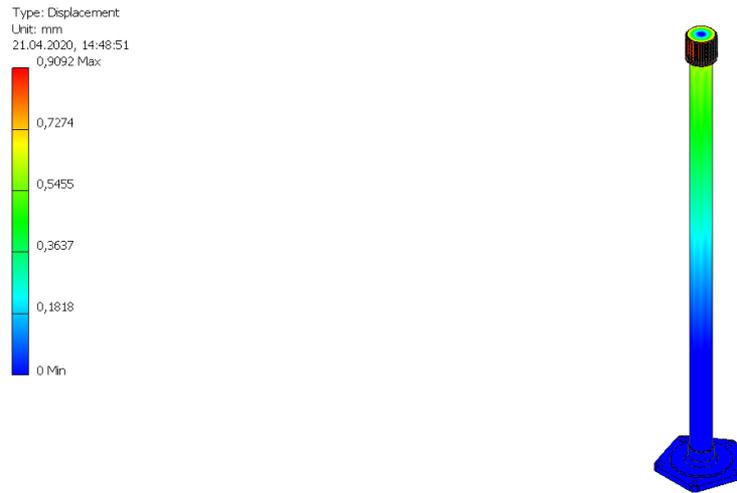
Figure 12 presented the values of total displacement obtained where the torque M_x was equal to 140 MPa. It was visible that near the middle of rear-axle shaft, displacement could reach values of 0.5 mm.

Fig. 12. The values of total displacement obtained where the torque M_x was equal to 140 MPa.

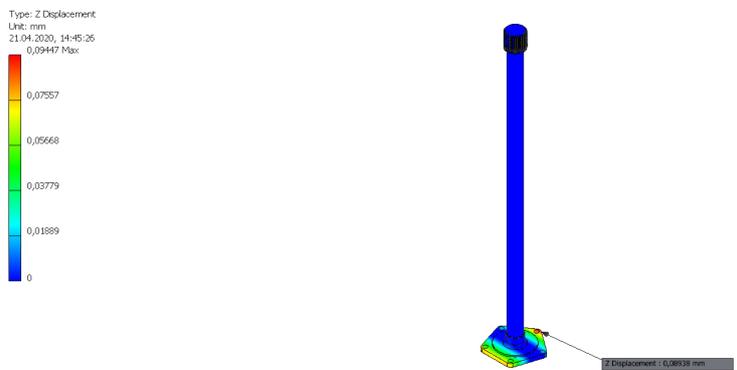
Figure 13 presented the values of displacement parallel to the axis of rear-axle shaft obtained where the bending torque M_x was equal to 140 MPa. It was visible that near the middle of rear-axle shaft displacement could reach values of 0.09 mm.

Fig. 13. The values of displacement parallel to the axis of rear-axle shaft (Z axis) obtained where the bending torque M_x was equal to 140 MPa.
