Analysis of Mechanical Traces Left Probably by Ball Lightning

Wiesław Z. Polak¹

¹ Department of Applied Physics, Lublin University of Technology, Nadbystrzycka Street 38, 20-618 Lublin, Poland

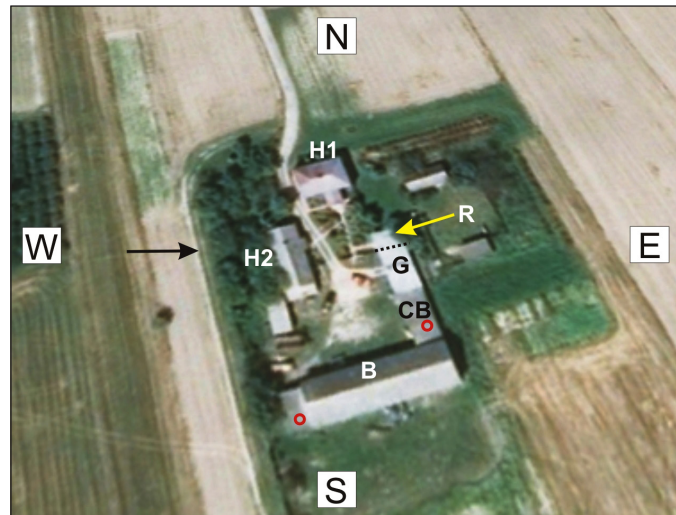
Fig. 1. Location of buildings on the farm as visible in the Google Earth Database: H1 and H2 houses, B barn, CB cow barn and G garage. Black arrow shows the wind direction, while yellow arrow points the location of the room (R) with eyewitnesses. Red circles point the location of holes in roofing made possibly by linear lightning strikes.

Observation of the surrounding area revealed large damage on the farm caused by the strong wind. A large part of the roof covering the cow barn was thrown away while the roof of house H2 and, to a lesser extent, in part of barn B (see location in Fig. 1) showed in numerous places torn, broken or bored large corrugated asbestos tiles. In one of the asbestos tiles on the cow barn roof, ca. 15 meters from the described room, the author found a round hole of several cm in diameter (the hole shape shown in camera snapshots in Fig. 4a), which could arise as a result of ordinary lightning stroke. More difficult for explanation is a large hole in the roof of the barn associated with two satellite small holes (see Fig. 4b). As a result of destruction of the roofs in buildings H2 and CB (see Fig. 1), numerous pieces of broken

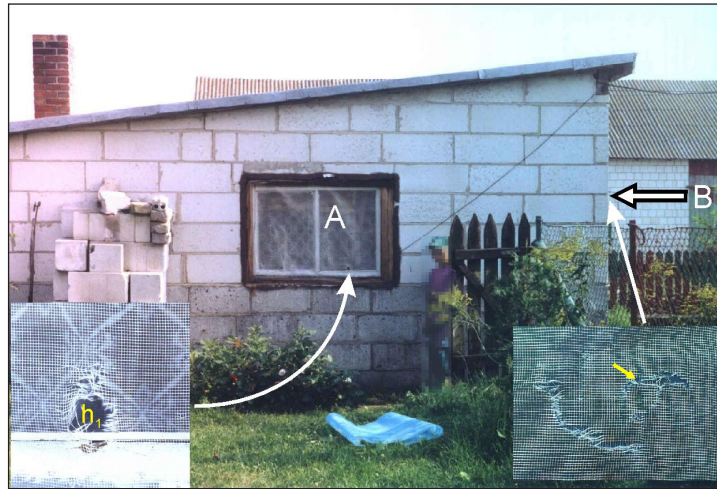
Fig. 3. View from the north to the building, where witnesses stayed, showing the window A with re-attached original anti-insect mesh and location of the window B on side wall. In insets are visible fragments of the meshes with holes created during the storm with the rounded one h1 from window A caused probably by ball lightning.

There was one rounded hole in the mesh A with torn away fibers (left inset in Fig. 3), but the number of holes in the mesh B (right inset in Fig. 3) was greater even though the surface of the window B is smaller about 2.5 times. Moreover, the holes in the mesh B are much more elongated, but the torn away fibers are practically absent. All holes in the meshes A and B have the characteristics of mechanical damage. There are no signs of high temperature or burning. This can be deduced from the fact that parallel mesh strings (their diameter is 1 mm and separation 2.5 mm), made of braided glass fibers and strengthened by a flammable plastic, were cut or thrown instead of being melted or burnt.

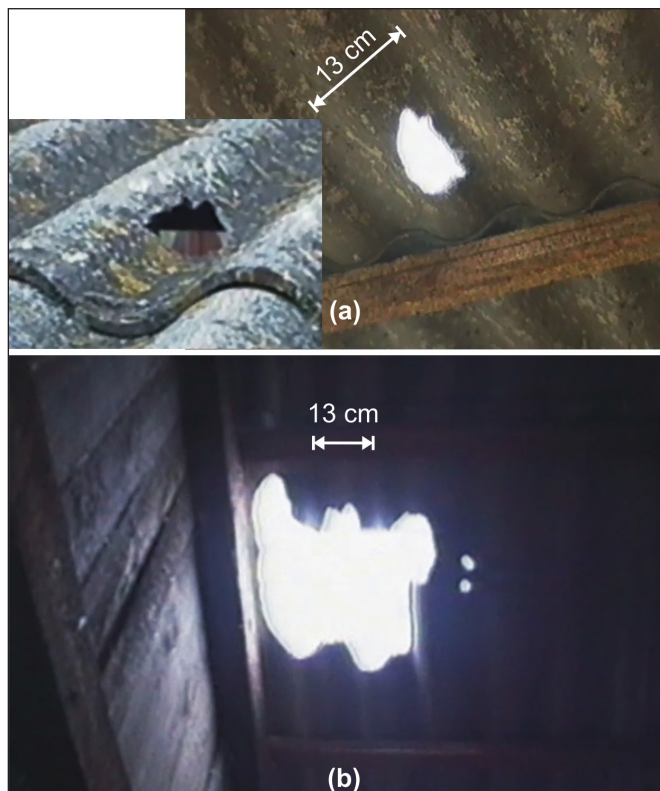
Fig. 4. Camera snapshots showing holes in asbestos tiles found in the farm on the roof of: (a) cow barn as seen from above (left) and from inside (right), and (b) barn from inside.

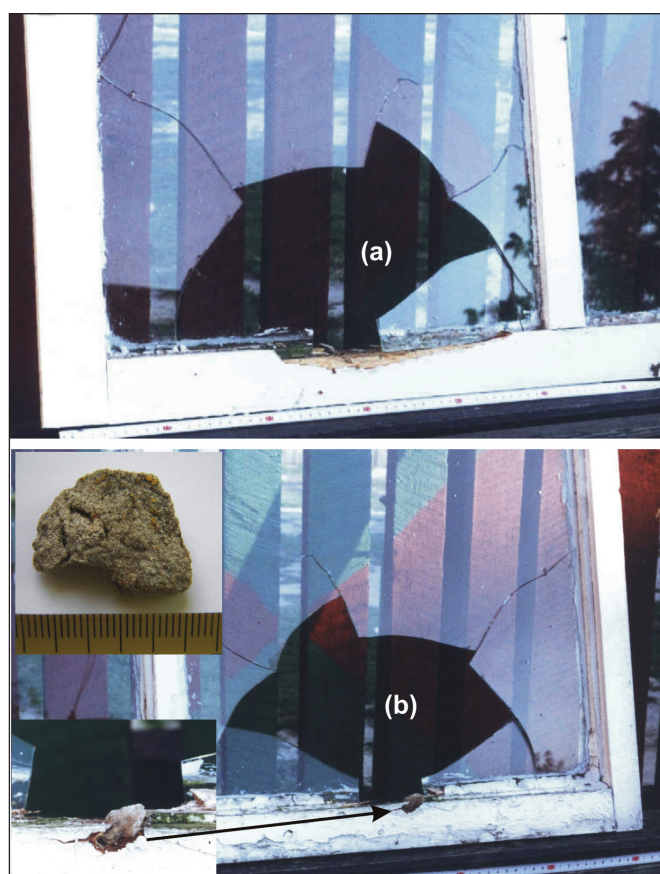
The author inspected carefully parts of the two windows in the utility room including: remaining pieces of the broken panes, wooden window frames and the front-window meshes. The latter ones, as damaged during the storm, had already been removed by the owners, but were fitted again to the window (see Fig. 3) to restore the state right after the event. The lower, internal part of the wooden frame of the window pane A was chipped off producing a splinter of the length of over 20 cm (Fig. 5a).

On the outer side of the frame from the window A the author found pounded an irregular pebble (see Fig. 5b) with a mass of 4.0 g and sizes $2.8 \times 2.1 \times 0.7$ cm, which in its composition resembled a piece of mortar. The pebble pierced the mesh as evidenced by mesh glass fibers found after removing the pebble from the cavity created during the hit in the wooden frame mounting the pane. Die-cast of the cavity retained these fibers, but also allowed to determine the volume of the hole to be about 0.8 cm^3 . Comparing the position and size of the pebble and the shape and size of the hole in the mesh (see left inset in Fig. 3) it could be concluded that at least two objects passed through the mesh in close proximity: the pebble and something else with a diameter of not more than 5 cm. From the inclination of the hole in the wooden frame, the direction of movement of the pebble during the hit as 25° with respect to

Fig. 5. View of the dismantled window A: (a) internal part with torn off a large piece of wood from the bottom of the frame, (b) external part with pebble driven in the wooden frame (magnified in inset). Upper inset photo shows the shape and size of the taken-off pebble.

the plane of the window pane (see Fig. 2) and 40° to the horizontal line (cp. Fig. 5b) was estimated.

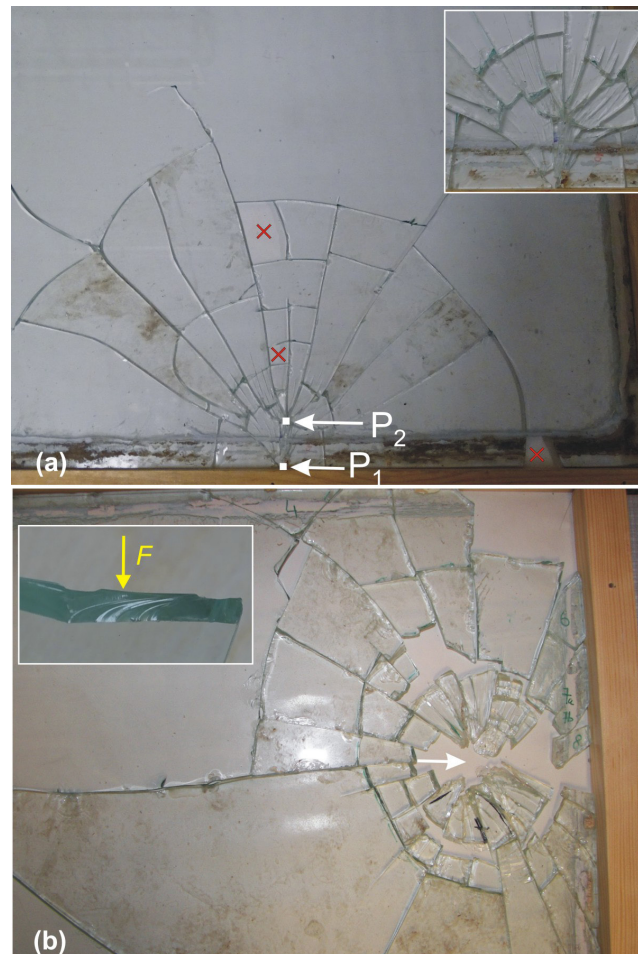
In the case of the window A, the reconstruction is almost complete, since only three small fragments are missing (see Fig. 6a). Some fractures propagate from the point P_1 on the edge of the windowpane located at the point where the pebble was driven to the pane frame (cp. Fig. 6a and the inset in Fig. 5b). However several cracks originate from another point P_2 located 3.0 cm above the point P_1 .

The glass of the window B was much more difficult to reconstruct because it cracked to many small pieces and some of them were even not found. Nevertheless, a dominant portion of the pane B was reconstructed enabling the location of the impact site pointed by arrow in Fig. 6b. Fragments of the broken pane B near this hypothetical impact point were too small to be collected by the owners or arranged properly during reconstruction.

line is always perpendicular to the glass surface opposite to the impacted glass surface (see inset in Fig. 6b) as it is expressed by 4-R Rule [13]. Applying the rule, it was found that fractures in both window panes are typical for the impact on the pane from outside.

It is known from the literature [13, 14] that cracking of a glass pane near the center of an impact point leads to the formation of radial cracks/fractures, propagating from the center, and concentric fractures surrounding the impact point. Shapes of fractures in the window glass B (Fig. 6b) are very similar to those shown in the manual [13] as caused by a blunt object. The large fragment of an asbestos tile, brought by the wind blowing from the building H2 (see Fig. 1), can explain the glass destruction. The elongated and curved shape of the largest hole in the mesh B (see right inset in Fig. 3) suggests that it could be initiated by cutting on sharp edges of the concentric fracture and torn by the asbestos fragment impacting the window glass through the hole in the mesh pointed by yellow arrow in Fig. 3.

In the case of the pane A, some radial cracks propagating from point P_1 terminate at point P_2 (see Fig. 6a), where new radial cracks originate, which, as judged from their directions, could not be initiated at P_1 . This suggests, if not confirms, that the pane breaking was initiated in two points P_1 and P_2 practically at the same time. Since the pebble hit and stuck in the wood frame, it could only initiate cracking of the pane from the point P_1 located on the glass edge near its impact point (cf. Fig. 5b and 6a). The pebble alone was not able neither to push the glass fragments into the room nor to tear off the above mentioned large splinter from the frame inside.

Fig. 6. Reconstructed glass panes from window: (a) A, and (b) B. Three missing fragments of the pane A are pointed by red cross. Two origins P₁ and P₂ of radial cracks in the pane A are marked by white squares pointed by arrows. In the case of pane B an arrow points the unique crack origin. Upper inset shows a magnified picture of the cracks in the pane A, while bottom one demonstrates shapes of the Wallner lines at the surface of a radial fracture caused by a perpendicular force F. Some collected fragments of the broken panes become dirty by soil particles.

attached pebble is accelerated to a relatively large value by the negative electric charge striking the building with the witnesses inside. After hitting and piercing the mesh, the pebble hits the window frame and sticks in it initiating several radial cracks at the windowpane edge at the point P_1 (see Fig. 6), while the BL core is destroyed rapidly turning into positively ionized nitrogen gas. Explosive destruction of moving BL core during contact with the mesh in the window A, strengthened by a kinetic energy, including possible core rotation, can be responsible for a mechanical destruction of the mesh. Due to large forces of interaction with negative charges on the ground or on the building, prior to the total electrical neutralization of the gas, it pushes the bottom of the pane leading to its breaking at the point P_2 . The forces are high enough to break off 20 cm long splinter of the wooden window frame (see Fig. 5a) and throw glass fragments far into the room. Sound effects can probably be attributed to the rapid release of nitrogen ions from the core particles and to the escape of the nitrogen gas through the broken glass.
