Research on the Causes of Cracking of Pipes Derived from Recirculated Polyethylene

The objectives of the research was to determine the causes of cracks in pipes made of high-density polyethylene (HDPE) regranulate during their storage. A visual assessment of the cracks was carried out and their fatigue nature was found. Due to the insufficient information on the composition and properties of the processed regranulate, tests were carried out on the density distribution and mass flow rate of plastic samples taken from various areas of the pipe wall. Comparative tests were performed using infrared spectrophotometry of a plastic sample taken from a pipe, commercial HDPE and commercial polypropylene (PP) by attenuated total reflection/Fourier-transform infrared spectroscopy (ATR-FTIR), thermogravimetry (TG) and differential scanning calorimetry (DSC) method. There were differences in density and flow rate depending on the distance from the outer surface of the pipe, reaching several percent. Based on the conducted spectroscopic, thermogravimetric and differential scanning calorimetry studies, none of the expected plastics contamination, mostly PP, has been found in recirculated polyeth

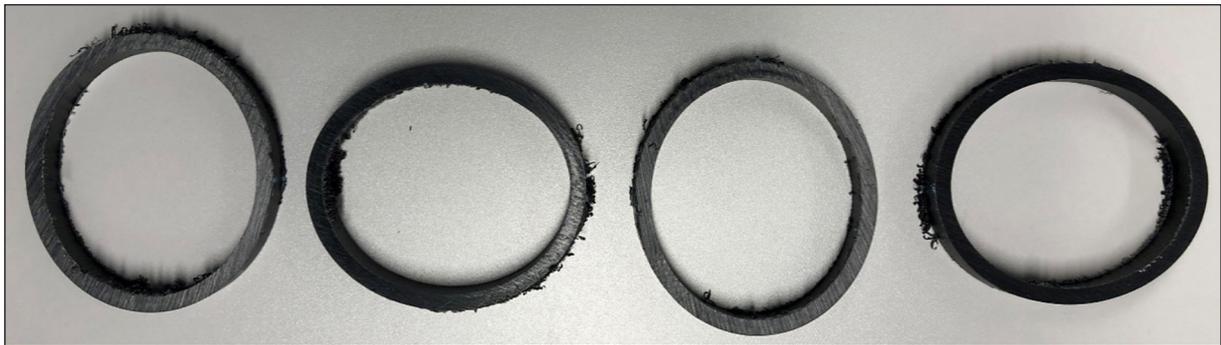
As a result of the pipe cross-section observation, a clear symmetry disturbance was found

(Fig. 1). This was most likely caused by storage with a significant external load, largely as a result of hoop stress in the coils pipes storage.

Fig. 1. Image of the cross-sections of the pipe sections

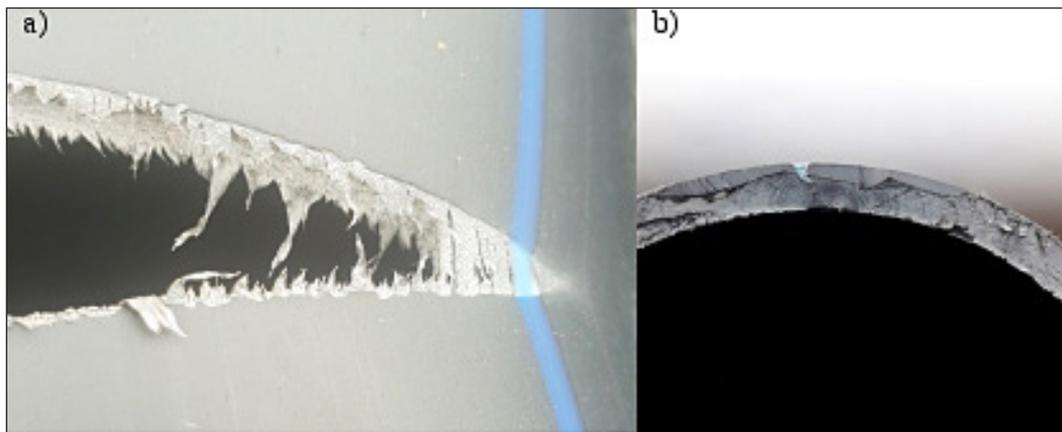
Transverse cracks were observed on the pipe surface (Fig. 2a), with predominant ductile fracture and transient mechanism. We can speak of a “quasi-brittle” fracture mechanism, typical for PEHD. However, the observation of the cross-section at the place of the crack (Fig. 2b) revealed its typical fatigue character, probably in the area of initiation and further propagation from the inner surface of the pipe. In this area of the pipe,

Fig 2. View of the pipe surface in the fracture area (a) and its cross-section in the beginning of the fracture's arc (b)

mainly compressive stresses occurred in the absence of longitudinal and transverse cracks, so the fracture was probably caused by changes in stresses due to temperature changes during storage, faulty material or surface defect.

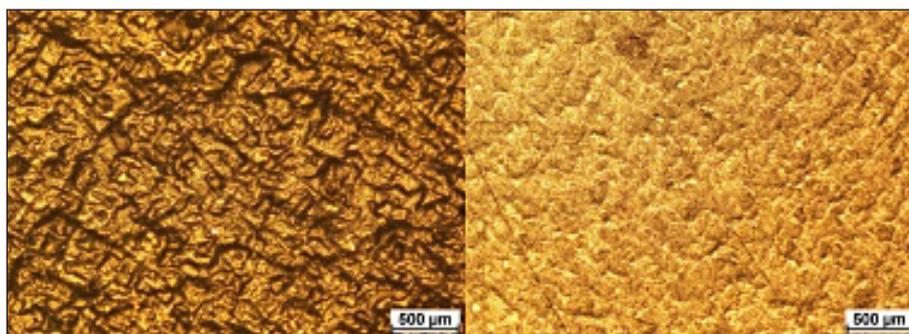
Fig. 3. Microscopic images of the recirculated (left) and fresh HDPE (right) internal pipe surface

The analysis of microscopic images of the inner surface for the tested and comparative pipe (Fig. 3). At first it indicates much greater unevenness on the surface of the pipe obtained from the recycled PE-HD, which could have contributed to cracking and to the rapid development of micro-cracks and their propagation due to the notch effect.

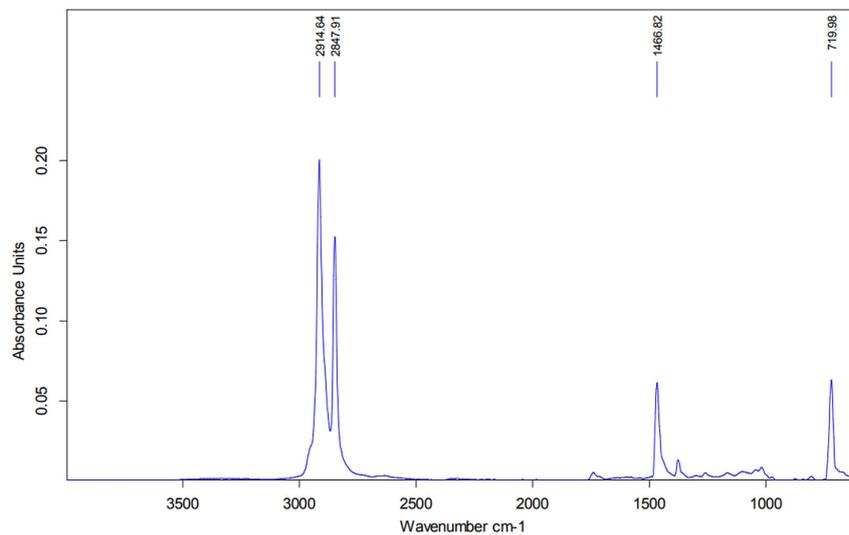
where the 2952 cm^{-1} and 1375 cm^{-1} bands are noticeable, which are responsible for the vibrations of the CH_3 group characteristic for polypropylene. The absence of these bands in the sample of polyethylene constituting the pipe material indicates no contamination with polypropylene.

Fig. 5. ATR-FTIR HDPE spectrum of the pipe

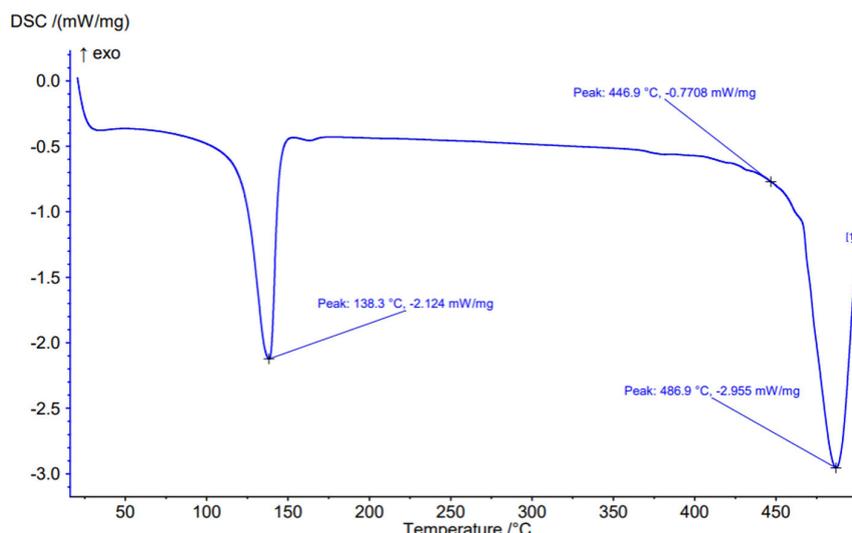
Figure 7 shows the DSC curve of the tested polyethylene regranulate used in the process of extrusion of the tested pipe in the range from 25 to 500°C . When examining the course of the DSC curve, its linear course can be noticed in the temperature range $25\text{--}120^\circ\text{C}$. Then there is a large endothermic signal at 138.3°C , which is responsible for the softening of the polyethylene due to disappearance of crystallites. Another recorded endothermic signal starts at about 440°C with a maximum at 486.9°C and is related to the thermal

decomposition of the material. There are no additional signals, which proves the absence of significant quantitative impurities, for instant PP.

Fig. 7. DSC curve of HDPE regranulate

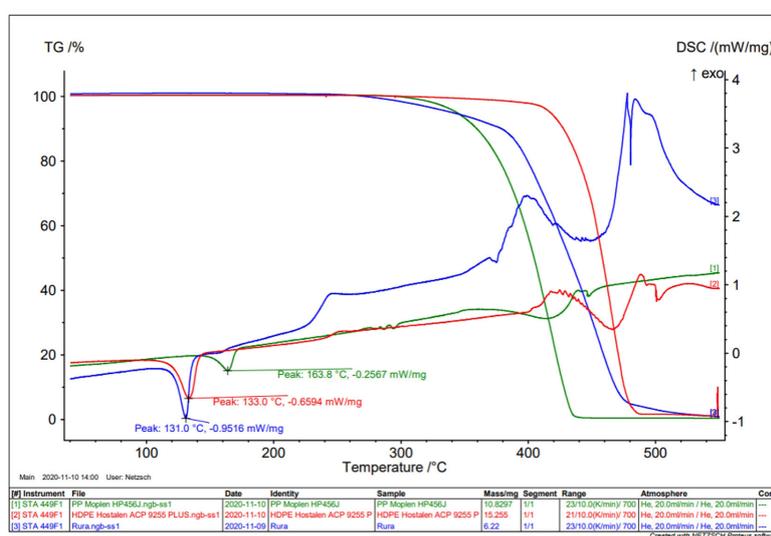
The analysis of the obtained TG/DSC curves makes it possible to state that the tested material taken from the pipe has the highest level of the transformation peak associated with the disappearance of the crystal structure at the temperature of 131°C , which is close to the transformation temperature of non-recirculated HDPE (133°C). At the same time, the transformation peak occurs at a slightly (about 7°C) lower temperature than in the regranulate sample, which may indicate some mechanical and thermal degradation of

Fig. 8. TG curves of the tested samples

polyethylene during the extrusion process. The phase change temperature of polypropylene is 163.8°C and is not visible on the TG curves in both tested polyethylene samples. The only dissimilarity that can be read from the TG curve are significant differences in the decomposition temperature of the tested materials. For recirculated polyethylene coming from the pipe it is about 280°C (maximum 400°C), while for non-recirculated PE it is about 420°C (maximum 460°C). The corresponding value for PP is 320°C (max. 430°C). Quiet slow mass reduction in the sample of recycled HDPE in the temperature range of 280–400°C, may indicate the presence of organic contaminant in the regranulate. In comparison to the unprocessed HDPE the initiate temperature of the dynamic mass reduction is lower, which

might be caused by passed thermo-mechanical polyethylen’s degradation during preinal use and futher processing.
