## Structure and Properties of the S49 Rail After a Long Term Outdoor Exposure

Jarosław Konieczny<sup>1\*</sup>, Krzysztof Labisz<sup>1</sup>

<sup>1</sup> Department of Railway Transport, Faculty of Transport and Aviation Engineering, Silesian University of Technology, ul. Krasińskiego 8, 40-019 Katowice, Poland

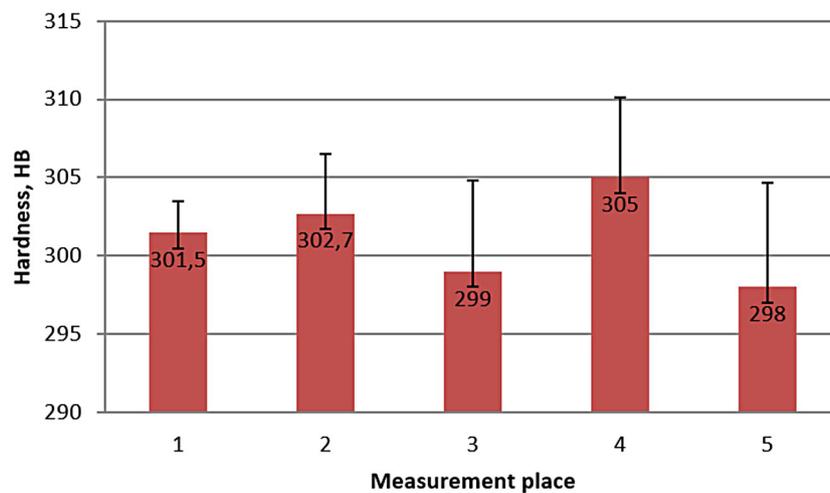
Fig. 4. Results of hardness measurement and standard deviation of the tested rail steel; measurement point 5 is related to RS area on Fig. 2

In accordance with the requirements contained in the Technical Conditions for the Making and Receiving of Rail Rails [13], the hardness on the centre line of the running surface of the rail head (at the RS point) should be in the range of 260–300 HBS. The measurement results showed that

the hardness of the tested rail meets the necessary conditions for using the rail for track construction (Fig. 4, Table 2). It is also worth to mention that the standard deviation of the measurements obtained in the required places is in the range of 2.0–6.7, which is 0.6–2.2% of the average value. This proves that the difference between successive measurement results is below the statistical error, it results from the fact that the tested rail over the entire cross-section is characterized by uniform values of the measured hardness.

The hardness tests performed indicate no impact of long-term rail aging on hardness, ranging from 298 to 305 HBS. Also noteworthy is the relatively low value of the measured standard deviation, confirming the homogeneity of the tested microstructure with regard to mechanical properties.

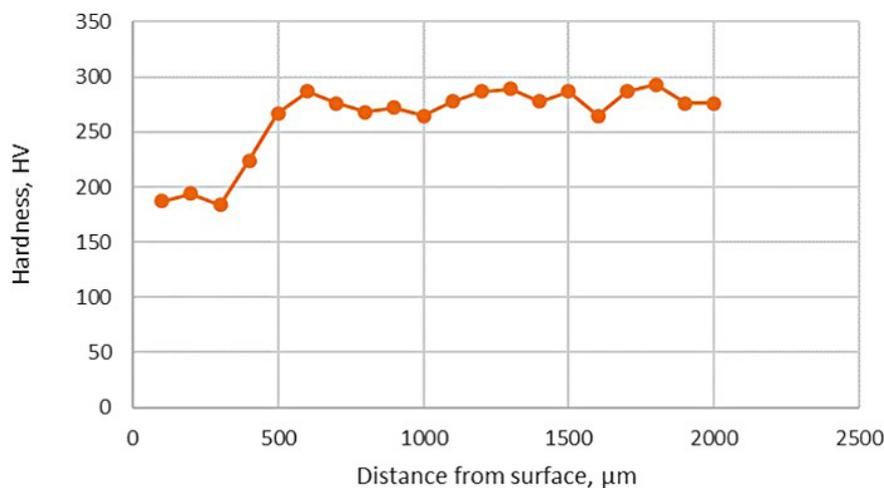
**Fig. 5.** Results of micro-hardness measurement and standard deviation of the tested rail steel measured in point RS, as shown in Fig. 3

Measured microhardness is presented in Figure 5, where the values decrease is visible, beginning from the relatively low level of up to 200  $\text{HV}_{0.05}$  in the decarbonizes layer going through a transition zone to the basic value of the rail core

reaching a value ca up to 300 HV<sub>0.05</sub>. There is visible a clear decies of the microhardness, related to the decarbonisation level in to a depth of 500 µm corresponding also with the obtained microstructures. On the top of the surface layer the microhardness is relatively stable in range of ca 180–200 HV<sub>0.05</sub> in to a depth of 300 µm. On this basis the decarbonisation can be confirmed and is similar to the microstructure related to the depth form surface presented on micrographs in Figures 7a and 7b.

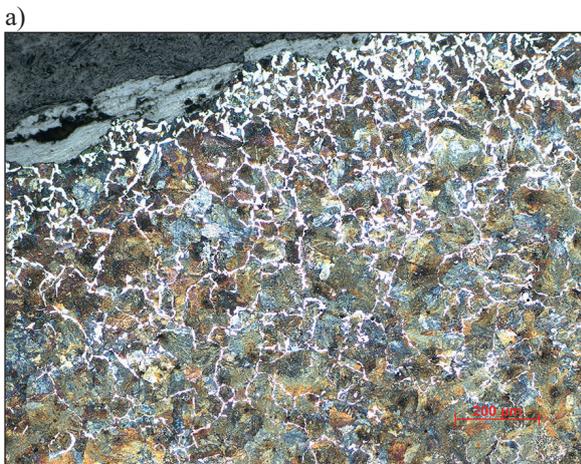
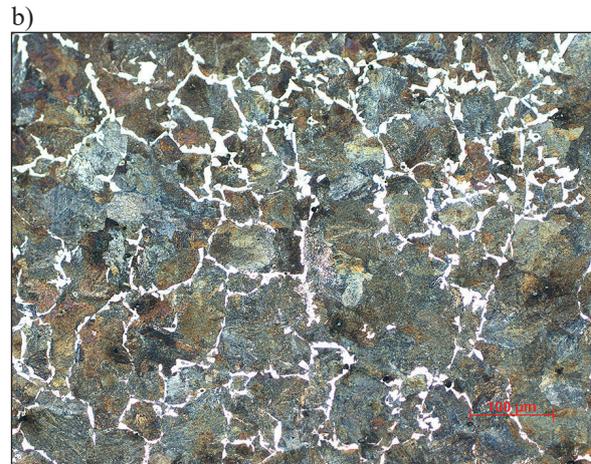
Fig. 7. Microstructure on the cross-section of the rail at the surface of the rail head from area 1 in Fig. 6

running surface of the head, the ferrite separation mesh no longer closes all grains (Fig. 6b) and finally disappears completely (Fig. 7).

No ferrite precipitates were found in the remaining area of the microstructure (Fig. 7a). The structure of the tested rail did not have the structure of martensite, bainite or cementite (Fig. 7b), which is in accordance with the requirements set out in the Technical Conditions for the Production and Collection of Rail Rails [13].

Figure 6 shows the places from which samples were taken for tests on the microscope. Decarburization occurred in form of closed ferrite mesh is visible in the area of 400–500 µm from the rail head surface.

As a result of microstructure tests, a uniform uninterrupted ferrite mesh was found in the examined rail material at a depth of up to 0.5 mm from the running surface of the rail head, which indicates that the heat treatment has been properly carried out and there is no visible impact of rail aging in natural conditions.

There are not found any cracks or defects of the surface layer, because of the nature of the storage of the rails, so the rail surface need only be to polish in terms of future usage grinding first of the decarbonized layer from the top of the rail.

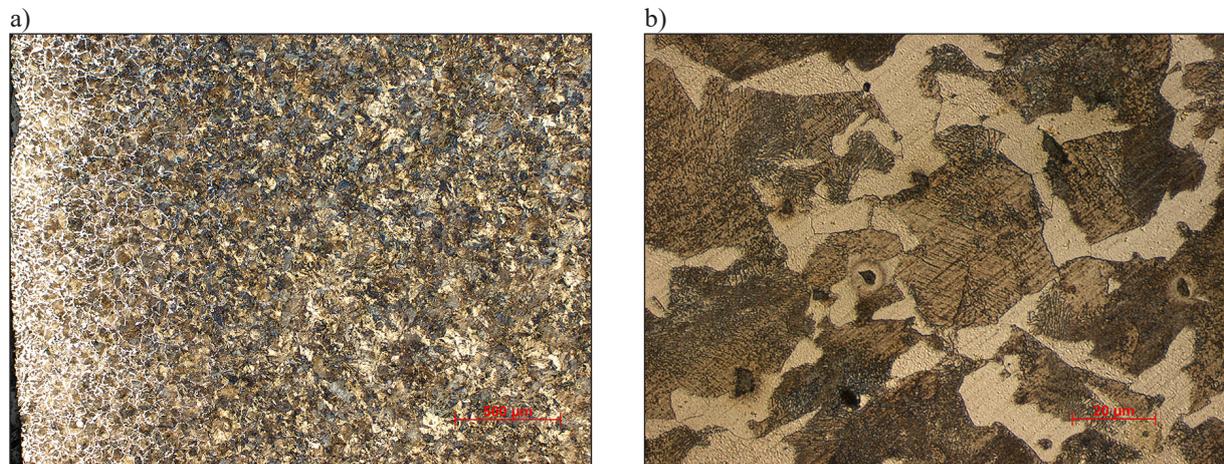
The presence of a decarbonised layer (Fig. 7, 9a) is well known, but its formation is still under investigation. Three occurrence of decarbonisation have been explained as reaction of the material surface with the environment also by oxidation. Much research has been done to elucidate the mechanisms and their effect on material performance and service life. Currently, it is argued that a mechanism can be used to explain this phenomenon, which is based on the combined action of friction and heat and dislocation that occurs as a result of plastic deformation. An additional factor affecting the quality of the material after long-term use is also the size and directionality of the pearlitic areas, in particular the direction of the ferrite plates (Fig. 9b, Table 3) which in the tested material indicates a relatively homogeneous character. On Figure 10 are presented microstructure obtained using the scanning electron microscope. There are visible large ferrite and perlite areas,

Fig. 9. a) Decarbonised layer on the left fig site, b) perlite plates direction

Concerning the size and perlite arms direction it can be proposed a decrease of the perlite areas size as well as to disorder the growth direction of perlite plates growth during plastic deformation of the rail in production process.

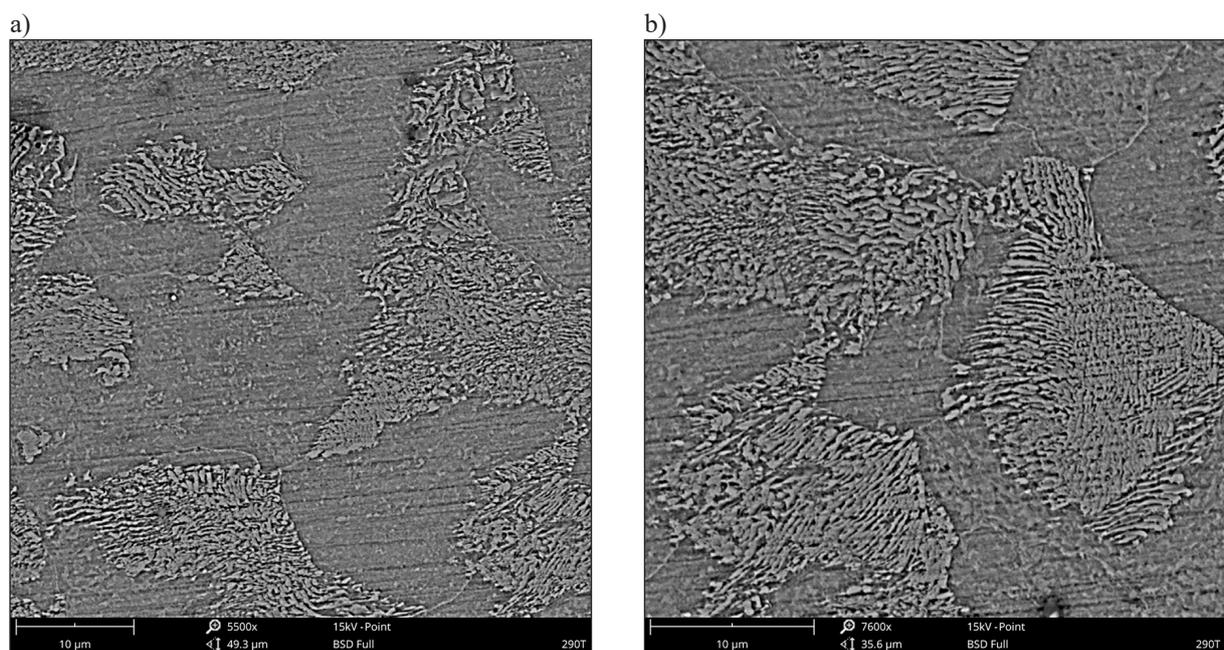
Fig. 10. Microstructure of the investigated rail steel, SEM

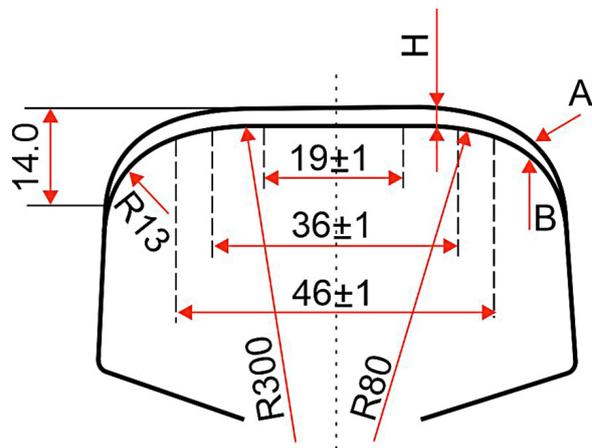
The required rail cross-section is presented on Figure 11, where the H parameter (maximum deviation from the theoretical contour of the running surface) is set as high as 0.16 mm for old-used rails. In the investigated case this distance is up to 450 μm, what requires mechanical removing of the surface area up to 300 μm, to be used main line, however for sidings line the additional machining is to be smaller or even can be skipping at all.

Fig. 11. Scheme of proper rail cross-section with parameters: H – maximum deviation from the theoretical contour of the running surface 49E1 (S49); distance A – B = H = 0.16 mm [36]
