MONITORING DIAGNOSTIC INDICATORS DURING OPERATION OF A PRINT MACHINE

Jozef Dobránsky¹, Petr Baron¹, Marek Kočíško¹, Monika Telišková¹

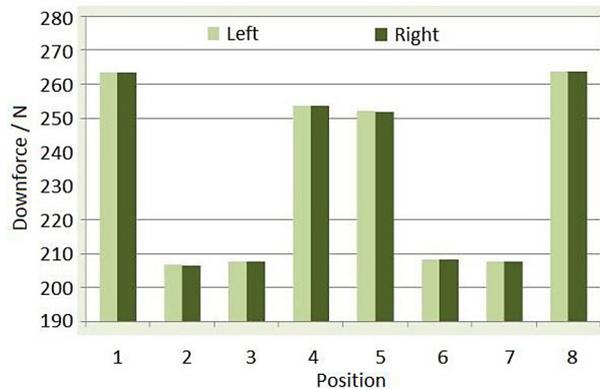
Diagrams (Fig. 1 and Fig. 2) present the downforce in the individual downforce positions. The impact of downforce is always horizontal. Regarding the position of valves no. 1, 4, 5 and 8, the downforce on the aforesaid valves is higher in comparison to other valves.

Fig. 1 Downforce on the anilox rolls in different positions

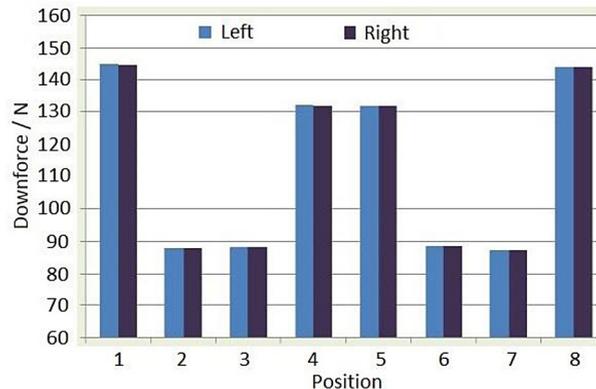
Fig. 2. Downforce on the plate in different positions

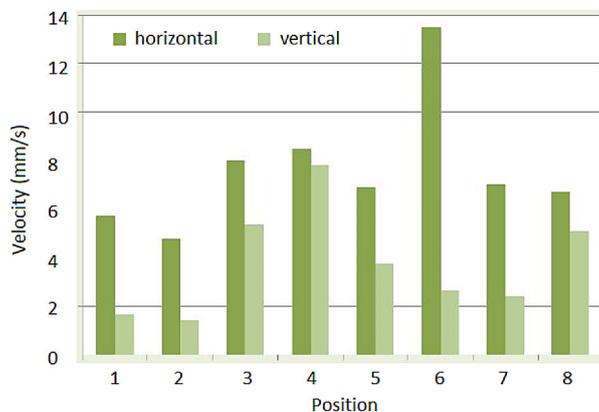
Based on the summation values recorded (diagrams in Fig. 3 and Fig. 4), we can conclude that positions no. 3, 4, 6 and 8 exhibit increased mechanical vibrations.

Fig. 3. The measured value of velocity on individual positions

We recommend checking the wear of the housings accommodating the bearings at the po-

sitions with high values of mechanical vibrations, discover and eliminate the cause of the oil leaking from the gear box.

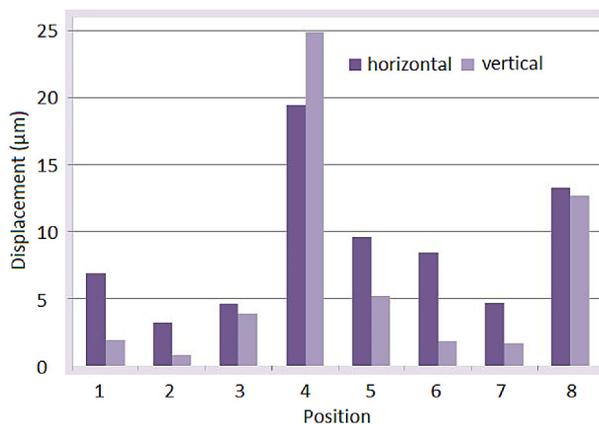
Fig. 4. The measured value of displacement on individual positions

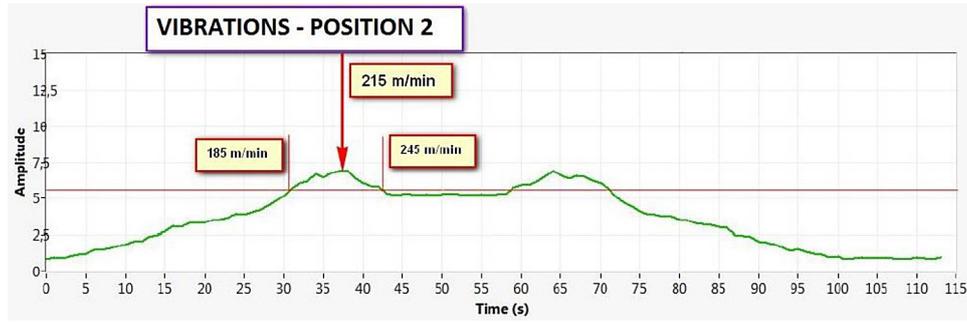
In Figures 5 and 6, difference in levels of summation values of different courses is visible. Measurement of courses was carried out at the velocity (of the line) from 50 to 250 m/min and back to 50 m/min. Position no. 4 exhibits the mechanical vibrations twice as high as position no. 2. In position no. 2, we discovered the resonance zone between the velocity of 185 and 245 m/min, reaching the maximum at 215 m/min.

Fig. 5. The course of vibration velocity to position 2

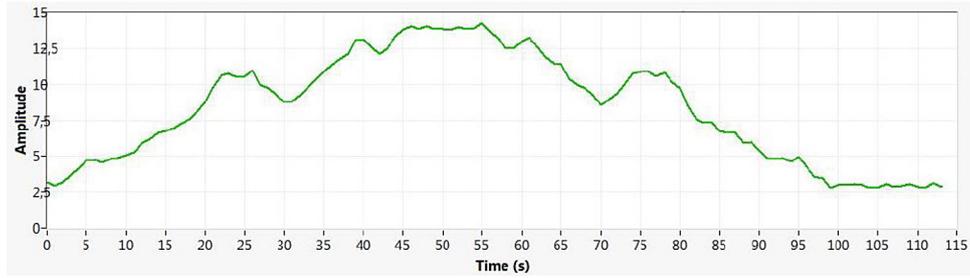
Fig. 6. The course of vibration velocity to position 4

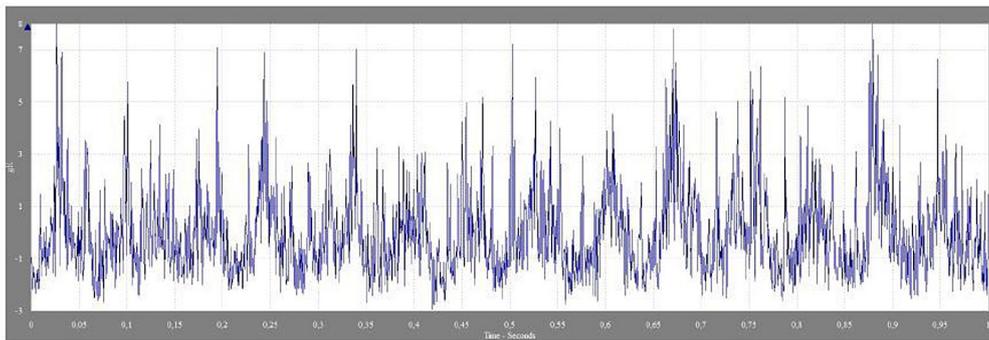
Recorded values listed in the table show that gearbox is the only troubled node (point 4, to be exact). The attempt to extract oil (transmission fluid) sample from the gearbox failed for there was almost no oil left. The transmission fluid was subsequently refilled. However, the oil did not re-

The records (Fig. 7, Fig. 8 and Fig. 9) contain significant amplitudes (several decuples) indicating the mechanical or tribotechnical problem. That was the reason why we proceeded with the physical check of the transmission gear. We checked the clearance as well as possible damage of the gear (pitting). Average clearance recorded was 0.5 mm, what suits the tolerance zone (0.3 to 0.6 mm). We found no visually recognisable damage on the individual cogs.

Fig. 7. Time recording HFAcc in point 4H (before oil-filling)

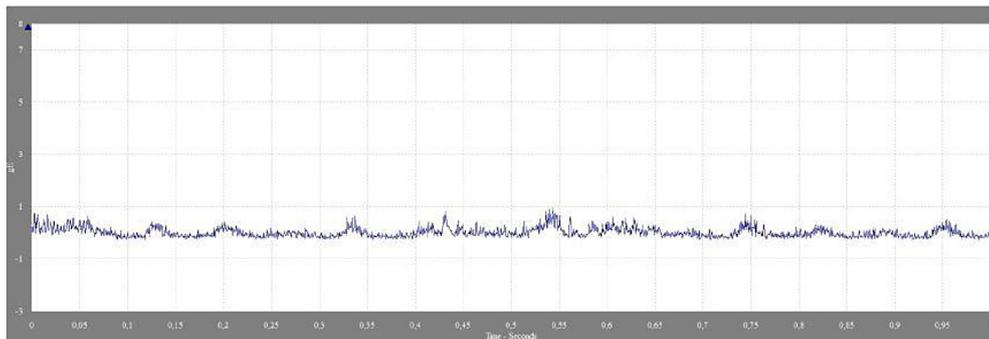
main inside the gearbox for a very long time and it leaked out. Following diagrams document the state of the HF vibrations in point 4 during the aforesaid states of the oil in the gearbox.

Fig. 8. Time recording HFAcc in point 4H (after oil-filling)

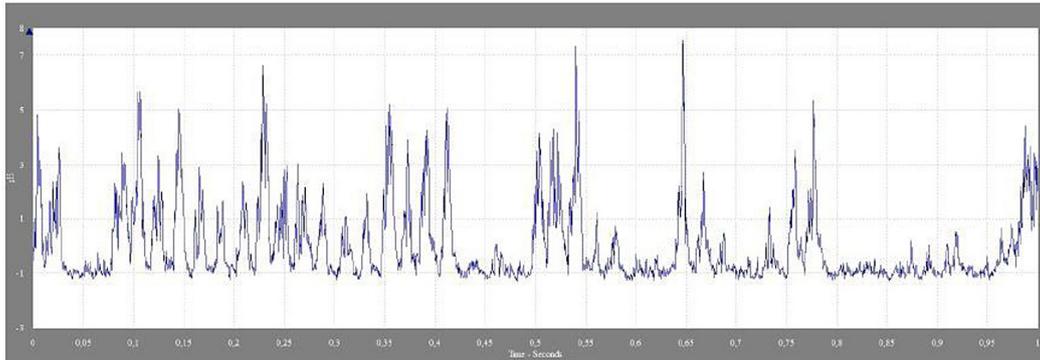
Fig. 9. Time recording HFacc in point 4H, a few days after oil-filling (oil spilled through the damaged seal)
