Damages of the Section Insulator Guide Caused by Electric Arc

ABSTRACT

This article presents research on the influence of an electric arc on the properties and structure of a traction section guide made of ETP (electrolytic tough pitch) copper in a segment insulator of a railway section. An electrical discharge occurring during use, which may accompany the passage of the pantograph current collector between adjacent guides, may cause many physical phenomena. In addition to existing guide wear mechanisms, such as friction, corrosion, and/or oxidation, the action of an electric arc also has a devastating effect on the guide in use, causing its complete destruction in extreme cases. The aim of the investigation was to determine what type of damage to the sectional guide in real operation conditions was caused by the impact of an electric arc that is induced when the pantograph passes from one guide to the adjacent one. The paper presents the results of tests on an operational guide made of hard electrolytic copper Cu-ETP, in particular the results of microscopic observations, the results of microscopic tests obtained using the ZEISS SUPRA 25 scanning electron microscope, as well as

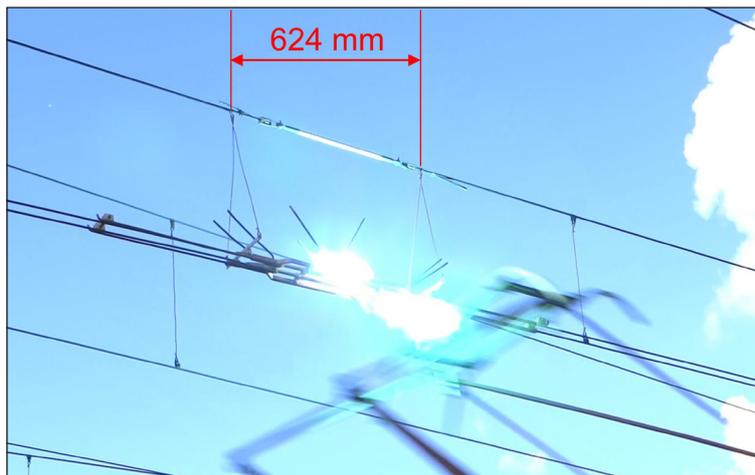
However, the most destructive mechanism is the electric arc, which arises during the passage of the pantograph through a section insulator (Fig. 2) and the physical phenomena generated with it [6], including local, short-term temperature increase up to a maximum of 20,000 °C [7], rapid expansion of evaporated metal and air [8], molten

Fig. 2. Electric arc caused by the pantograph movement between the guides of the section insulator

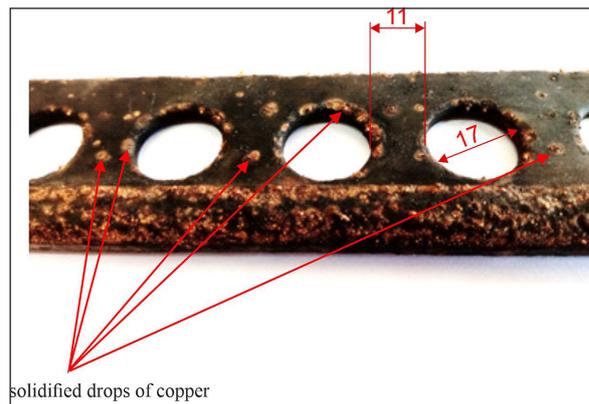
Such events are rare, but they do occur, as the photo below shows (Figure 4). Numerous drops of solidified copper are visible on the guide. Figure 5 shows the working surface of the guide; it shows no signs of tribological wear, but burnt craters are clearly visible and there are drops of solid copper on the side surface. Visible changes in the guide surface are the result of the electric arc.

Fig. 4. Damaged section guide; macro observations; maximum train speed on the route was 40 km/h (replaced after 1 year)

material diffusion. The authors of this publication noticed a similar phenomenon of guide degradation (Fig. 4 and Fig. 5). An electric arc consists of many separate, simultaneous discharges. The typical spot size observed in the structure is in the sub-micrometre range; local melting may result in the formation of a large number of characteristic cavities and pits (Figs. 6 and 7). The arc emigrates from one place to another with a relatively high probability of igniting near the pits formed by previous arcs, which ultimately leads to the formation of visible traces on a macro scale, which consist of a large number of craters of several micrometres in size [16, 17]. Arc erosion that appears during the use of the connector also depends on the surface quality, among

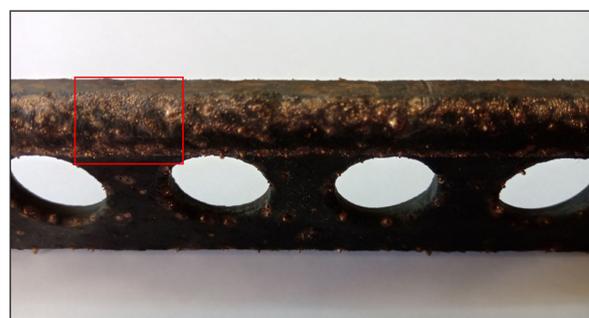
Figure 5 shows the impact of high temperature generated when an electric arc is discharged on the

guide (working) surface of the guide. Microstructure observations made using a scanning electron microscope (SEM) showed the presence of molten copper drops. This is the result of the melting of copper due to the high temperature that is generated when a discharge occurs in the form of an electric arc. In this area, traces of melting of the guide material were also found on the surface (Fig. 6). Although the high temperature is short-lived, it has locally reached the copper melting point.

Fig. 5. The working (sliding) surface of the guide and the side surface with traces of the influence of an electric arc; macro observations; and the maximum train speed on the route was 40 km/h (replaced after 1 year)

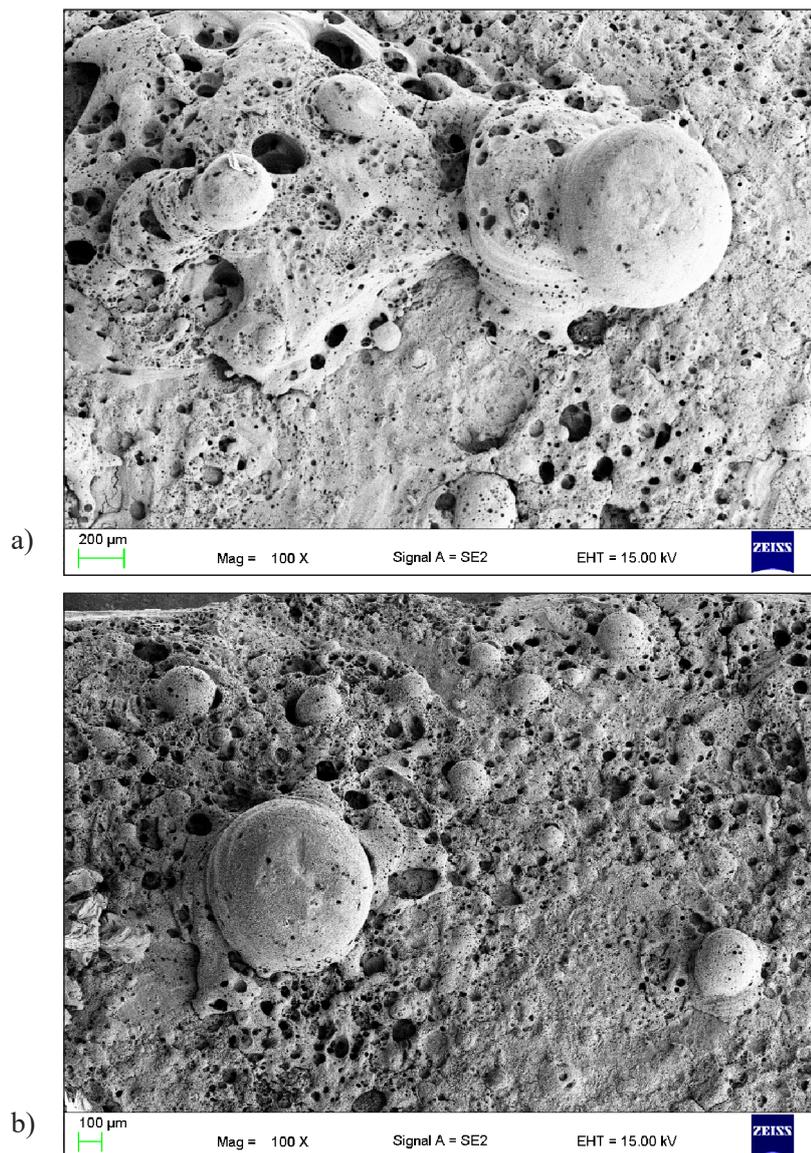
Figure 6 shows the working surface of the guide, which was the subject of the research. No traces of tribological wear were found. Grooves and burnt craters are clearly visible on the side surface, as well as drops of solidified copper resulting from spatter during the discharge of an electric arc. Additionally, quite numerous recesses and holes (holes and pits) are visible, which are also formed as a result of melting of the guide surface under the influence of an electric arc. Any changes occurring on the surface of the Cu-ETP copper guide are the result of electrical discharges during the operation of the traction network.

Fig. 6. (a) Working surface of the guide of a section insulator melted with an electric arc, view from the boxed area in Fig. 5; (b) the adjacent area to Fig. 6a, shown enlarged

3. The consequence of induction of an electric arc is the melting of the guide surface (Fig. 6, Fig. 7a), which results in deterioration of its surface condition and promotes the induction of an electric arc during subsequent passes of the pantograph through the insulator.

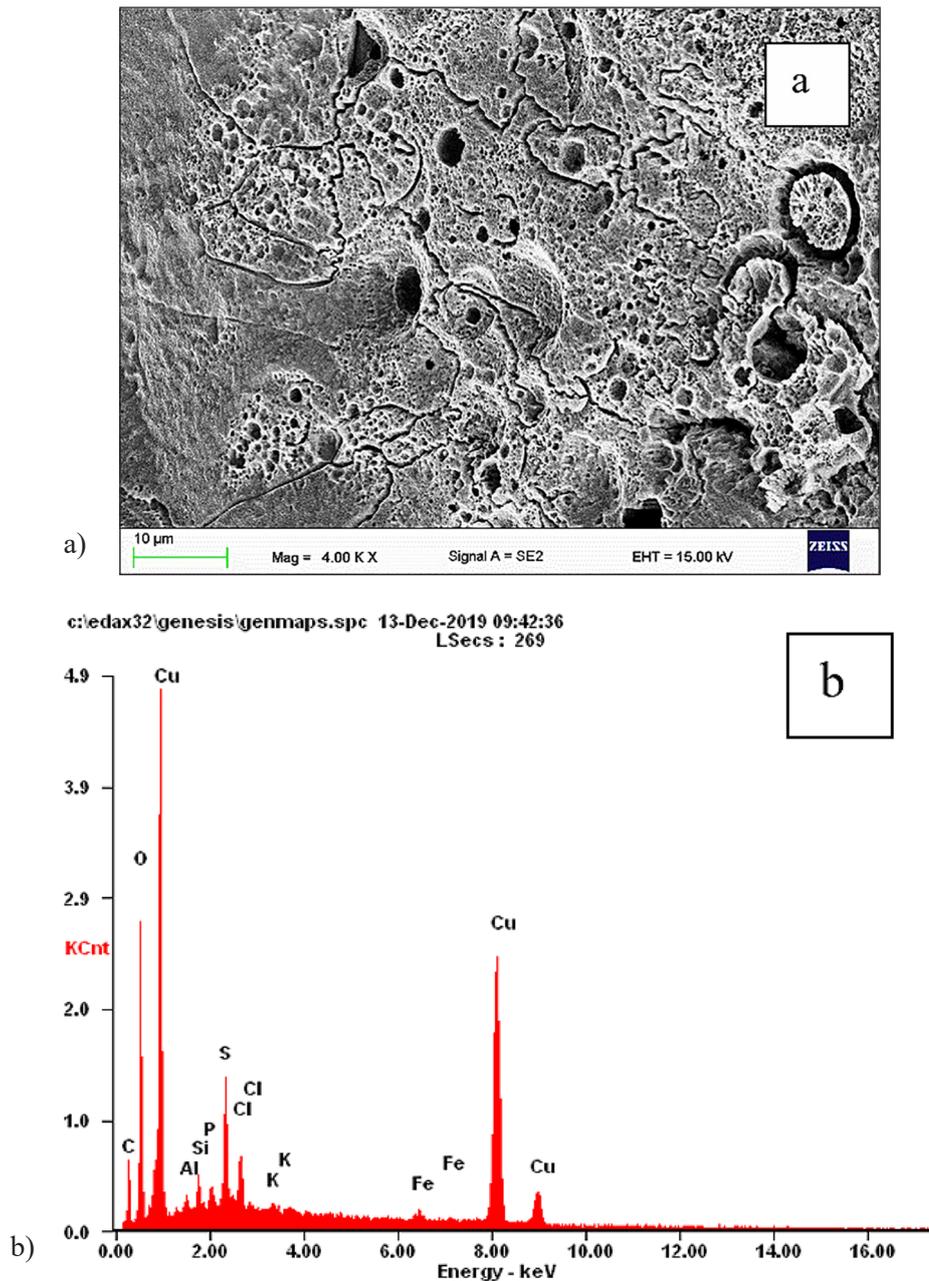
Another observed impact of electric arc discharge on the investigated copper guide made of Cu-ETP is the formation of cracks on its surface, as can be seen in Figure 7. The drawing shows the outer layer of the guide melt with burns and/or craters, as well as numerous traces of cracks occurring on this surface, similar to the impact of laser surface melting, carried out with HPDL laser for the purpose of enhancing the characteristic of the treated surface [36]. These cracks are most likely the result of relatively quick solidification of metal (Cu), which was previously melted at high temperature during the occurrence of electric arc discharges. Similar results were reported in the study reported in [14].

Moreover, based on the analysis of the scattered X-ray spectrum (EDS) performed on the surface of the guide exposed to the electric arc, the presence of elements occurring on the surface of the molten conductor and originating from the external environment was found, as well as a large amount of oxides (Table 2). What may be surprising is the relatively high content of chlorine, silicon, sulphur, carbon and iron, as well as minimal amounts of aluminium, phosphorus and potassium. These elements can also act as a factor influencing the hardening of the surface layer of the insulator guide, but they also reduce the electrical conductivity [37].

Fig. 7. (a) Guide surface deformed by an electric arc; (b) analysis of the chemical composition of the area shown in the Fig. 7a; SEM

4. As a result of remelting of the guide surface, particles of materials (Fig. 7b; Tab. 2) from the outside (dust cloud accompanying the train passage, transported materials, and raw materials) are feed into the material, which reduces the electrical and thermal conductivity, which increases the probability of an electric arc occurring during next train run.

6. Elements in the upper surface microstructure were found to come from the external environment, so efficient saving of the insulator part is suggested and required just to avoid huge electric arc discharge actions.
