Damage Investigation of a Stork Wärtsilä 6SW280 Engine Valve Exhaust – A Case Study

Michał Kawiak¹, Sławomir Krajewski¹, Kamil Urbanowicz^{1*}

¹ West Pomeranian University of Technology in Szczecin, al. Piastów 19, 70-310 Szczecin, Poland

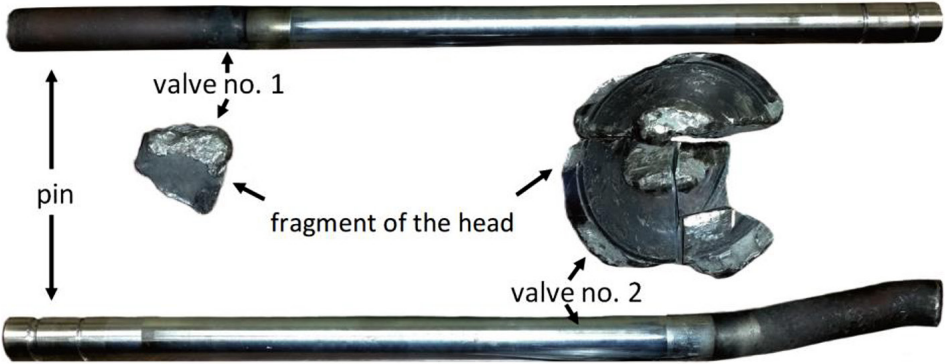
The investigation detailed in this article is based on the examination of research materials available to the author, as depicted in Figures 2 and 3. Figure 2 illustrates that, for valve no. 1, the material included the pin and a singular head fragment. Conversely, for valve no. 2, the material comprised the pin and two head fragments. Notably, the larger fragment of the latter valve had been dissected into four pieces during a prior

Figure 2. Examined exhaust valves parts valve no. 1 and 2

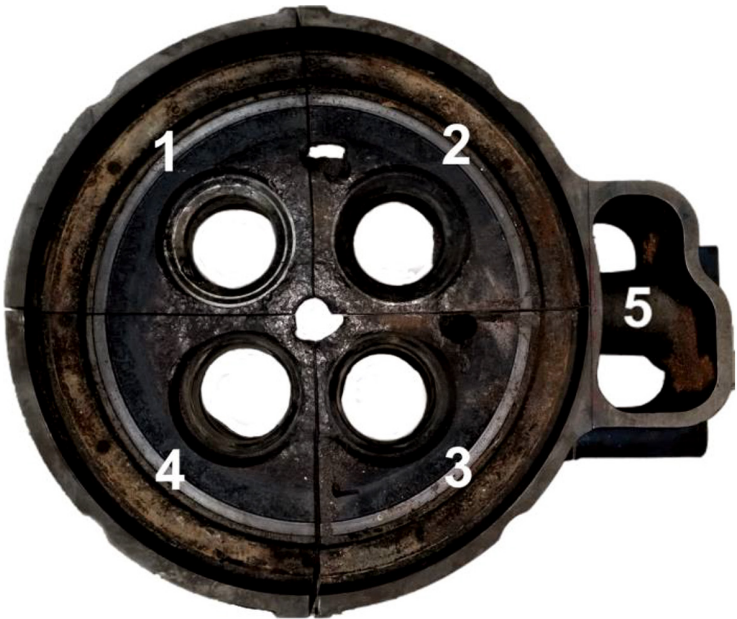
Figure 3. A fragment of the head of the marine engine cylinder no. 1 cut into five pieces numbered 1 to 5

The seats of the exhaust valves, affixed within the openings in the engine head, were found to be securely fixed in parts 1 and 2, as depicted in Figure 3. These seats displayed no propensity for movement under the influence of applied forces. To conduct a visual inspection of the outer surfaces of the valve seats and the openings in the engine head, kerfs were introduced on parts 1 and 2 using a chainsaw. Following impact with a hammer, part no. 1 of the head fractured into three pieces (refer to Fig. 7), while part no. 2 split into two (refer to Fig. 9). The exhaust valve seat from part no. 1 was extracted intact (refer to Fig.

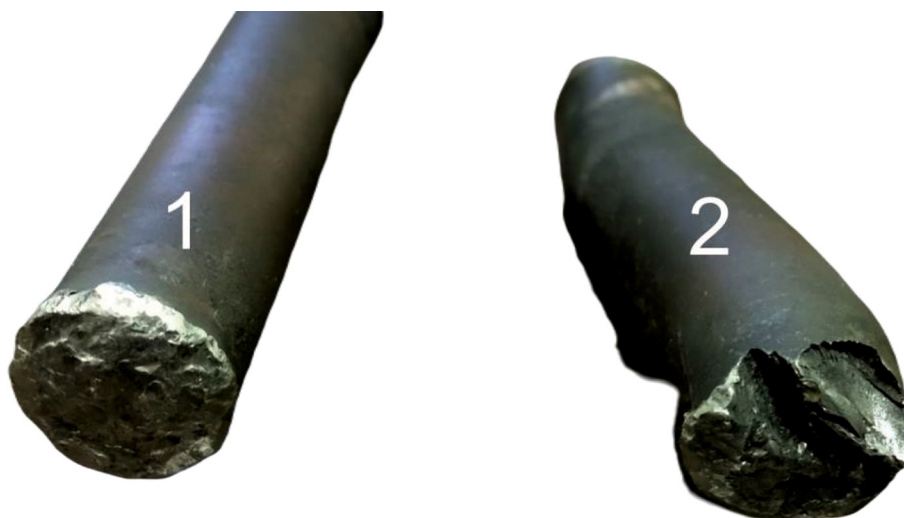
The failure of the two exhaust valves did not occur simultaneously, as evident from the distinctive fractures observed on the valve pins, illustrated in Figure 4. The fracture pattern strongly suggests that valve no. 1 was the first to experience failure. It is reasonable to consider two equally probable scenarios for the deterioration of valve no. 1.

The fracture observed on the pin of valve no. 2, depicted in Figure 4, exhibits characteristics consistent with a typical brittle fracture, manifesting within a relatively brief timeframe under a load surpassing the tensile strength, particularly during the valve-closing operation. Unlike the fracture surface of the pin of valve no. 1, which is predominantly perpendicular to the pin axis and indicative of a fatigue fracture, the fracture surface of the pin of valve no. 2 displays a less

Figure 4. Fractures of the pins of valves no. 1 and 2

pronounced perpendicular orientation. Furthermore, in contrast to the fracture of the pin of valve no. 1, the fracture of the pin of valve no. 2 underwent minor deformation during subsequent engine operation, as depicted in Figure 4. The fractures observed in the heads of valve no. 1 (refer to Fig. 5) and valve no. 2 (refer to Fig. 6) manifest distinct characteristics attributable to different types of loads, as substantiated by the outer structures of the valves.

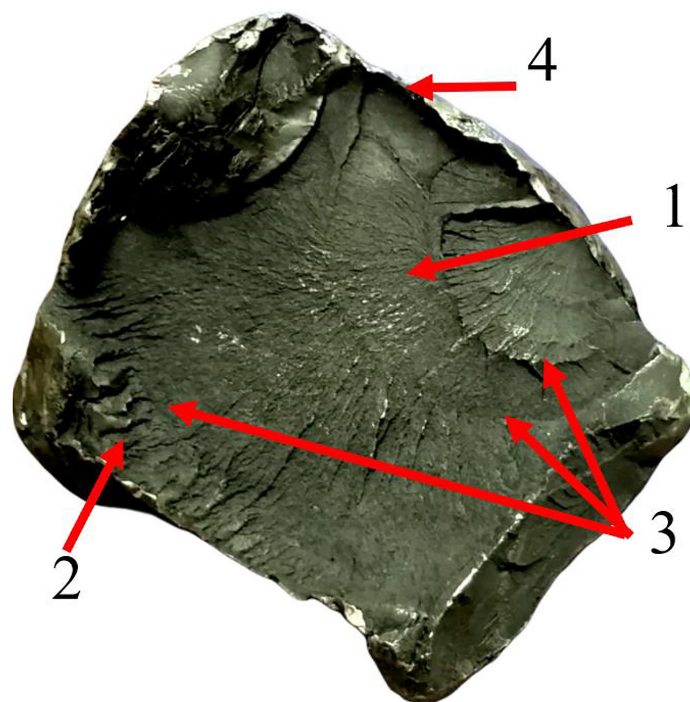
In Figure 5, the surface of the fracture exhibits hallmark features indicative of a fatigue fracture. Characteristic markings of a nucleation point, from which crack fronts radiate, are evident on this surface. As the dynamic load cycles increase, the fatigue crack systematically propagates deeper into the material. This fracture pattern aligns with typical fatigue behavior where repeated loading over time induces crack initiation and propagation.

Figure 5. A photograph showing the fracture of the head of the valve no. 1: 1 – fatigue part of the fracture, 2 – immediate part of the fracture, 3 – front lines propagating the fracture, 4 – plastically deformed outer surface of the head of valve no. 1

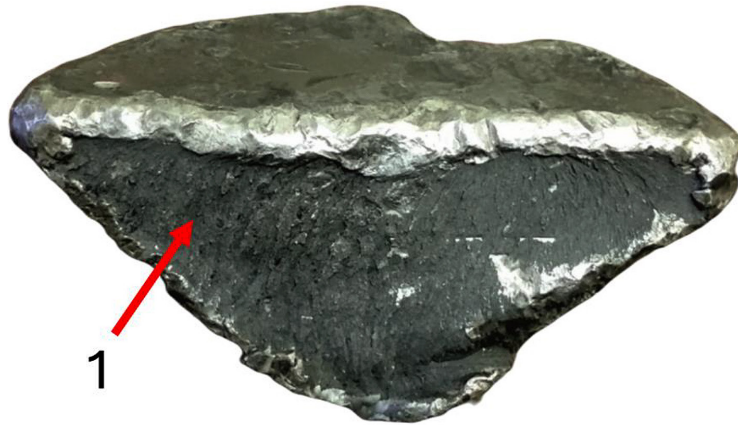
Conversely, the fracture surface displayed in Figure 6 possesses notable roughness, with irregular bands spreading predominantly parallel to the valve axis. The shape and characteristics of these irregularities strongly suggest extensive plastic deformation of the head material in this region. Regarding the presented fracture of the head of the valve number 2 (Fig. 6), there is no

visible focal point where fatigue crack initiation occurred due to deformation. This fracture is emblematic of a type that occurs under transient or temporary loads, indicating a distinct mechanism compared to the fatigue fracture observed in Figure 5.

Figure 6. A photograph showing the fracture of the head of the valve no. 2:1 – the fracture is characterized by significant roughness; its shape indicates significant plastic deformation, which is characteristic of acute fractures

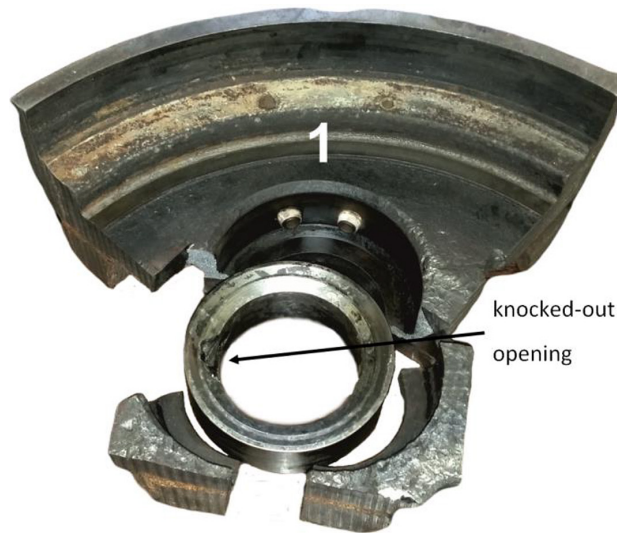
Figure 7. Part no. 1 of the head (Fig. 3) split into three pieces, along with loose valve seat no. 1

smooth, and shiny. However, in this case, the surfaces of both the valve seats and the openings retained a layer of tarnish. This suggests that the seats of the exhaust valves remained stationary in relation to the engine head during engine operation, exhibiting no discernible traces of axial or rotary movement. Moreover, the ports of the conduits supplying water to the seats showed no signs of damage or visible strains, as depicted in Figures 7 and 9.

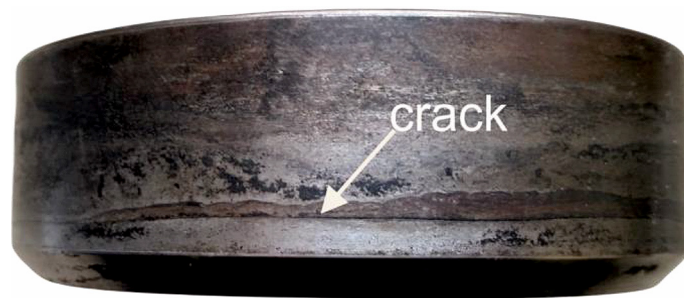
Figure 8. The seat of the exhaust valve no. 1 after having been extracted from the engine head

Upon extracting the seat of valve no. 1 from the engine head, the author noted a crack

extending for more than half of the seat's perimeter, as illustrated in Figure 8. The cracks in the valve seat no. 2, which manifested during engine operation, were of such magnitude (refer to Fig. 10) that when the seat became dislodged, it fractured into three distinct pieces.

These cracks in the valve seats emerged due to thermal stresses, particularly in the regions where there were significant variations in cross-sectional areas. Such cracks did not appear under normal engine operating temperatures. This implies that the temperature of the valve seats exceeded

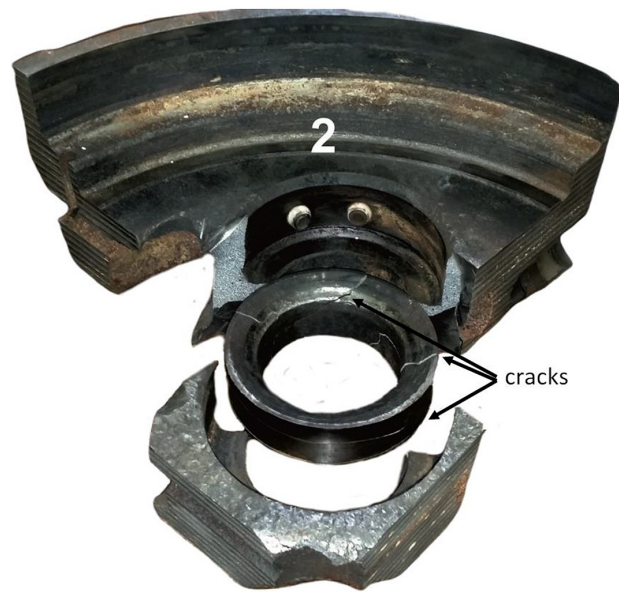
Figure 9. Part no. 2 of the head (Fig. 3) divided into two pieces and the loose seat of the valve no. 2

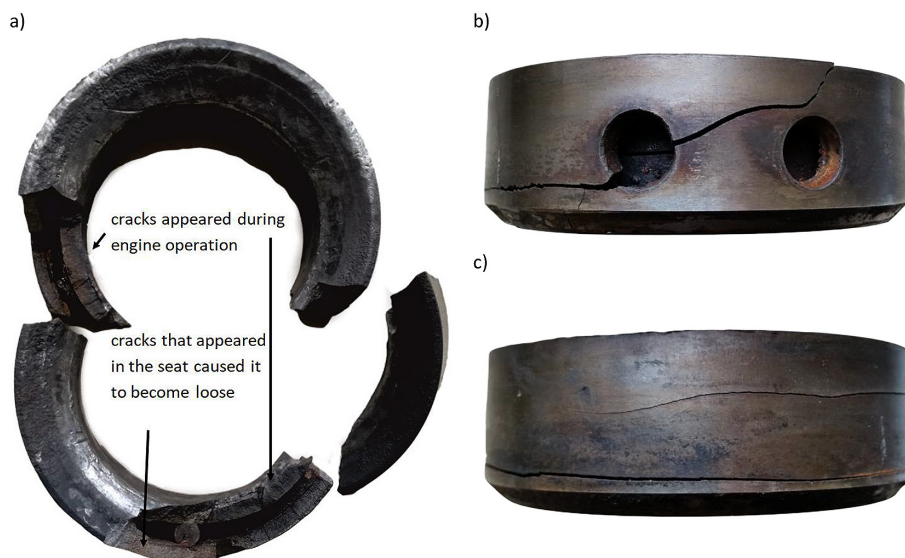
Figure 10. The seat of the exhaust valve no. 2 after having been extracted from the engine head – three shots showing the size of the cracks

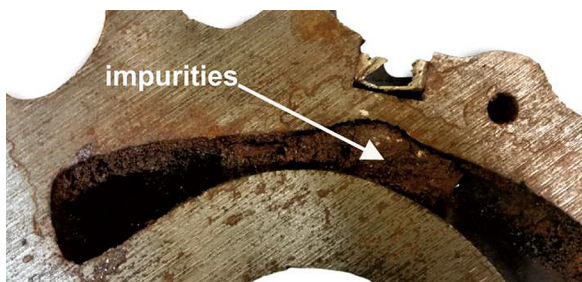
Figure 11. Uncovered cooling conduit in the engine head, partially filled with a mixture of swarf and rust

operation, potentially leading to an uncontrolled rise in cylinder temperature. A conglomeration of impurities (refer to Fig. 12) was extracted from the conduit (refer to Fig. 11), followed by an analysis of its chemical composition.

On the basis of these considerations, it can be concluded that the cooling conduit remained unobstructed, with its cross-section experiencing only a minor reduction due to the layer of rust deposited on the inner surface of the conduit.

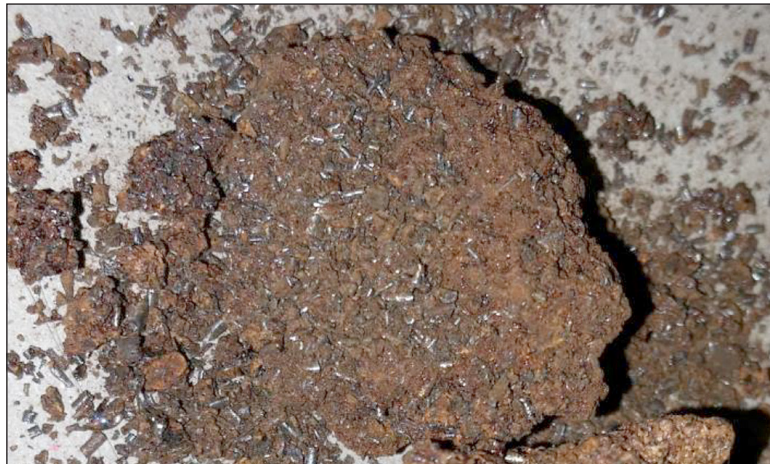
The analysis clearly indicates that such impurities only took this particular form during the chainsaw cutting of the head. They represent a blend of cast iron chips generated during the head cutting process and rust spalled from the inner surface of the conduit. The chip surfaces exhibit no corrosion, and their chemical composition aligns with the iron from which the head was cast. The rust, on the other hand, contains elements from both cast iron and cooling water. It had been accumulating on the inner surface of the conduit over an extended period. Subsequent spalling resulted in the rust and swarf accumulating in the lower part of the conduit, a phenomenon triggered by the head-cutting process.

Figure 12. A lump of swarf and rust extracted from the cooling conduit in the engine head

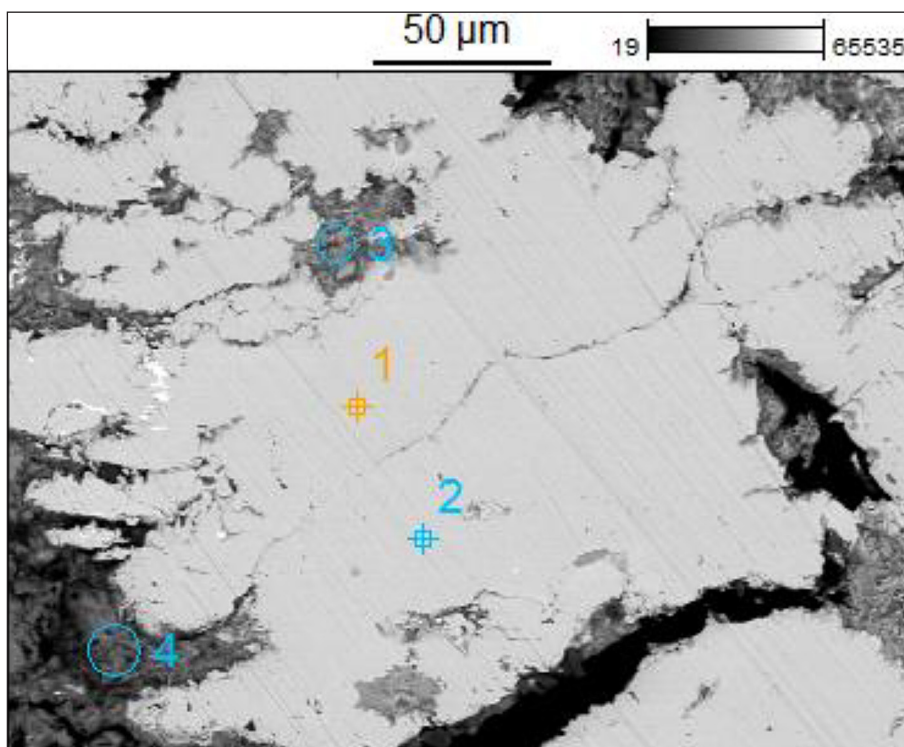
Figure 13. Points 1–4 of performing EDS analysis on the component extracted from the cooling channel of the analyzed engine. Marked locations of the destruction of a mixture of shavings and rust.

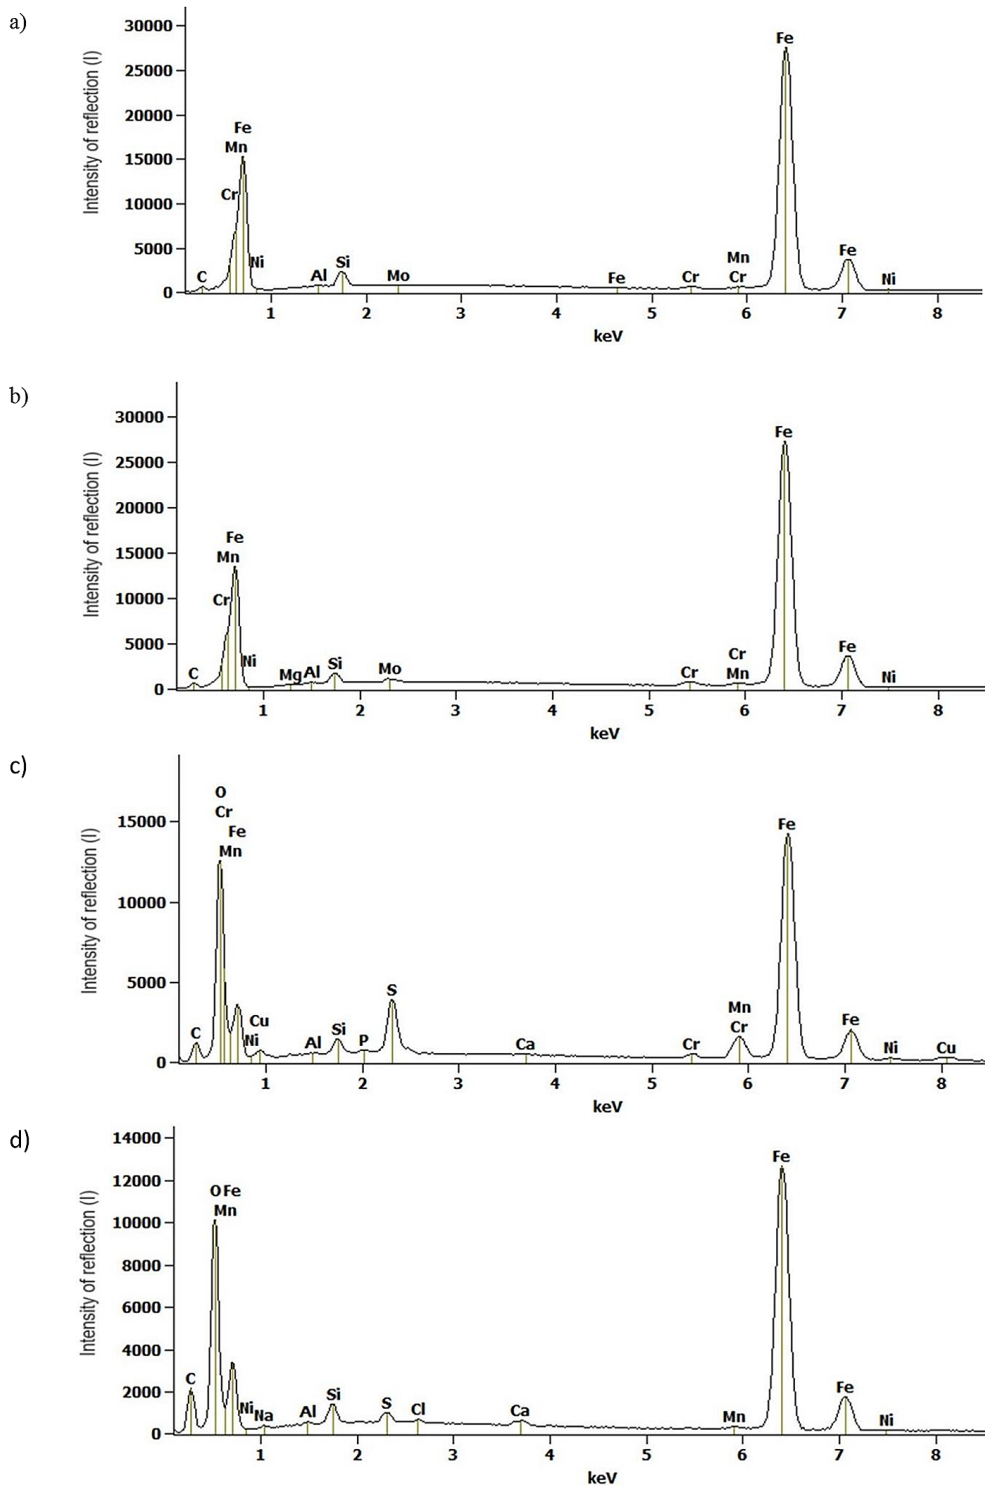
The chemical analysis was performed utilizing energy-dispersive spectrometry (EDS) with a Hitachi field emission scanning electron microscope, equipped with the Noran 7 microanalysis system by ThermoScientific. The analyzed material was mounted in Struers' PolyFast conductive resin, and a standard metallographic specimen was produced. Even at low magnification, it was evident that the impurities comprised a mixture of swarf and rust. Consequently, measurement points for analyzing the chemical composition were situated on the swarf and within the rust area. The analysis of impurities in the cooling channel of the engine was conducted using (EDS) on a sample taken from the locations marked in Figure 13 that depicts the destruction of a mixture of shavings and rust. Points 1 and 2 correspond to locations on the cross-section of the shaving, while Points 3 and 4 represent the areas on the cross-section of the material exhibiting a rusty color. The results of the analysis are presented in Figure 14 and Table 1.

As a result of the conducted "swarf" analysis, it is determined that the examined element is made of cast steel. The analysis revealed a carbon content not exceeding 2%, with manganese and silicon present in the material. The EDS method poorly identifies the carbon

not significant. The concentrations of other elements and impurities were important. In the "rust," elements such as oxygen, phosphorus, sulfur, and chlorine indicate a typical corrosive environment, such as exhaust gases.

Figure 14. Results of chemical composition of the impurities from the cooling conduit in the head: a) and b) measuring points on swarf, c) and d) measuring points on rust
