Use of magnetic flux leakage detection in diagnostics of coated elevator ropes

The aim of this article is to present the active magnetic method used in diagnostic tests to locate damage and determine the technical condition of flat steel-polyurethane cables and plastic-coated steel ropes used in lifting equipment. This article discusses the diagnostic equipment developed at AGH University of Science and Technology for magnetic testing of ropes in lifting devices. The results of tests conducted over the course of several years of operation of cables are presented. The changes in amplitude and signature of signals recorded during successive tests of selected flat steel-polyurethane belts are compared.

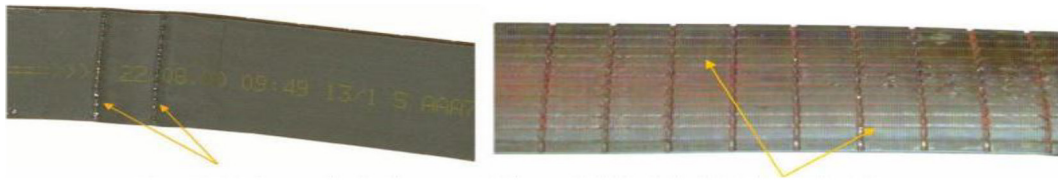
Figure 4. Deformation of the coating and imprints of the cables along the belt [22]

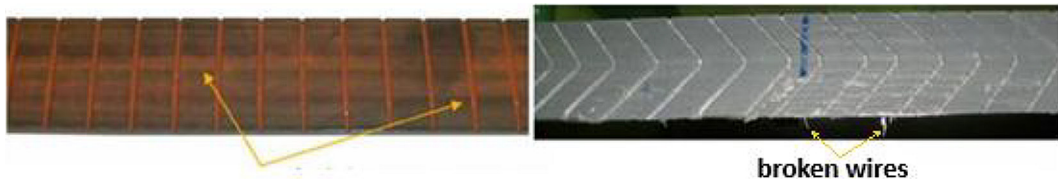
Figure 6. Corrosion symptoms and protruding wires [22]

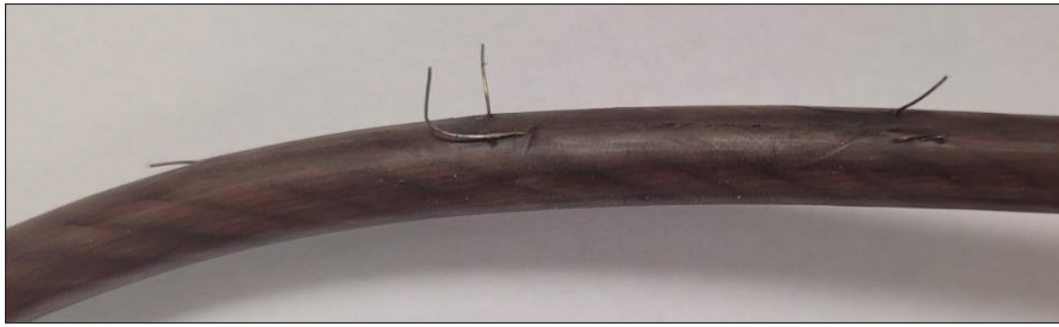
rope solely based on signs of wear observed on its external surface. The presence of broken wires can be detected when they penetrate the PVC warp. Figure 8 presents examples of operational damage to the wires in a CTP rope.

Figure 8. Damage to the wires of the CTP rope

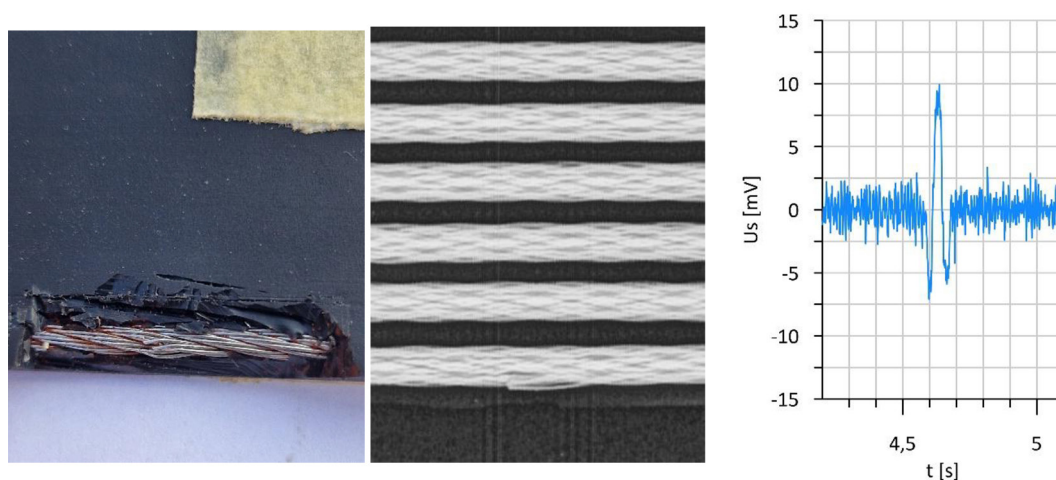
The diagnostic system used in the study, consisting of a measuring head and an MD121 recorder, was verified through laboratory testing. During these tests, a signal was recorded on a belt with artificially created damage. Modelled damage, consisting of cuts of 3, 4, 5, 6, 7, 14, and 21 wires in one of the cables, was created at appropriate distances along its entire length. Verification of the modelled damage was performed using RTD digital radiography. An example image of the modelled damage with 7 cut wires, a radiograph of this location, and the voltage signal recorded during its magnetic testing are shown in Figure 11. Analysis of the obtained test results for the belt with modelled damage enabled the development of a calibration relationship for the diagnostic set. The relationship between the recorded voltage signal and the percentage loss of the metallic cross-section is shown in Figure 12. This relationship makes it possible to determine the percentage loss of the metallic cross-section of the tested tendon and, on this basis, to estimate the number of broken wires.

Figure 11. A modelled damage in the form of 7 cut wires, a radiograph of this location and a voltage signal recorded during its examination using the magnetic method

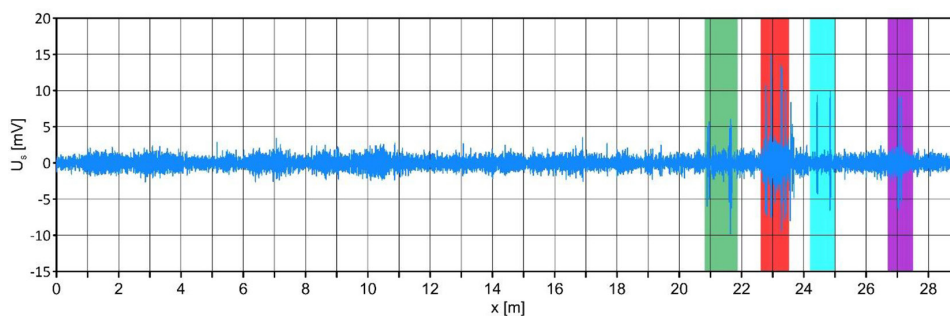
In the results recorded on the first elevator (Figure 14, Figure 16), over a distance of approximately 21 m to 28 m, which corresponds to the cabin’s position at the bottom of the shaft, changes in the amplitude of the recorded signal are visible. For the second elevator, the voltage signal from the belt test, recorded during the cabin’s entire lift, is shown in Figure 17. At a distance of approximately 18 m from the start of the measurement, three diagnostic signals are visible, located close to each other. The changes in signal amplitude are associated with the occurrence of magnetic field disturbances, the source of which is loss of the metallic cross-section of the tested cables, e.g., cracks in wires embedded in the plastic matrix. A visual inspection of the indicated areas revealed no protruding wires, deformation, or other damage to the outer coating of the cable.

Figure 16. Voltage signal recorded during the test of the entire length of the belt (2019) of elevator no. 1

Due to the current lack of standard criteria for the replacement of steel-polyurethane flat belts based on magnetic testing results, a criterion for replacement was adopted in consultation with the owner of the equipment: a maximum 2% reduction in the metallic cross-section for individual tendon damages. The occurrence of continuous or clustered damages also results in the termination of the belts service life.

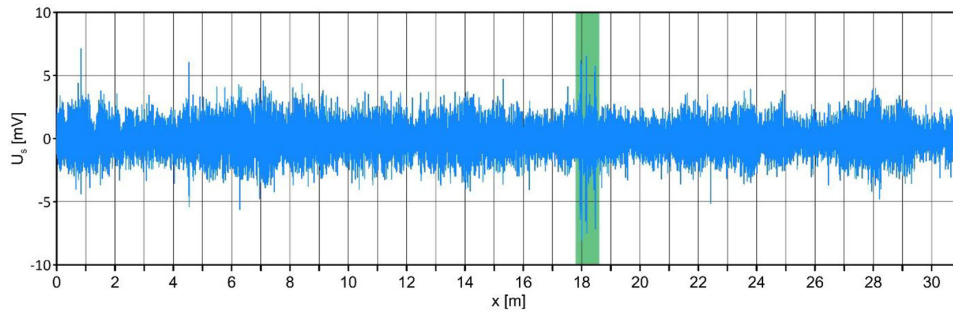
Figure 17. Voltage signal recorded during the test of the entire length of the belt (2022) of elevator no. 2

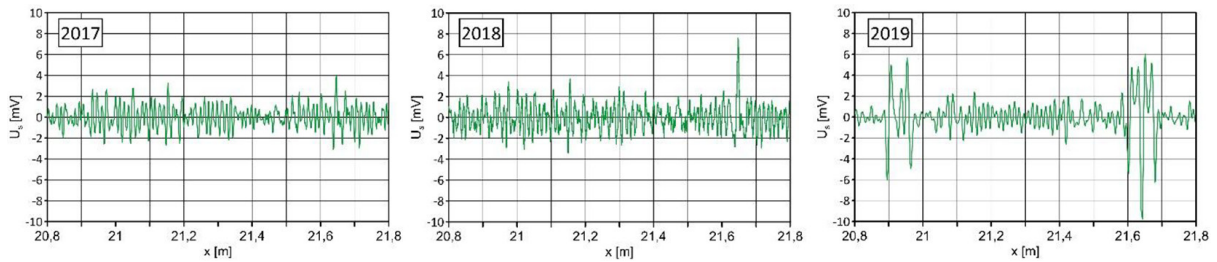
Figures 18–21 present a summary of selected locations on the tested belt of elevator no. 1 (Figure 16), illustrating sections of the belt characterized by signal changes in subsequent measurements taken at annual intervals during the tests in 2017, 2018, and 2019. The graphs presenting the results from subsequent years show changes in the amplitude and signature of the recorded signal. This indicates a change in the size of the observed damage, increasing losses in the metallic cross-section of the tested belt with continued operation, changes in the distance between the ends of the broken wires, or their displacement relative to each other and the matrix. The figures presenting the results of the tests conducted in 2019 also show new signals from subsequent damage events.

The results of the change in the metallic cross-sectional area of the tested belts (ΔS_{Fe}), determined based on the signal amplitude recorded during magnetic testing, are presented in Table 1. Analysis of the signal signature confirmed the presence of continuous damage and clusters of individual damages, which have been visible in recent years of operation: belt of elevator no. 1 at distances of 20.90 m and 21.65 m (Figure 18), and belt of elevator no. 2 at 17.09 m, 18.16 m, and 18.46 m (Figure 22).

Figure 18. Fragment of the recorded signal in subsequent years of research (fragment marked in green in Figure 16)

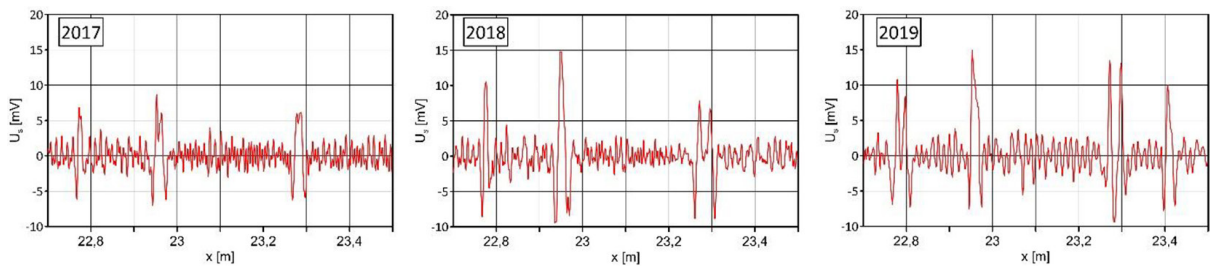
Figure 19. Fragment of the recorded signal in subsequent years of research (fragment marked in red in Figure 16)

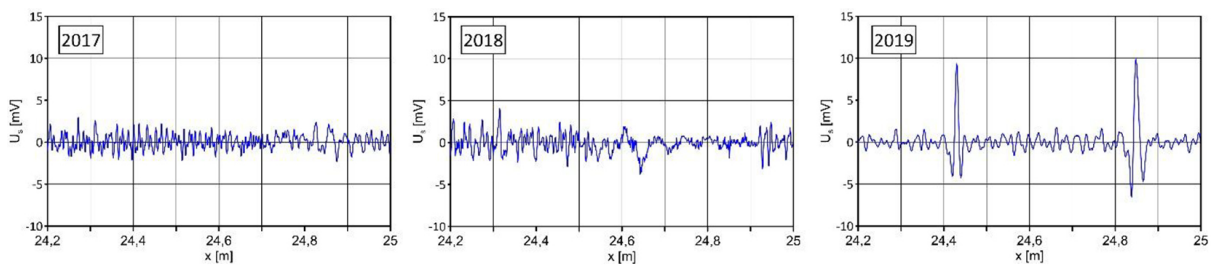
Figure 20. Fragment of the recorded signal in subsequent years of research (fragment marked in blue in Figure 16)

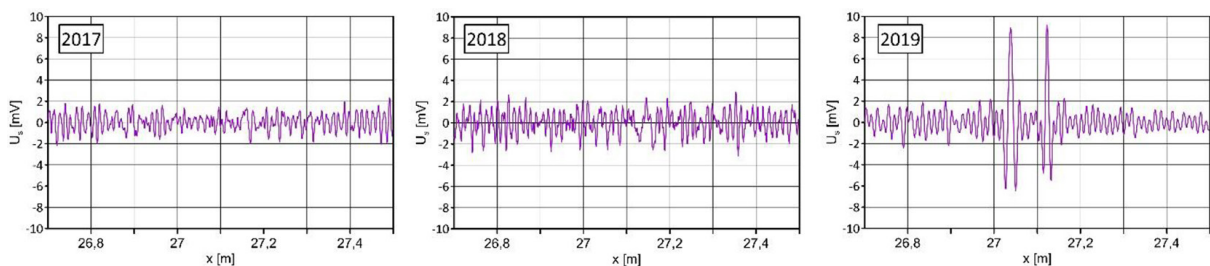
Figure 21. Fragment of the recorded signal in subsequent years of research (fragment marked in purple in Figure 16)

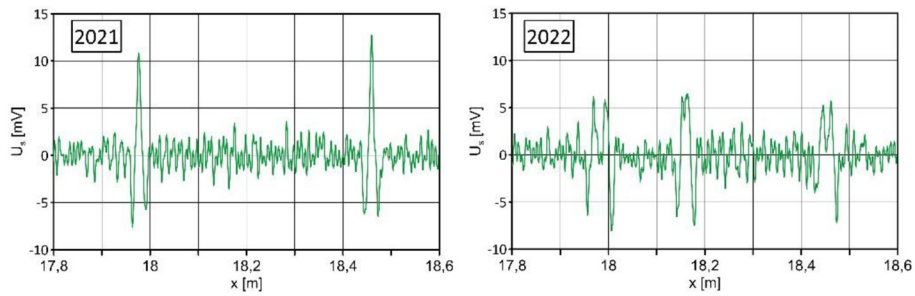
Figure 22 shows a fragment of the signal recorded on elevator no. 2 (Figure 17) during measurements conducted in 2021 and 2022. A change in the

signal amplitude and signature is visible, resulting from the change in distance between the broken wires. A new signal is also visible from the third fault, located approximately 18.1–18.2 m from the beginning of the tested belt.

Figure 22. Fragment of the recorded signal in subsequent years of research (fragment marked in green in Figure 14)
