## Investigation of failure causes in a modern single-axis solar tracker structure

The paper presents a recent failure that occurred during the construction phase of a utility-scale photovoltaic power plant with a total capacity exceeding 20 MW. Modern single-axis tracker structures and PV modules were damaged during a severe summer storm. The study includes an analysis of the construction work carried out on site, as well as an assessment of the available design documentation. To verify the correctness of the applied structural solutions, numerical models of the investigated system were developed. A frequency analysis and an assessment of possible torsional galloping occurrence were performed. Based on the conducted investigations, it was concluded that the failure resulted from a combination of factors, including incorrect assumptions regarding design loads, design and execution errors, and excessive simplifications adopted in the structural modelling process. Complex soil conditions at the construction site were also found to be a significant contributing factor. The conducted analysis indicated that the requirements of current standards were not satisfied with respect to both

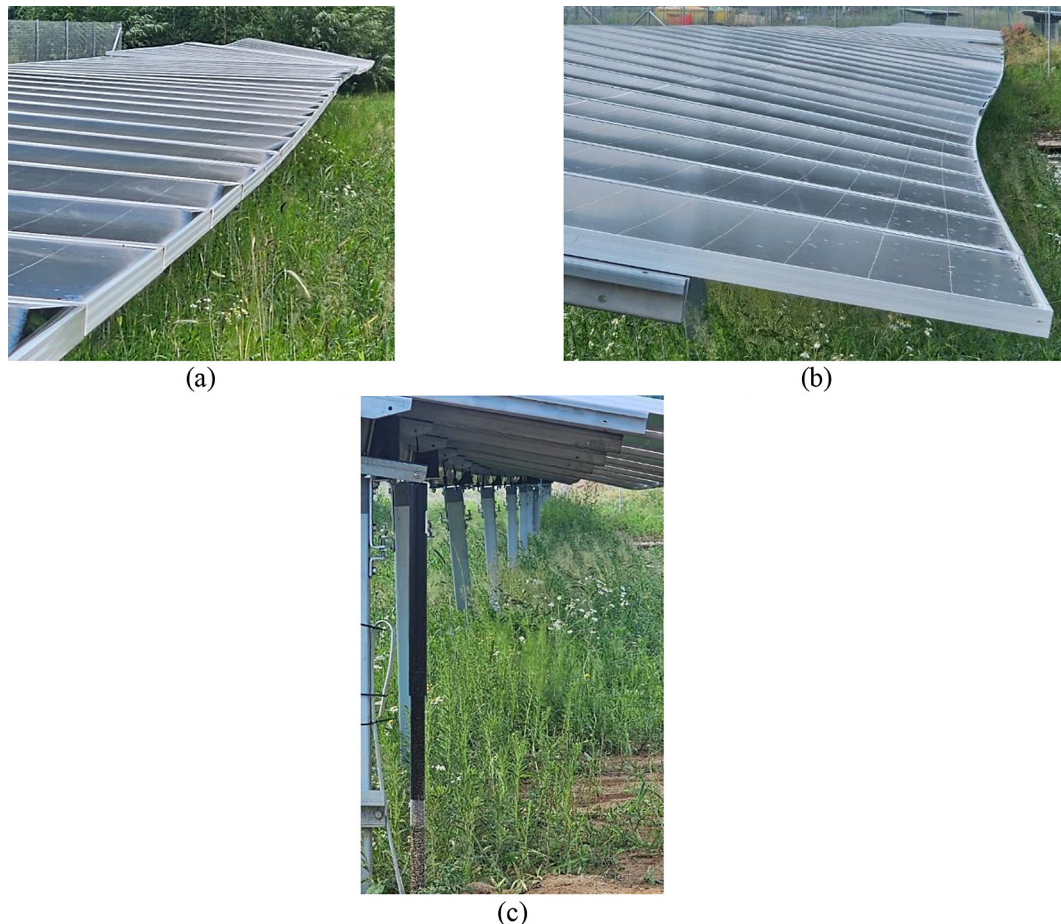
The support structure was damaged in summer during a storm, with wind gusts reaching speeds of up to  $23 \text{ m/s}$ . At the time of the failure, the structure was not complete and was still in the assembly phase. The most critical issues were the absence of the end dampers and the lack of an electrical connection, which prevented the proper operation of the automatic protection

systems described above. Additionally, significant amounts of water accumulated in terrain depressions in the vicinity of the columns. Available industrial-camera recordings indicate that torsional galloping occurred in at least some of the support structures. The damage observed after the storm included, among others, panel surface wrinkling, bearing failures, and permanent deformation of the columns (Figure 2).

**Figure 2.** Selected structural damages: a) and b) wrinkling of the photovoltaic panel surfaces c) permanent displacements of the columns

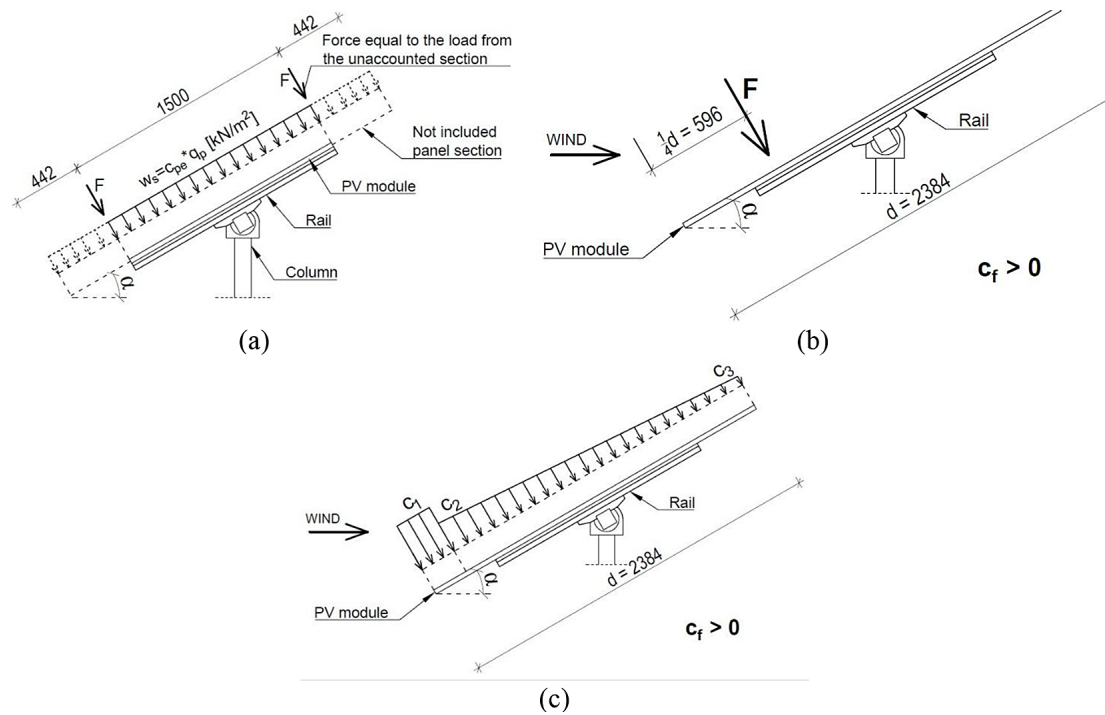
photovoltaic panels. In this situation, the loads were calculated analogously to single-slope roofs with inclination angles of  $5^\circ$  and  $30^\circ$ . As part of further simplifications, for the  $60^\circ$  position, the load coefficients corresponding to a  $30^\circ$  inclination angle were adopted. However, in the load tables prepared in the design documentation, only uniformly distributed surface loads determined on the basis of net pressure coefficients [19] were included. The case of non-uniform loading of the structure (global force coefficients according to [19]) was entirely omitted. A comparison of the loading scheme applied in the design and the correct wind-load scheme is presented in Figure 3.

**Figure 3.** Wind-load scheme: a) scheme adopted in the design b) correct scheme according to standard [19] c) correct scheme according to guideline [20]. Only wind-pressure case is shown (without the wind-suction case)

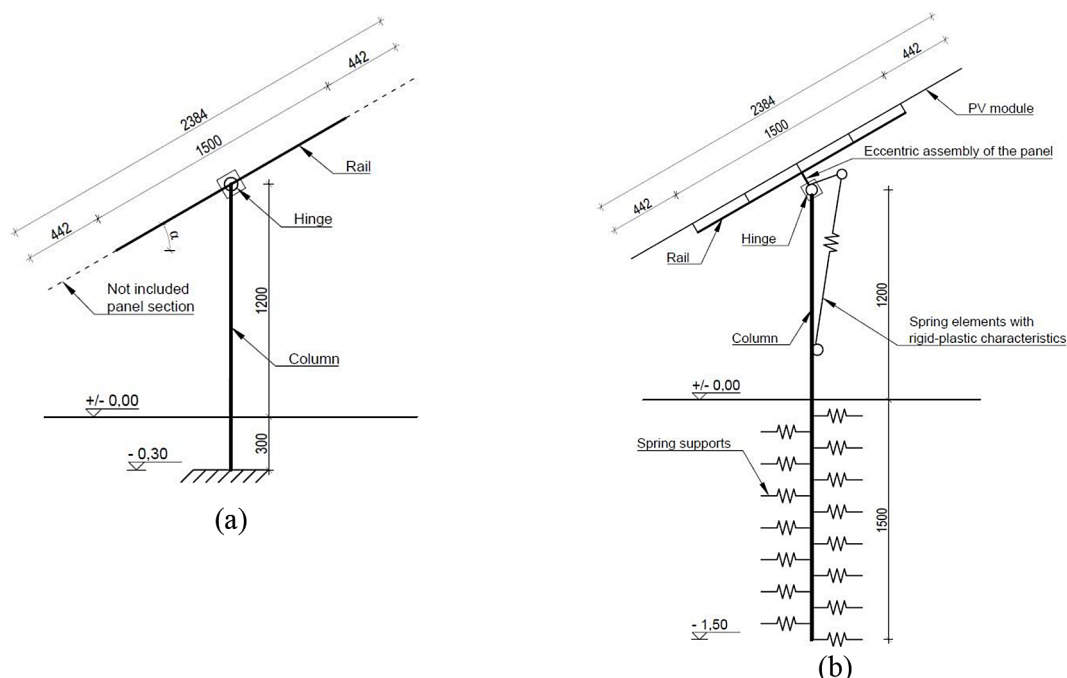
Another highly significant detail was the manner in which the structural support was modelled. In the design, fixed support was assumed at a level 0.30 m below ground level. In reality, the stiffness

of the column embedment in the soil was very low, which was a direct result of the assumptions adopted during the field tests. The test columns were driven to a depth of 1500 mm and then loaded with a force corresponding to the characteristic horizontal reaction. Simultaneously, horizontal

displacements at ground level were measured. The embedment depth was considered adequate when the displacement measured in this manner did not exceed 20 mm. When this condition was not met, the embedment depth was increased and the procedure was repeated. As a result, embedment depths ranging from 1500 to 2000 mm were applied on site. Nevertheless, regardless of the final embedment depth, each column was able to displace at ground level by up to 20 mm, which in no way corresponded to the fixed support model used in the calculations. The significant displacements were caused by the low stiffness parameters of the soil (plastic soils). Selected geological data are depicted in Figure 4 to present the variability of the ground conditions across the area of the photovoltaic farm. In many locations layers similar to those identified in borehole A4 were identified. However, at the same time layers like for cases A1–A3 were observed at nearby measurement points. A high groundwater level was also observed at all investigated locations. A schematic comparison of the structural model applied in the design and a more detailed and accurate model is presented in Figure 5.

**Figure 5.** Incorrect (a) and correct (b) structural model

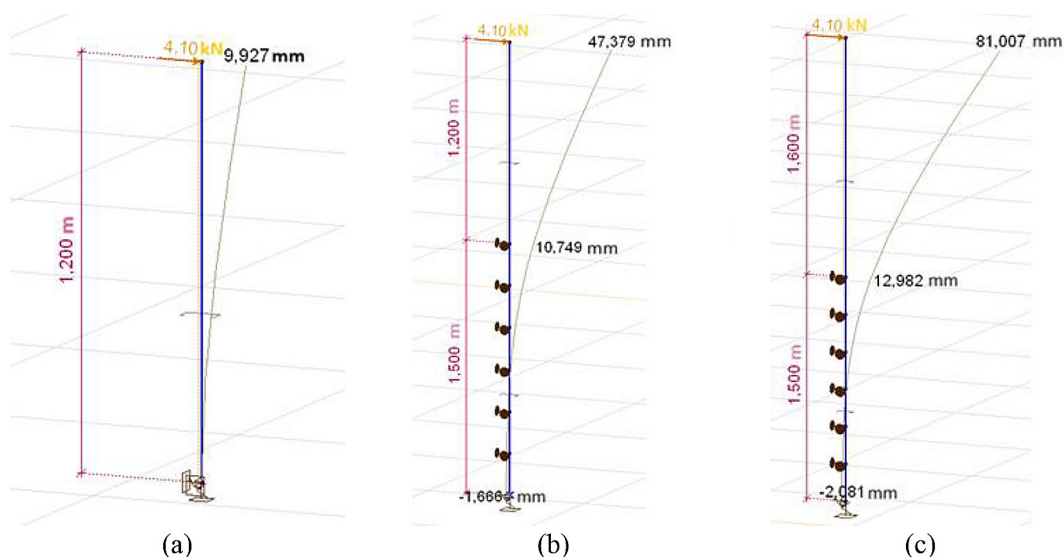
The displacements at the top of the column also exceeded not only the code values (1/150 of the column height) but also the limits permitted by the device manufacturer (30 mm for technological reasons). This may potentially lead to damage to individual panels. A comparison of the column displacements determined using various computational models is shown in Figure 8.

**Figure 8.** Comparison of horizontal displacement values of the columns depending on the modelling approach: a) model applied in the project, b) model with soil flexibility considered, c) model with soil flexibility considered and with the actual value of the load-application eccentricity

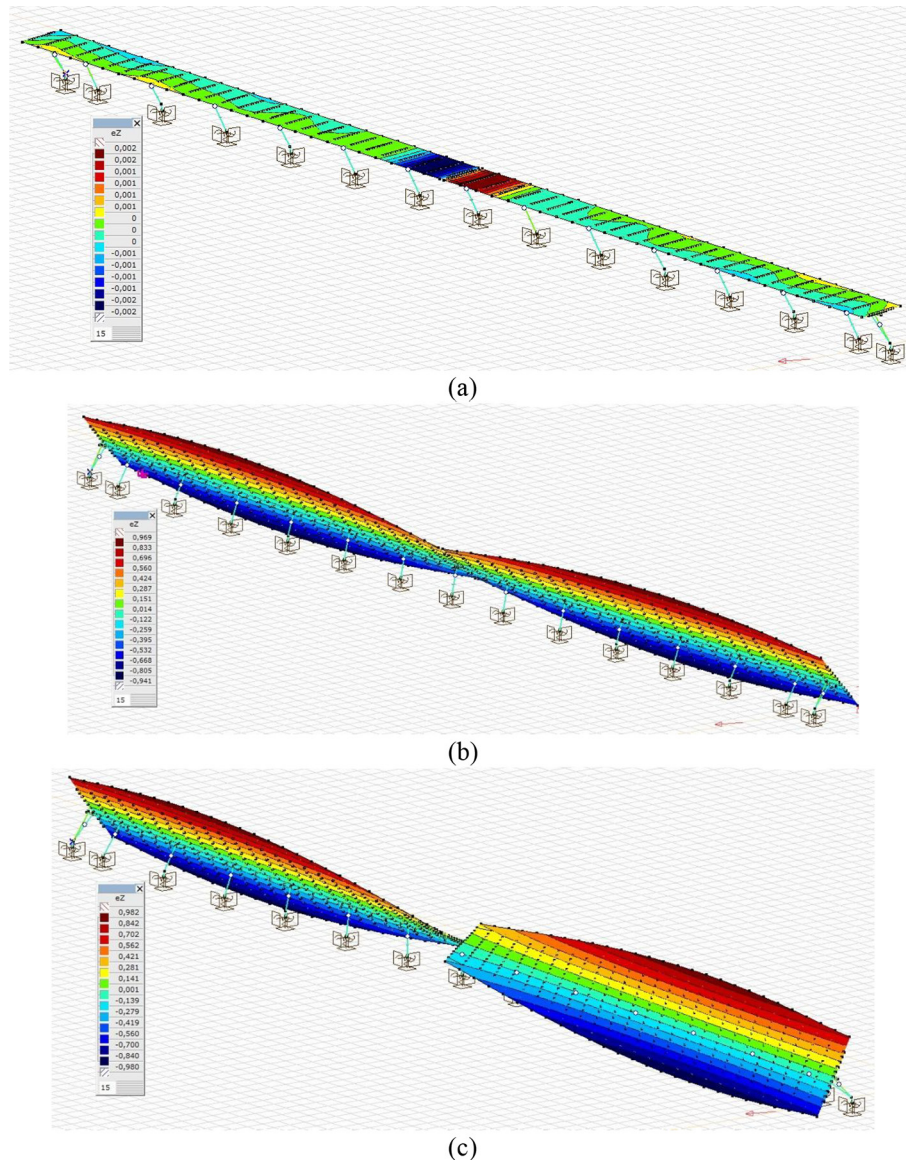
Based on the performed computer simulations, very low natural frequencies of the structure were also identified. The normal modes are presented in Figure 9 and in Table 3. Verification calculations carried out in accordance with [20] demonstrated that the analyzed structure is

susceptible to torsional galloping. This case occurs both during the installation phase and after the installation of all required components. It should be noted that performed assessment was primarily focused on compliance with the requirements of current European standards. A more comprehensive dynamic analysis would enable a more thorough understanding of the structural behavior and response.

**Figure 9.** Normal modes: a) mode 1 – 2.35 Hz b) mode 2 – 3.09 Hz c) mode 3 – 3.27Hz. Vertical displacements in [mm] ( $e_z$ ) are presented
