## The use of 3D scanning to assess the technical condition of passenger car bodies

Jarosław Krzysztof Gonera<sup>1\*</sup>

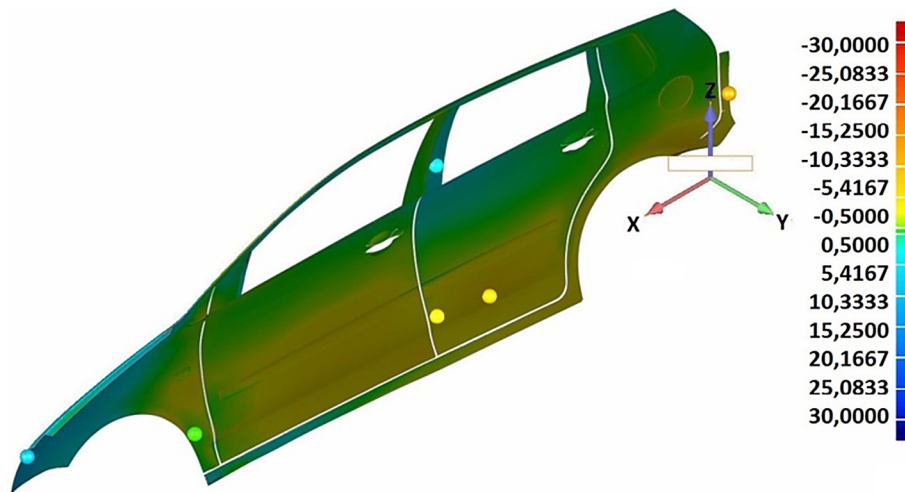
**Figure 6.** Results of 3D scanning of the bodywork of a damaged car

Significant bodywork deformations and distortions were found in the tested car after lifting two wheels. Significant deviations in the position of points between both sides of the vehicle were noted in many parts of the bodywork of this car.

Very large negative deviations could be observed on the front fender, the beginning of the front sill, the middle part of the rear door, and the front door frame. On the other hand, large positive deviations were visible in the rear part of the sill, the lower part of the rear fender, the lower part of the rear door, and the front door. Such large differences between the right and left sides of the

bodywork indicate not only changes in the geometry of the bodywork, but also a lack of adequate bodywork rigidity, which was caused by improperly performed bodywork repairs.

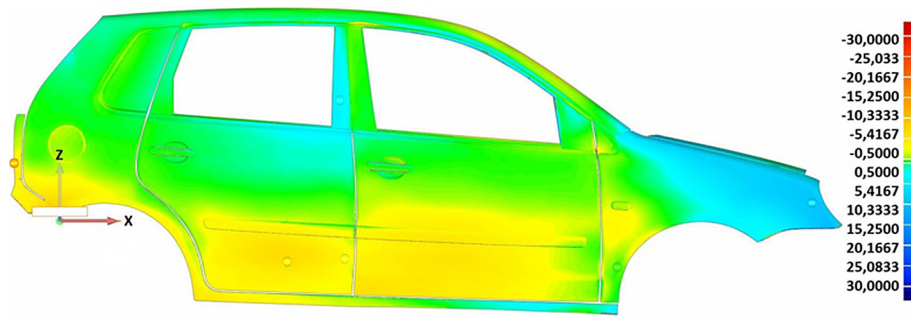
Figure 7. View from the right side of a car body after an accident

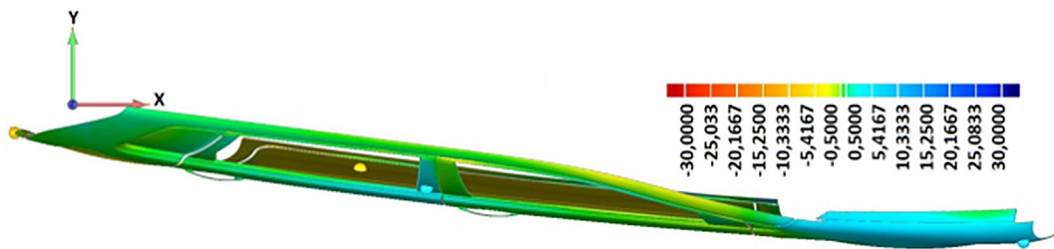
Figure 8. View from above the vehicle to the right side of a car body after an accident

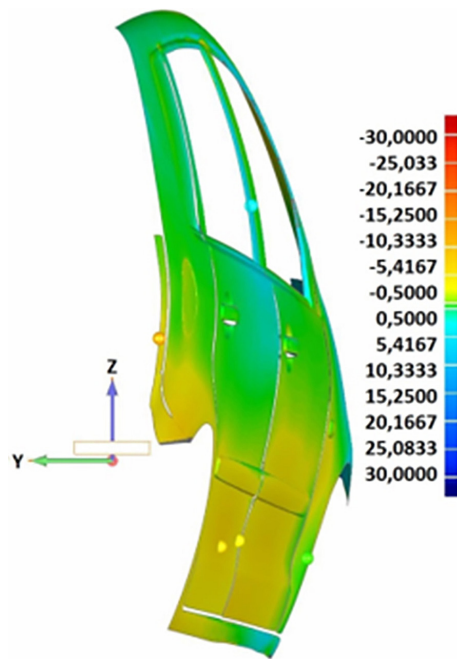
**Figure 9.** View from the rear of the vehicle on the right side of a car body after an accident

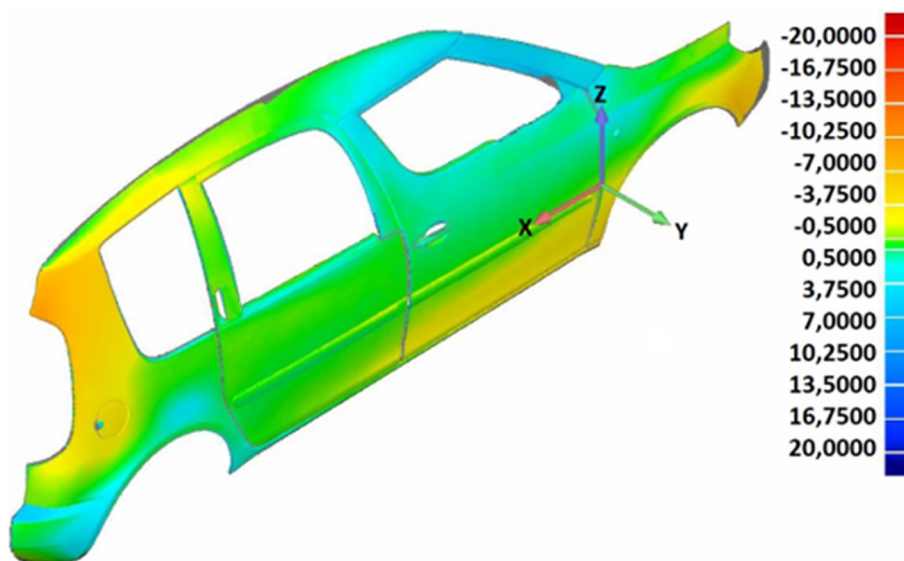
although the vehicle was not involved in any collision, its bodywork showed significant deformation. Significant deformation appeared after lifting two wheels of the car. This was visible in many areas of the bodywork. The deviations in the position of the points between the right and left sides of the vehicle body were significant. Negative deviations occurred in the rear part of the sill, in the lower part of the rear fender, in the upper part of the front door, on the A-pillar, and in the front part of the roof gutter. Positive deviations were visible on the D-pillar, in the upper part of the rear fender, in the rear part of the roof gutter, in the front part of the sill, in the lower part of the front door, and in the lower part of the front fender. This car also suffered a loss of body rigidity. Both the changes in body geometry and the loss of rigidity are the result of intensive use of the vehicle by many drivers who were not directly responsible for maintaining the vehicle in proper technical condition.

**Figure 10.** Results of 3D scanning of the body of a heavily used car

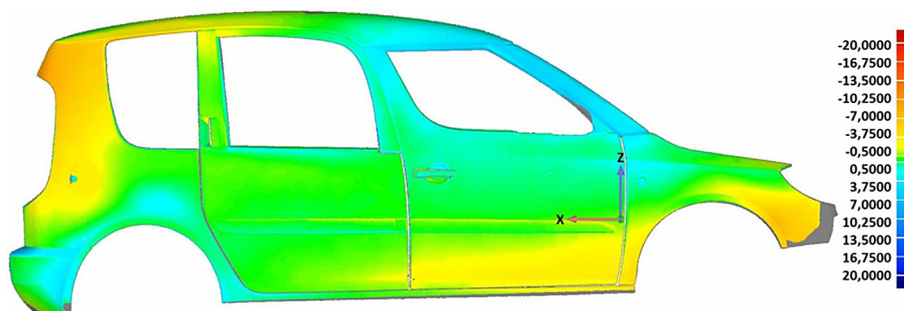
**Figure 11.** View from the right side of the bodywork of a heavily used car

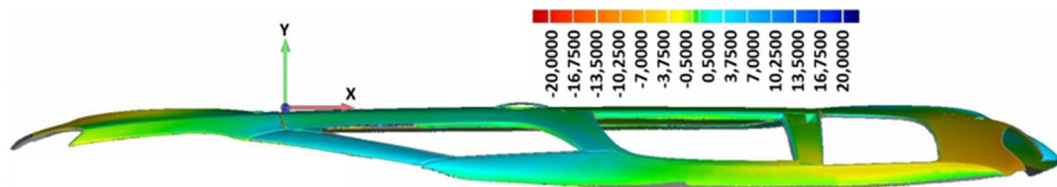
**Figure 12.** View from above the vehicle to the right side of the bodywork of a heavily used car

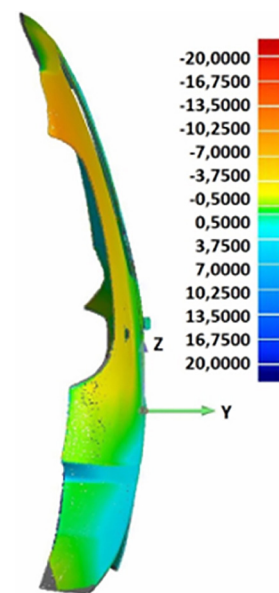
**Figure 13.** View from the rear of the vehicle to the right side of the bodywork of a heavily used car

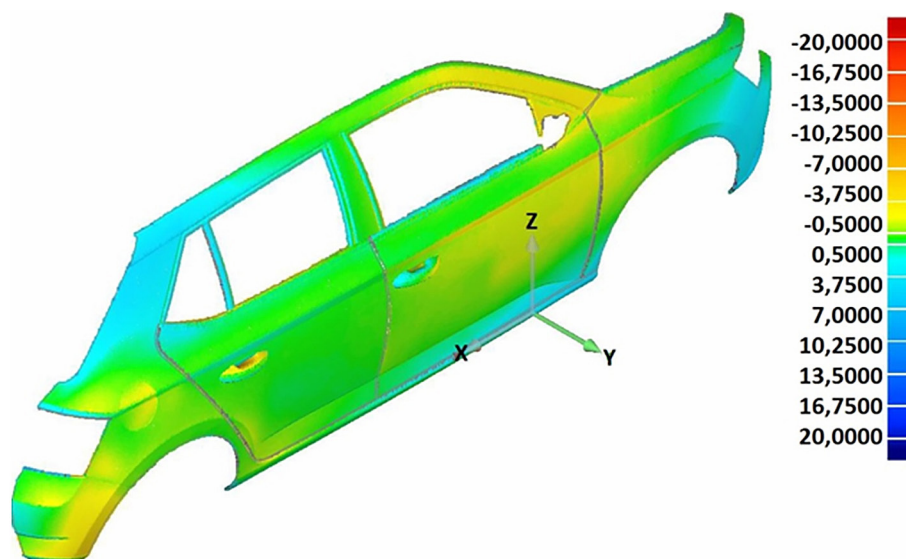
The next car to undergo 3D scanning was the vehicle with the lowest mileage, used under standard operating conditions by a single driver. In this case, 1,384,793 points were identified on each side of the vehicle during the testing phase. In the case of this car, several intervals were also selected during the analysis, for which the number of points falling within these intervals was determined. As in the case of the second vehicle, the critical intervals were those for which the largest deviations between the right and left sides of the vehicle occurred, amounting to  $\pm 20$  mm. In turn, the nominal ranges for this vehicle were those for which the deviations between the right and left sides of the vehicle were the smallest, amounting to  $\pm 0.5$  mm. The results of the 3D scan of the third car are presented in Figure 14 and Table 5. In this car, there were many smaller differences between the positions of the points on the right and left sides of the vehicle than in the previous vehicles.

Nevertheless, this vehicle also exhibited relatively large differences between the right and left sides, which may be related to the relatively low rigidity of the vehicle body. Based on the analysis of the measurement results, it was found that over 27% of the points were within a range where the

**Figure 14.** Results of 3D scanning of the body of a car with low mileage

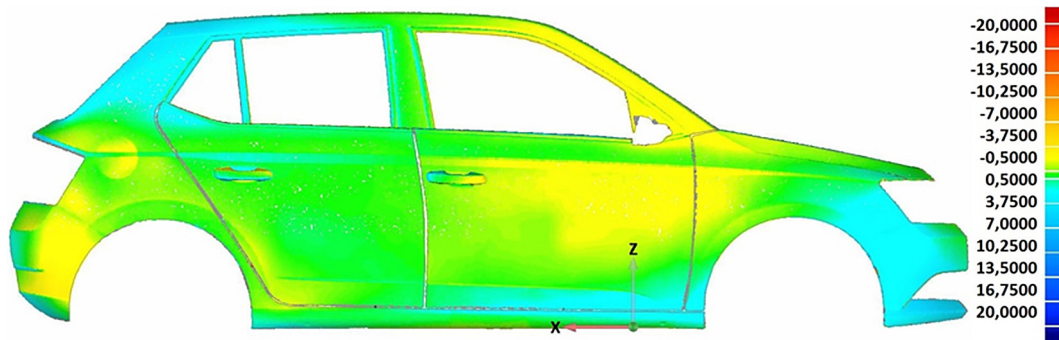
**Figure 15.** View from the right side of the bodywork of a car with low mileage

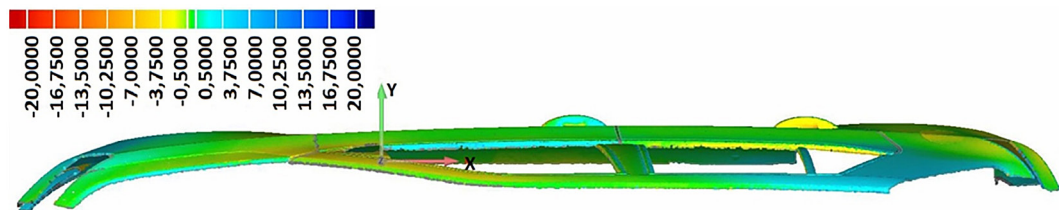
**Figure 16.** View from above the vehicle to the right side of the bodywork of a car with low mileage

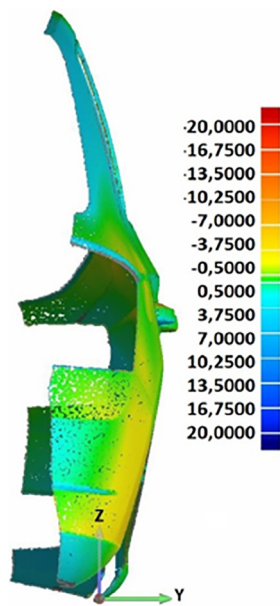
bodywork, there were much smaller deviations in the position of points between the two symmetrical sides of the car body. Negative deviations occurred in the front part of the sill, the lower part of the front doors, around the C-pillar, the front part of the front fender and the front bumper. Positive deviations, on the other hand, occurred in the area of the A-pillar, in the middle of the front door, on the rear bumper, and in the middle of the rear fender. The deformations occurring in the body of this car were due to a certain loss of body stiffness, but they were significantly smaller than in the case of the two vehicles described above.

**Figure 17.** View from behind the vehicle to the right side of the bodywork of a car with low mileage

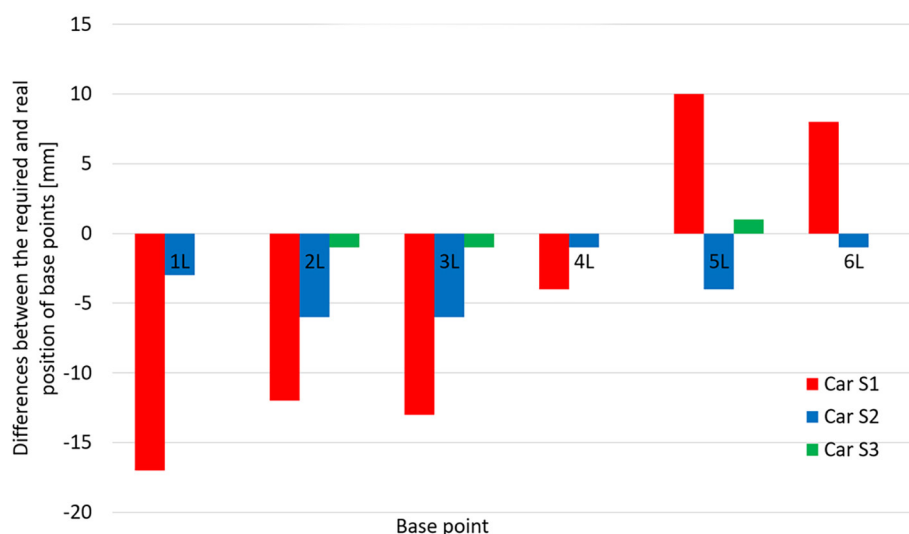
the greatest changes in the geometry of the floor panel were found in car S1, which was involved in a road collision and underwent bodywork repairs after the accident. The difference between the required and actual position of the reference point located on the front longitudinal member was 17 mm. The difference between the required and actual position of the reference point on the rear longitudinal member was 8 mm. In car S2, which was used intensively by many drivers, significantly smaller displacement values were found for both points in the described area. They were 3 mm and 1 mm, respectively. In contrast, in car

S3, which was used by a single driver and had low mileage, no changes in geometry were found on the left side of the vehicle for both side members. The reference point located near the bulkhead on the left side was displaced by 4 mm in the car after a road collision and by 1 mm in the car that had been used intensively. However, in the car with the lowest mileage, this point did not shift at all during operation. Changes in the geometry of the floor panel within the base points responsible for active safety, i.e., the points where the front suspension, front suspension bench, and rear suspension are attached, were also greatest in the car that had undergone bodywork repairs after a road collision. In the case of this vehicle, the displacements of the points were 12 mm, 13 mm, and 10 mm, respectively. Significantly smaller values of base point displacement were found in a car that had been used intensively by several drivers for business purposes. In this car, the difference between the required and actual position of the base point attaching the front suspension was 6 mm, the base point attaching the front suspension bench was also 6 mm, and the base point attaching the rear suspension was 4 mm. In the car with the lowest mileage, which was used by only one driver, all three points had the smallest displacement, which was only 1 mm. Based on the measurement results presented in the figure, it can be concluded that the previous use of the vehicles and conditions exceeding standard use had a significant impact on the extent of changes in the body geometry of the tested cars. Particularly large changes in the geometry of the floor panel were found in car S1, which was involved in a road collision and

**Figure 18.** Results of measurements of changes in the geometry of the floor panel on the left side in the tested cars

underwent bodywork repairs on the left side of the vehicle after the accident. The displacement values of all analysed points exceeded the permissible change values, i.e., 3 mm. In the case of car S2, which had been used intensively, the displacement of the reference points also exceeded the permissible change values, i.e., 3 mm. However, in this car, this only applied to the suspension mounting points and the suspension bench.

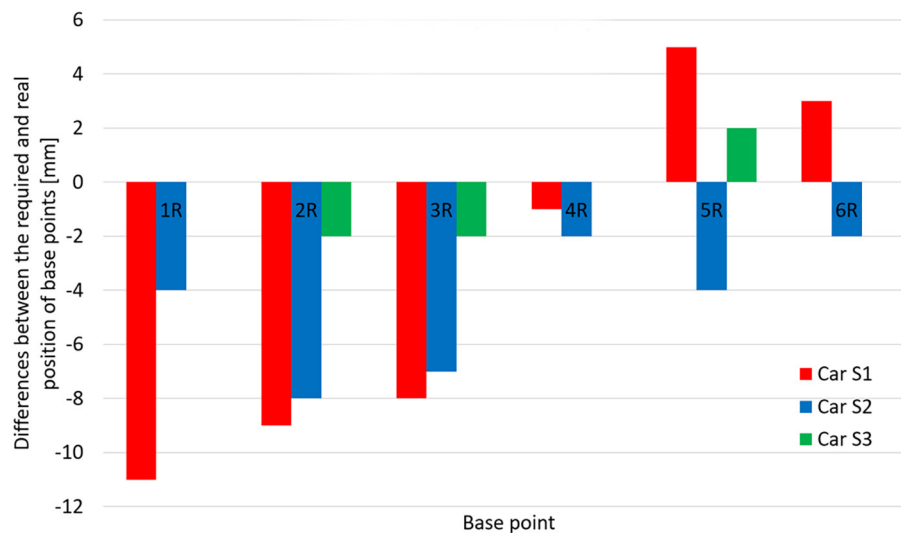
Figure 19 shows the results of measurements of changes in the geometry of the floor panel on the right side of the tested cars. The nature of the changes is slightly different from that on the left side of the vehicles. In car S3, as on the left side of the vehicle, no changes in geometry were found on the right side within the reference points located on the front and rear side members and in the vicinity of the bulkhead. In contrast, in car S1, in which the left side of the vehicle was repaired after a road collision, a displacement of 11 mm was found in the reference point on the front longitudinal member and 3 mm in the reference point on the rear longitudinal member. The point located in the vicinity of the bulkhead moved by 1 mm. In car S2, which had been used intensively by several drivers, the reference points on the right side of the front and rear side members were found to have shifted by 4 mm and 2 mm, respectively, and the point near the bulkhead wall had also shifted by 2 mm. The smallest displacements of base points related to active safety were found in car S3. The mounting points for the front suspension, front bench, and rear suspension moved by 2 mm. In car S1, which had undergone bodywork repairs after a road collision, and in car S2, which had been used intensively by many drivers, a similar level of geometric change was found within these three points. In car S1, the front suspension mounting point moved by 9 mm, and in car S2 by 8 mm. The front suspension mounting point moved by 8 mm in car S1 and by 7 mm in car S2. The rear suspension mounting point in these cars moved by 5 mm and 4 mm, respectively. The significantly greater changes in the geometry of the floor panel on the left than on the right in car S1, which had undergone bodywork repairs, were because the left side of the vehicle was seriously damaged in a road collision. However, the base points on the right side were also displaced as a result of the forces generated during the impact, causing deformation. Unfortunately, the bodywork repair of this vehicle did not restore the floor panel to its proper geometry. In turn, in the S2 car, which was used

intensively by many drivers, greater changes in the geometry of the floor panel on the right side of the vehicle were found. These changes were the result of forces and moments acting on the bodywork due to traffic conditions. The values of these changes resulted from the mileage of the vehicles and the nature of their previous use. The greater displacement of points on the right-hand side than on the left-hand side was caused by the poorer condition of the road infrastructure on the right-hand side of the road than on the centre line. In addition, the suspension and steering components are subjected to high forces and moments when parking and driving up kerbs, which contribute to greater changes in the geometry of the bodywork. In the S3 car, which was used by a single driver and had relatively low mileage, greater displacement of the reference points on the right side of the floor panel than on the left could also be observed. These changes were also the result of the same factors. The fact that significant forces and moments resulting from driving conditions act on the bodywork is largely confirmed by the deformation of the floor panel in the area of the front suspension mounting points, the front suspension bench, and the rear suspension. In this car, due to its low mileage, only minor deformations were found in this area. No displacement of the other points has been found yet.

**Figure 19.** Results of measurements of changes in the geometry of the floor panel on the right side in the tested cars

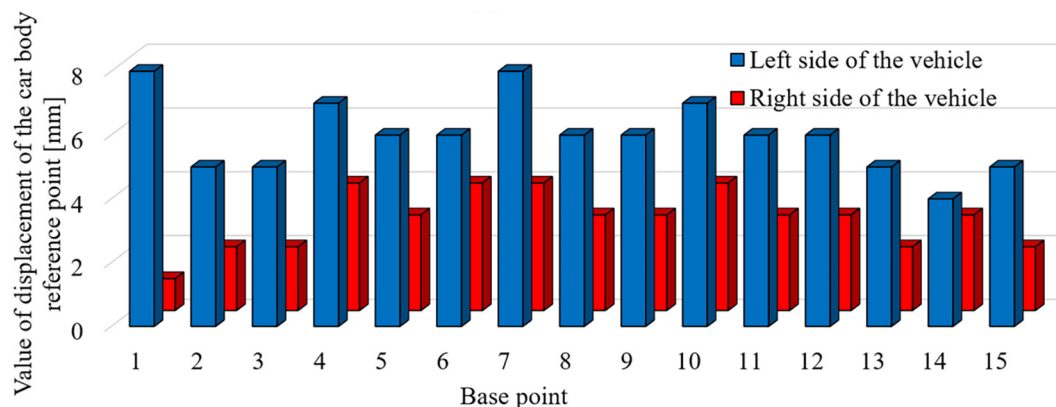
significant changes in the geometry of the upper body parts. These changes are shown in Figure 20. Significantly greater changes in geometry within the same reference points occurred on the

**Figure 20.** Results of measurements of changes in the geometry of the upper parts of the body in car S1, which underwent bodywork repairs after a road collision

left side than on the right side of the bodywork. This was due to the impact on the left side of the vehicle during the collision and the significant extent of deformation of this part of the car. Although the impact occurred on the left side of the vehicle and caused greater deformation on the left side, the deformation also affected the right side of the vehicle. This was due to the impact of the forces generated during the collision on the load-bearing structure of the entire body. In this car, the greatest displacements on the left side were found at points located on the front reinforcement and in the lower part of the A-pillar. They amounted to 8 mm. On the right side, they were 1 mm and 4 mm, respectively. Significant displacements on the left side were also found at the points located at the beginning and end of the sill. These displacements amounted to 7 mm. On the right side, they amounted to 4 mm each. In the case of many points, a displacement of 6 mm was observed. These were points located in the middle and at the top of posts A, B, and C (points 5, 6, 8, 9, 11, and 12). On the right-hand side, most of these points were displaced by 3 mm, except the point at the top of pillar A, which was displaced by 4 mm. The points at the beginning and end of the front fender reinforcement, at the end of the rear wheel arch, and at the end of the rear fender at the top moved 5 mm on the left side and 2 mm on the right side. On the left side, the smallest displacement of the reference point on the upper parts of the body was found for the point located at the end of the rear mudguard at the bottom. It was 4 mm. On the right side, it was 3 mm. On the left side of the body, it was found that the displacement of all reference points in the upper parts of the body exceeded the permissible displacement values for reference points, i.e., 3 mm. This indicates significant deformation of the body and improper bodywork repair. Even on the right side of the bodywork, it was found that the displacement of some of the reference points exceeded 3 mm. The results of measurements of changes in the geometry of the upper parts of the body confirm, similarly to the results of measurements using the method proposed in the thesis, based on 3D scanning of the body and the results of measurements of the geometry of the body floor panel, that in the tested S1 car, there were significant deformations of the entire body structure. As a result of the described changes in geometry, both passive and active safety levels may be reduced in this car.

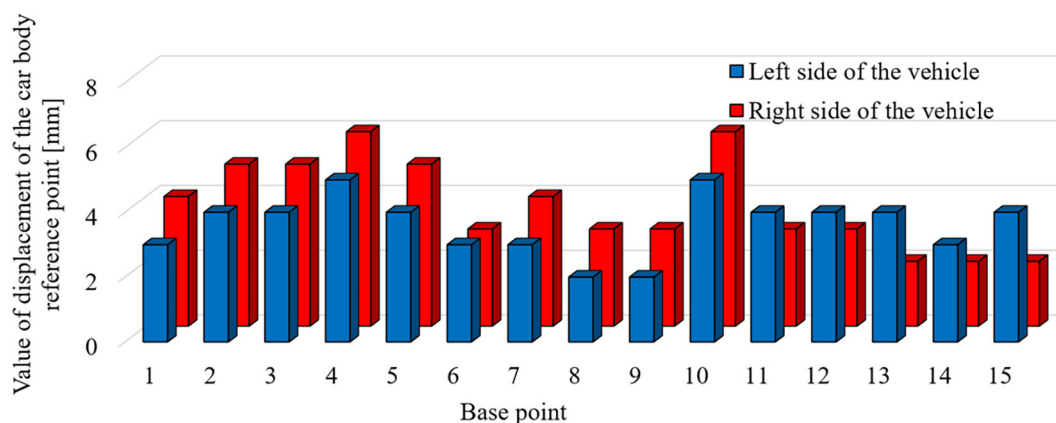
**Figure 21.** Results of measurements of changes in the geometry of the upper parts of the body in car S2, which was intensively used by many drivers

The results of measurements of the geometry of the upper body parts in the S2 car, which was intensively used by many drivers, are presented in Figure 21. Based on the measurement results, it can be concluded that in the tested car, there was a greater displacement of the reference points on the right than on the left side of the vehicle in the front and middle parts of the vehicle. In contrast, in the rear part of the vehicle, there was greater displacement of the reference points on the left than on the right side of the vehicle. The largest displacements were found on the right side for the points located at the beginning and end of the sill. These displacements amounted to 6 mm. Among all the points on the left side of the vehicle, the largest displacements of the reference points were also found for the points located at the beginning and end of the sill. In this case, they amounted to 5 mm. Significant displacement of the reference points also occurred at the points located at the beginning and end of the front fender reinforcement and in the middle of the A-pillar. The displacement of these points was 5 mm on the right side of the vehicles and 4 mm on the left side. The reference points located on the front reinforcement and at the bottom of the B-pillar moved by 4 mm on the right side and 3 mm on the left side. In turn, the points located in the middle and at the top of pillar B moved 3 mm to the right and 2 mm to the left. In the case of the reference points in the upper part of pillar A, the same displacement values were recorded on the right and left sides of the vehicle, which was 3 mm. In the rear part of the vehicle, greater displacements of the reference points were found on the left side of the vehicle. The displacements of the reference points located in the middle and at the top of pillar C were 4 mm on the left side and 3 mm on the right side. In turn, the points located at the end of the rear wheel arch and at the end of the rear fender, at the top, were displaced by 4 mm on the left side and 2 mm on the right side. However, the points located at the end of the rear fender, at the bottom, were displaced by 3 mm on the left side and 2 mm on the right side of the vehicle. The greater changes in the geometry at the front and in the middle of the vehicle on the right than on the left are due to intensive use of the vehicle, during which greater forces and moments resulting from traffic conditions affect the right side of the car. This is related to the poorer condition of the road infrastructure on the shoulder side than on the centre line side. In addition, during vehicle

operation, the wheels on the right side often hit kerbs. Greater changes in geometry in the upper parts of the body at the rear of the vehicle on the left than on the right indicate some loss of rigidity in the body's load-bearing structure. The forces and moments resulting from driving conditions also act on the body diagonally across the vehicle, and the deformations of the body are transferred diagonally across the vehicle. In the case of the displacement of many reference points in the upper parts of the bodywork in the tested car, both on the right and left sides of the vehicle, the permissible displacement of reference points, which is 3 mm, was exceeded. This may affect the active and passive safety of the vehicle. The results of the measurements of the geometry of the upper parts of the body confirm that, as a result of intensive use of the vehicle by many drivers, there have been significant changes in the geometry of the entire body. Significant changes in the geometry of the body were also confirmed by the results of measurements of the body geometry using the 3D scanning method and the results of measurements of the geometry of the body floor panel.

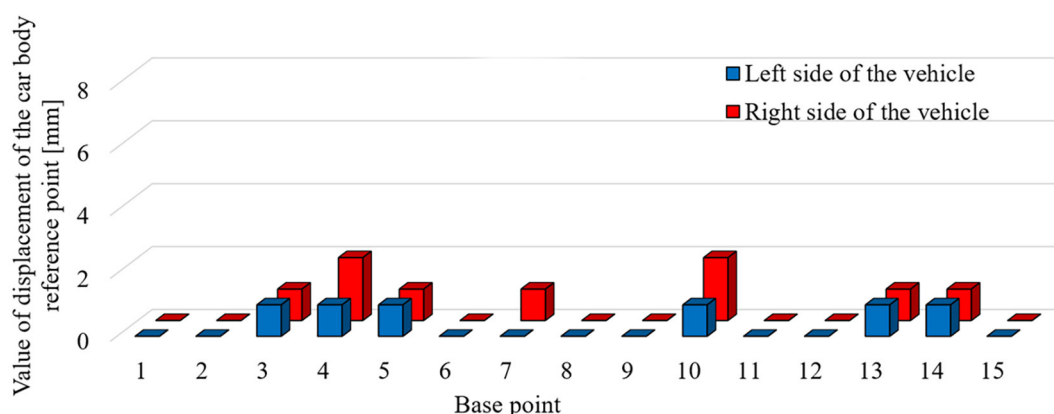
Figure 22 shows the results of measurements of the geometry of the upper body parts in an S3 car, which had low mileage and was used by only one driver. Compared to the cars described earlier, this vehicle had the smallest changes in geometry in the upper body parts. In the case of many reference points, no displacement was found. The displacement of none of the reference points exceeded the permissible displacement of reference points, which is 3 mm. The reference points on the right side of the vehicle were displaced by a maximum of 2 mm, and on the left side by a maximum of 1 mm. On both the left and right

sides of the vehicle, the displacement of the reference points located at the end of the front fender reinforcement, in the middle of the A-pillar, at the end of the rear wheel arch, and at the end of the rear fender at the bottom was 1 mm. However, the reference points at the beginning and end of the sill were displaced by 2 mm on the right side and 1 mm on the left side. In the case of the reference point at the bottom of the B-pillar, a displacement of 1 mm was found on the right side of the vehicle. On the left side of the vehicle, no displacement of this point was found. Slightly greater changes in the geometry of the upper parts of the bodywork on the right than on the left side of the vehicles are the result of greater forces and moments arising from traffic conditions and related to the poorer condition of the road infrastructure on the right side of the road and kerbs. Such minor changes in geometry indicate the best technical condition of the body in terms of the parameters tested among all the vehicles examined. Minor changes should not have any impact on the safety level of this vehicle. Also, when identifying changes in body geometry using 3D scanning and floor panel geometry measurements, the smallest changes in geometry were found in this vehicle.

**Figure 22.** Results of measurements of changes in the geometry of the upper body parts in car S3, which was used by one driver and had low mileage
