Analysis of Hard Facing Material Designed for Application on the Forestry Tools

Miroslava Ťavodová¹, Michaela Hnilicová¹, Izabela Miturska^{2*}

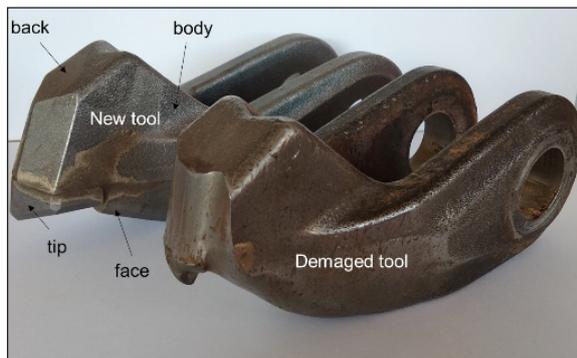
The tools for crushing of undesirable advance growth are fixed on the rotor – the adapter of the forest wheeled tractor. On average, they comprise 48 pieces. They are made by means of thermoforming technology, so they are forgings. According to the research reported in [13, 6], the tools made of 15MnCr5 steel do not meet the conditions under which they work, because of their mechanical properties and a ferritic-pearlitic structure in not heat-treated state after losing the WC tips mounted on the tool body. They are object of strong abrasive wear in the heterogeneous environment, which is associated with shock loading. Figure 1 shows a new tool and a damaged tool that is out of service.

Fig. 1. New and damaged tool for crushing of undesirable advance growth

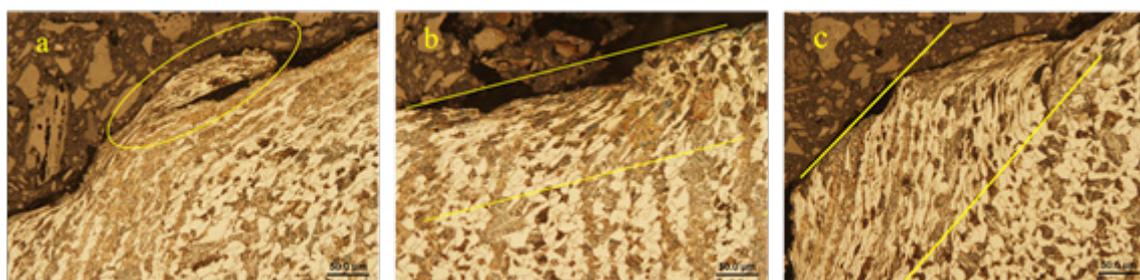
surface from the cyclically repetitive abrasive load of the tool surface (high speed of the adapter rotor) causes the tool surface to harden. This is manifested by the separation of material parts (Fig. 2a). Surface craters are formed (Fig. 2b). Fig. 2c indicates the depth of plastic deformation at a depth of about 0.2 mm.

Fig. 2. Plastic deformation on the back surface of the tool [13]

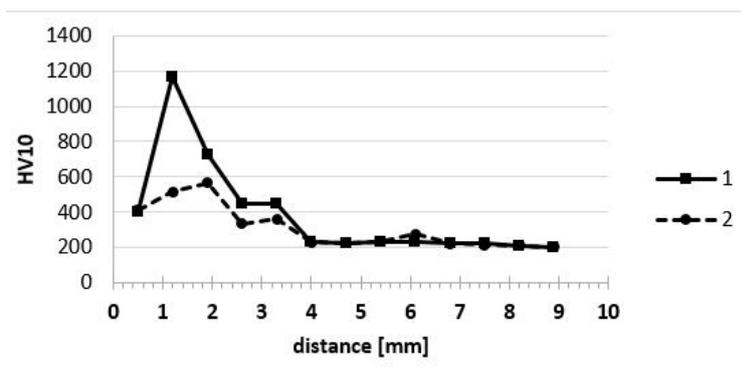
Vickers hardness was measured in two parallel directions from the weld deposit into the base material (Fig.4.). The hardness course is shown in Fig.4. The thickness of the weld deposit is about 2.5mm. The authors noticed a significantly higher hardness than in the base material, 825HV10, on average. A second indent of line number 1 indicates that a very hard particle was captured with the measured value of 1200HV10. It is probably W₂C carbide, which contains the weld deposit. The waveform curves in the graph are not completely jumped. It is possible to observe a transition area

of about 1.0 to 2.0mm in thickness between the first layer of the weld deposit and base material. This would indicate the presence of HAZ.

Fig. 4. Hardness course of HV10 of the test sample

It can be concluded that the high presence of Fe in the zone of insufficient mixing also indirectly confirms the decrease of the hardness recorded in the graph (Fig. 4). The hardness value of the fifth indent is close to that of the base material.

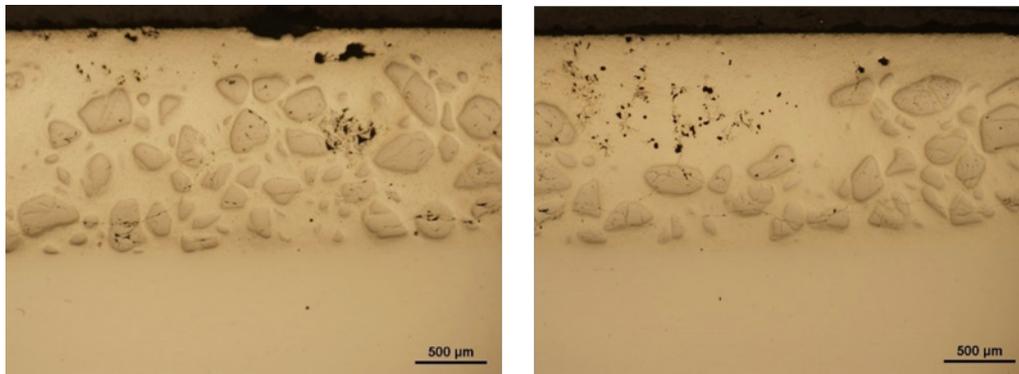
sample surface after the abrasive wear test is shown in Figure 5. The weld deposit contains a number of W_2C carbides. The cavities are visible below the surface causing damage to the surface due to abrasive particles in the test.

Fig. 5. Part of the track surface profile after abrasive wear test

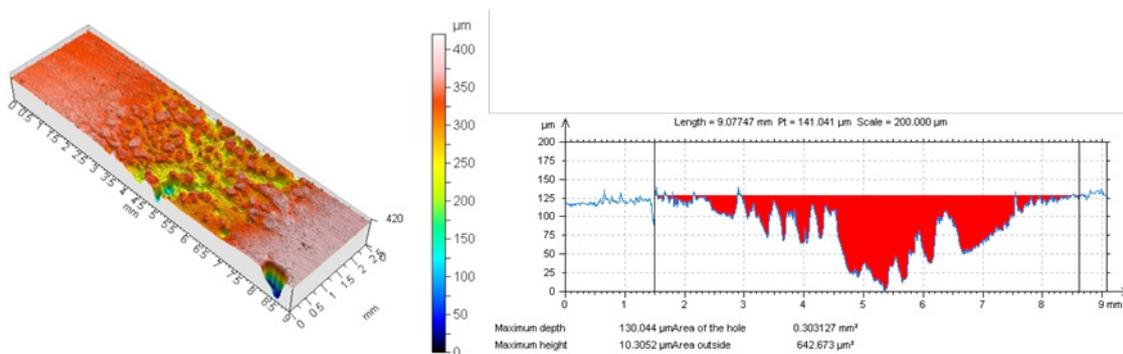
The Figure 6 shows the profile and depth of the roll of the device on the test sample captured by confocal microscope. High wear resistance is also reflected on the track profile. Uneven material removal was recorded. The maximum trace depth value was $P_t = 141 \mu m = 0.141 mm$. This is less than the detected thickness of material loss in plastic deformation found on the back of a worn material.

Fig. 6. Profile and trace depth after abrasion resistance test

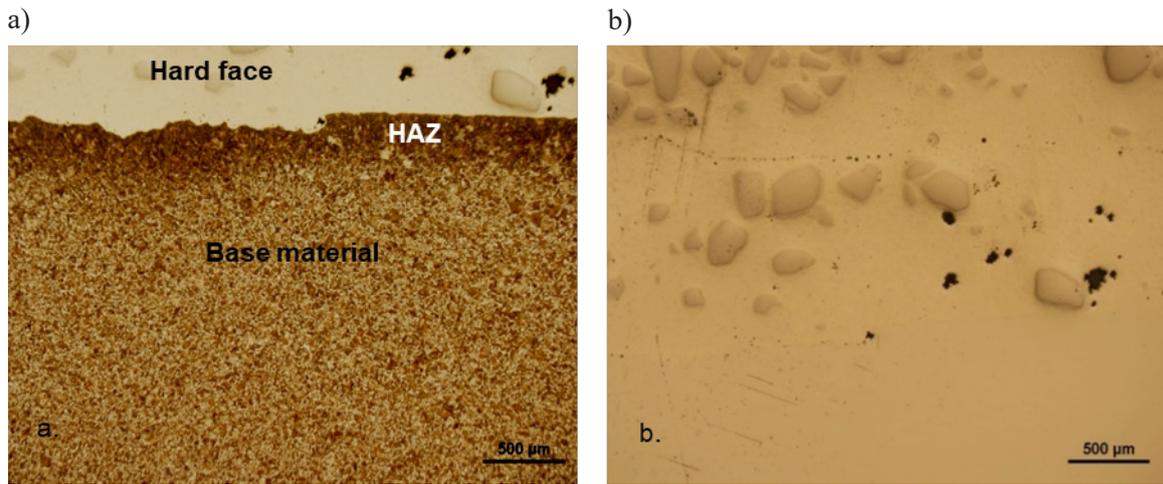
The Figure7a shows the interface of the tool base material – weld deposit RD571 with a visible heat affected area. The basic material of the tool is made of perlite and ferrite. Unevenly distributed carbides and pores are visible in the weld deposit (Fig. 7b).

Fig. 7. Weld deposit RD 571; connection the base material and the first layer of the hard weld deposit (a); weld deposit on the base material (b)

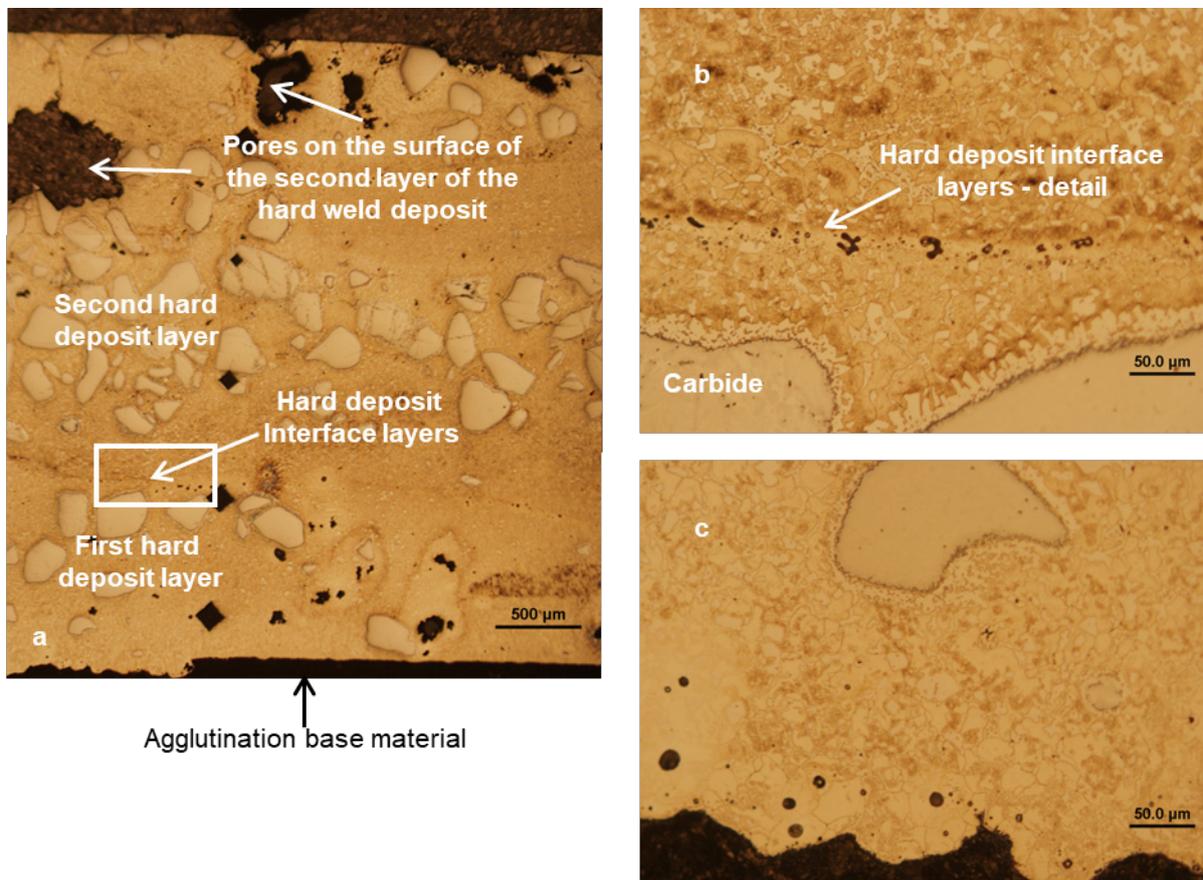
The Figure 8a shows the overall disposition of the RD 571 weld deposit electrode etched in COR. A small, etched part of the base material is visible here. Unevenly distributed carbides are visible in the weld deposit. Pores are present in the top of the second layer of the weld deposit. Figure 8b shows the interface of the weld deposit layers. Figure 8c captures the interface of the base material and the first weld deposit. As can be seen from Figure 7 and 8, the base material was joined by mixing it with the first layer of the weld deposit as well as the layers of the weld deposits

between them. However, pores are observed at the interfaces which are a potential initiator of peeling off of the layers during the abrasive load of the weld deposit in operation. Moreover, the cracks in the weld deposit through carbide grains; they can cause carbide crumbling and peeling them from the matrix. It can lead to rapid wear of the weld deposit.

Fig. 8. Overall disposition of the hard weld deposit electrode RD 571 (a); interface view (b)

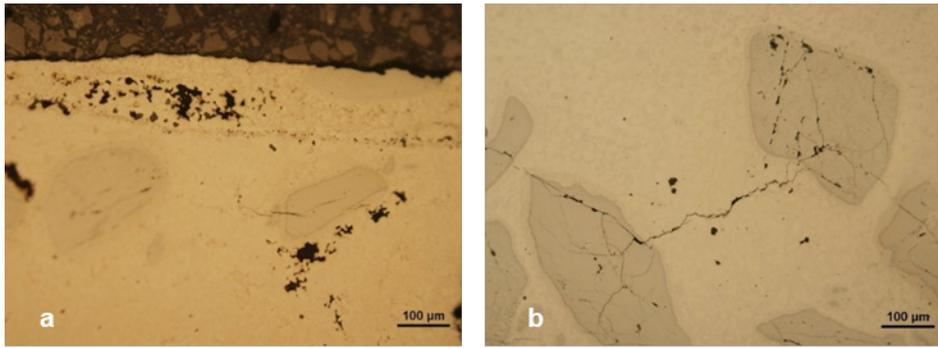
The Figure 9a. shows the local integrity defects on the surface of the weld deposit RD571. Pores are also observed. Cracks occur in carbides and also in the base material of the weld deposit. Figure 10b shows the detail of the cracks in the weld deposit matrix as well as the carbides present.

Fig. 9. Hard weld deposit with pores and cracks (a) detail – cracks in the matrix and carbides (b)

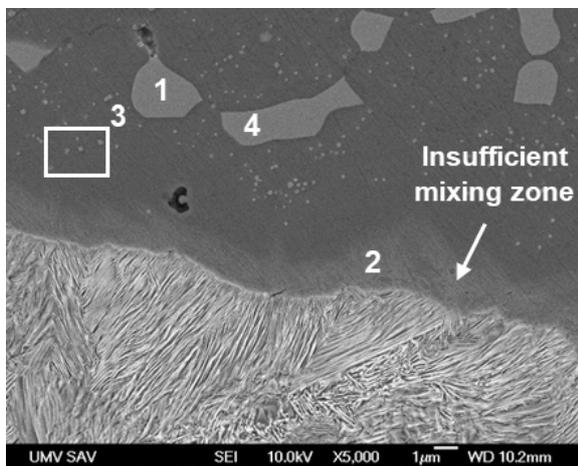
The Figure 11. shows the EDX microanalysis of the weld deposit RD 571 and around the boundary of the weld deposit and base material. Carbides (Point “1” and Point “4”) are visible in the weld deposit as the sharp-edged particles. Their shape can cause peeling from the matrix at high load of the weld deposit. In addition to large, sharp-edged carbides, there are also small

A lighter zone with a thickness of up to 10 µm is observed in Figure 11 at the interface of the weld deposit and base material. The point analysis was also carried out at this point. It is continuously visible in Figure 11a. A high iron value was found in this zone by chemical

analysis (Table 5 – Point “2” of EDX analysis). There is probably a diffusion connection but without the presence of the carbides. This probably confirms that the materials were not mixed at the interface. The importance of performing the point analysis is given by the fact that the area analysis could also capture locations outside the observed lighter zone in the weld deposit and base material. This could distort the information about the likely zone of mixing

Fig. 11. The EDX microanalysis of the weld deposit RD 571 on the base material
