NON-DESTRUCTIVE TESTS OF LOCK TONGUES USED IN ATR-72 AIRCRAFT LANDING GEAR BASED ON MAGNETIC METHOD

The purpose of this work is to highlight the opportunities of using and analyzing process progression of Non-destructive Testing in aeronautical industries and technologies. This paper concentrates on magnetic-fluorescent method, which is used to showcase the practical test of lock tongue installed in ATR-72 aircraft landing gear.

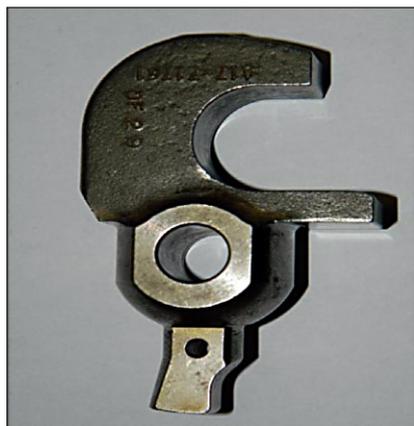
The object of this test was an aircraft lock tongue responsible for blocking the landing gear hatch of ATR-72 airplane. It cooperates with a capstan and an electromagnetic lifter. Each opening of the lock is signaled by the pressure on the capstan and relay contacts, the joining of which is further relayed in the cockpit and interpreted as the opening of the hatch.

The tongue performs the function of a lock block, preventing the hatch from opening during the flight. It is made of the tool steel NC11X-210Cr12 and its dimensions are 150×60×20 mm. Due to the function of this device any damage to this element preclude it from further use. Figure 1 presents this component. All tests of this element have been conducted in NDT research laboratory, furnished with tools and specialized equipment necessary to conduct the tests based on magnetic-fluorescent method.

Fig. 1. The tested component – a lock tongue of a landing gear

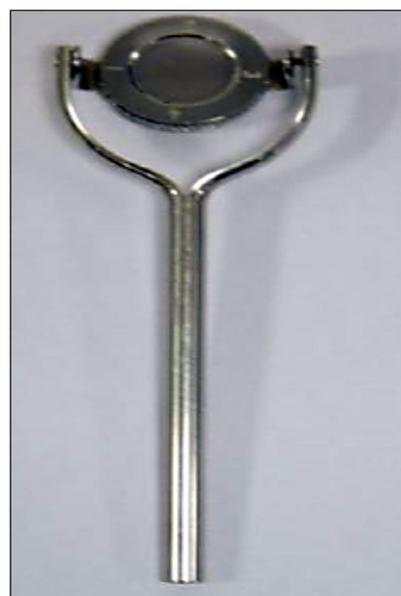
performance used in NDT. In this case, the subject of inspection is CM – 152 magnetic defectoscope. The aforementioned inspection is twofold: it involves assessing the direction of magnetization and its thoroughness. The direction of magnetization was verified with Berthold Magnetic Field Indicator (Figure 2). This indicator is a simple measuring device, which enables researchers to determine approximation of measurements in the test conducted with the use of magnetic powder and helps to verify the direction of magnetic field. Berthold's Magnetic Field Indicator comprises: a ring, which is to be free of any magnetic residue, and a cylinder of soft steel set into it, which consists of four segments. These segments are separated from each other by non-magnetic facets which create two perpendicular fissures. A membrane with a thin brazen lid is screwed onto the cylinder. As the membrane turns the lid's position relative to the ground becomes shifted. In order to conduct the measuring the indicator must be placed on a magnetized object; as a result a fraction of magnetic field lines will flow through the cylinder made of soft steel. After the powder of magnetic suspence is applied, depending on the direction of the field the membrane reflects one or two lines of cross fissure. As the membrane is moved away upwards without the loss of measurements, the measurements taken using this method are proved to be more accurate as a result of higher current intensity or the quality of the magnetic suspence. The model component rotates slowly around the cylinder's axis until the fissure becomes clearly reflected. In this position the

Fig. 2. Berthold's Magnetic Field Indicator

magnetic field goes perpendicularly in relation to reflected fissure. The estimation of the direction of magnetization using the abovementioned indicator has been supplemented with the evaluation of the thoroughness of magnetization with Block A model. Block A model is a steel cuboid measuring 30×110×20 mm, with multiple holes 1.5 mm in diameter each.

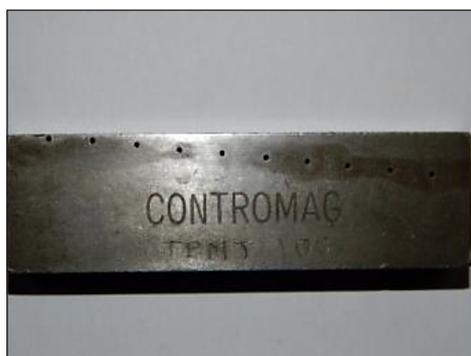
If the location of damage is known it is easy to determine the thoroughness of magnetic test. The abovementioned model – Block A – has been placed into the clip of the defectoscope CM – 152 after which it has been subjected to magnetization three times, with a 2.7 kA/m current within the duration of 5 seconds each time (Figure 3).

Fig. 3. Model – Block A

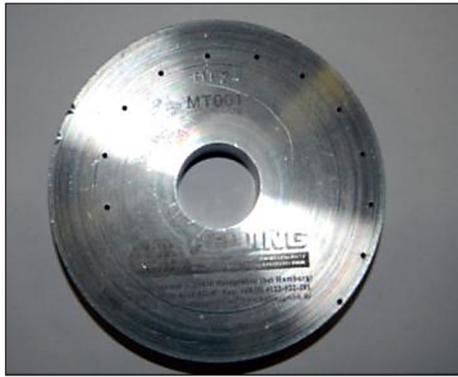
ness of magnetization a Ketos Ring was placed on a copper electric conductor, after which the current of 8 KA was switched on for the duration of 2 seconds – this procedure was repeated three times. Ketos Ring is a metal ring, 127 mm in diameter with drilled holes located 1.78–21.34 mm from the outer rim. Just as during model – Block A check, in this case the quality of defectograph was determined. After the test had come to an end it was possible to pinpoint deliberately damaged segments. A number of lines appeared on the rim of the ring, which signified that the test was conducted appropriately. The intensity of the field on the tested component was 1000 A/m. Figures 5 and 6 present, respectively, Ketos Ring and the way it looked after magnetization.

Fig. 5. Ketos Ring

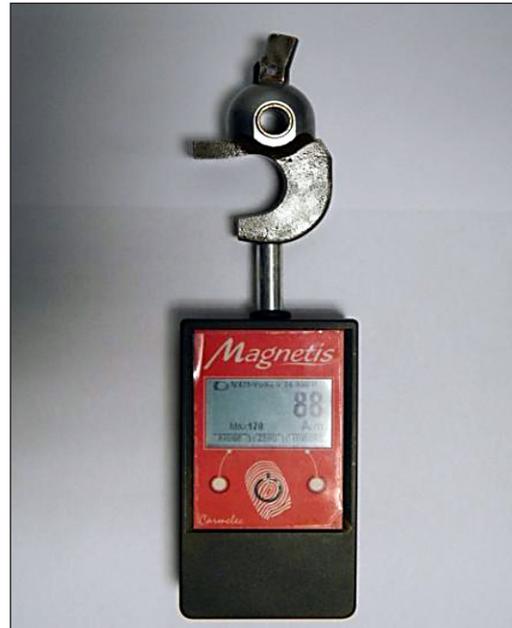
The last stage of the test based on magnetic method is the final demagnetization of the test component (Figure 9), and clearing it from the suspension. The final demagnetization is very important, because the value of magnetic field intensity must not exceed 240 A/m. The test object – a damaged lock cap – was isolated from other, flawless components used in the test and subjected to thorough clearing, which involved using cleaning salve and clearing in an ultrasonic

Fig. 9. The final measurement of residual magnetism in the tested component
