VISUAL ANALYSIS OF HEAT TRANSPORT IN A UNIQUE OBJECT

ABSTRACT

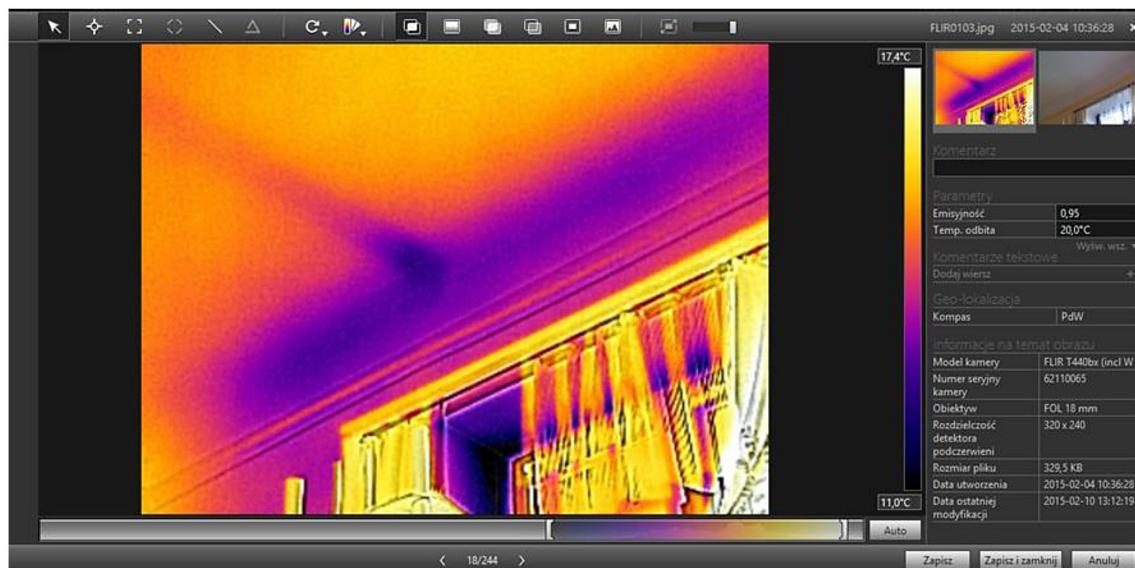
The example presented in Figure 1 shows the selected part of a building interior. The colors reflecting measurements are allocated in natural coincidence with heat flux propagation direction, i.e.: from blue at lowest temperature values to red at the highest ones. This method is usually recommended if the measurements are taken for the purpose to persuade the observer to prevent from heat losses. The assumed surface emissivity has been established at 0.95, which is appropriate for a painted wall and the temperature distribution is properly recognized by the camera. The only source of misunderstanding can occur for the observer looking at a curtain, partially shading the surface behind. This figure additionally presents the software screen features enabling some extra read outs from the device. The measurement distance is 3 m, room

ambient air temperature 20 °C and air relative humidity is 50%. It is also possible to compare with the report given in Figure 5. The particular recommendation for this procedure is to reduce the distance and this could help to increase the measurement precision and avoid curtains in this distance. Concluding from this image, the minimal temperature is about 11 °C, which is likely to result from a gap in layers in consequence of the combined influence of worn – weak internal construction and poor thermal insulation outside the wall. The adjacent digital view on the discussed element does not show the presumed gap which confirms the reliability of presented measurements as visible gaps could give light reflections and even lower the clarity of measurements by thermal vision methods [2, 4].

Another detail that can be analyzed in this figure is a darker band of about 14 °C. This temperature is lower of about 4 C deg. than in the most of the presented ceiling area. This is a typical thermal bridge, resulting from improper wall structure. In the contrary, the upper left window corner does not show any weakness in a wall structure but poor window frame air-tightness.

Moreover the perpendicular dark line is the most probably the result of improper scaffolding support during previous modernizations of this part of the building dated almost 100 years now. This multispectral image gives us more details than a typical thermal-vision image (compare Figure 2). This detail is a brighter lines over the window: the first one is definitely the curtain rod (reflecting the light from its shiny surface but not the temperature), the second one (of higher tem-

Fig. 1. Multispectral image of building interior

perature) is probably an electric cable in its tube cover [6]. The additional horizontal line appears because the multispectral thermal image is shifted from the digital one. This is the most reliable interpretation as no system documentation is available. The vertical bright element is supposed to be a part of air bleeding pipeline in their space heating system.

Typical errors in imaging, but unavoidable here, are visible on the window glass panels. The bright colors are not reliably reflecting the glass panel temperature but the light reflected from a part of blinds and the curtain falling in folds. This is important to know during such measurements. The blinds are visible behind this curtain not because it is transparent material but because it is not folded and the vision comes out through the lace fabric.

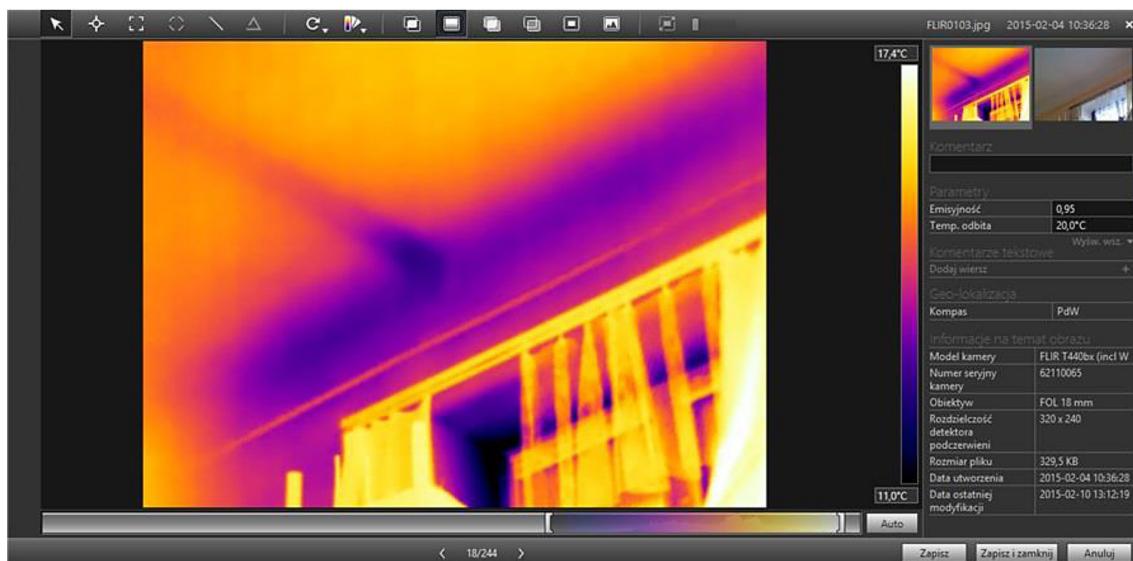
Fig. 2. Thermal-vision image for the analyzed interior area

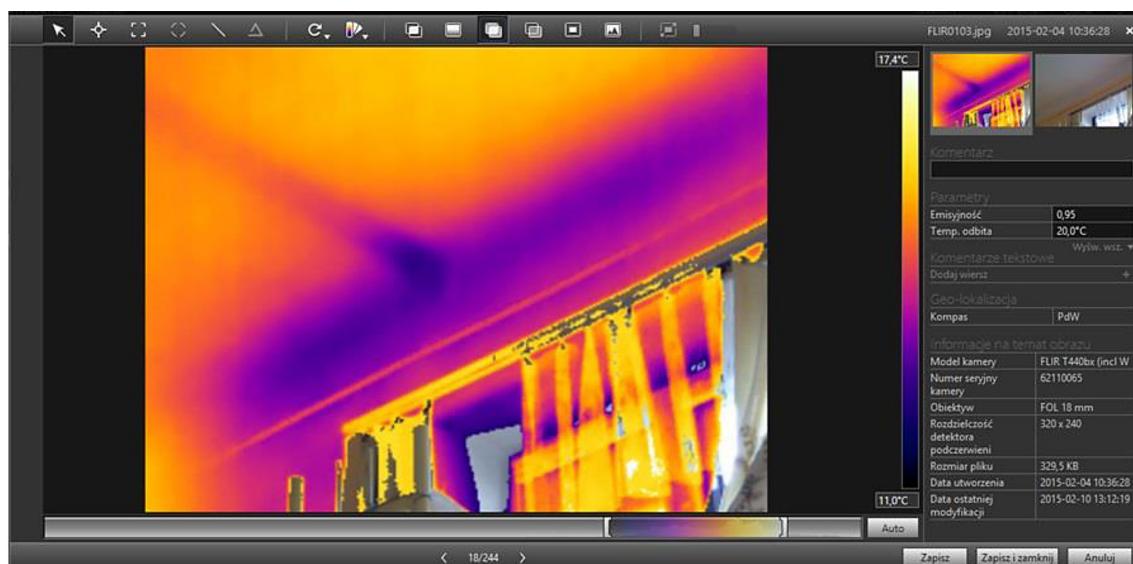
The additional image is presented in Figure 3 in the form of thermal fusion, however, in this case it brings no additional information (in contrary to the exterior images in Figure 6) it is optically more distinctive. The fusion is composed of thermal and digital images. The only digital image of this selected area is presented for comparisons in Figure 4. Shades on the surface inform us of improper conditions in the area where they occur but the real information is delivered in this case from Figure 1.

Fig. 3. Thermal fusion image

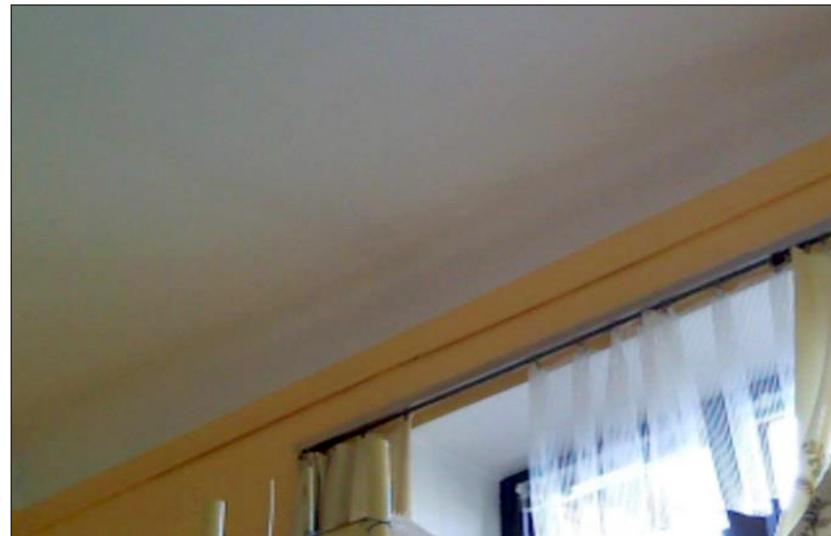
Fig. 4. Digital image of the interior area

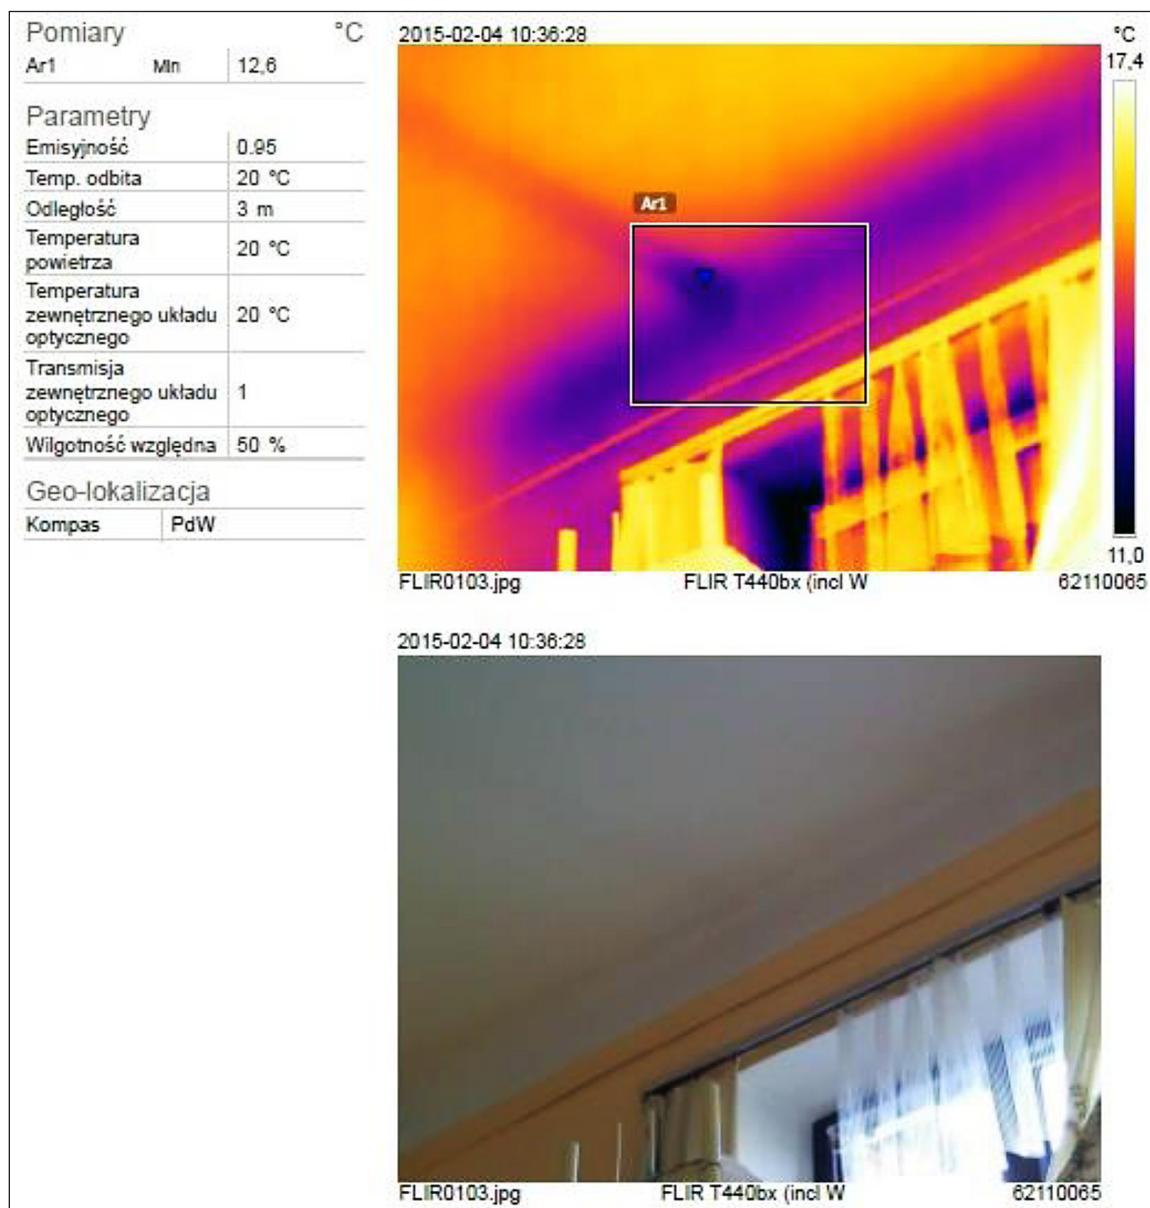
If one considers the method in aspects of didactics, it is important to use additional visualization convenient for evaluations. These can be performed on the basis of report forms. The example is presented in Figure 5. From the view of evaluators, it is important that, beside images,

Fig. 5. Exemplary Report Form generated for the evaluation of measurements

temperature and other conditions are indicated as numbers specified in relevant units.

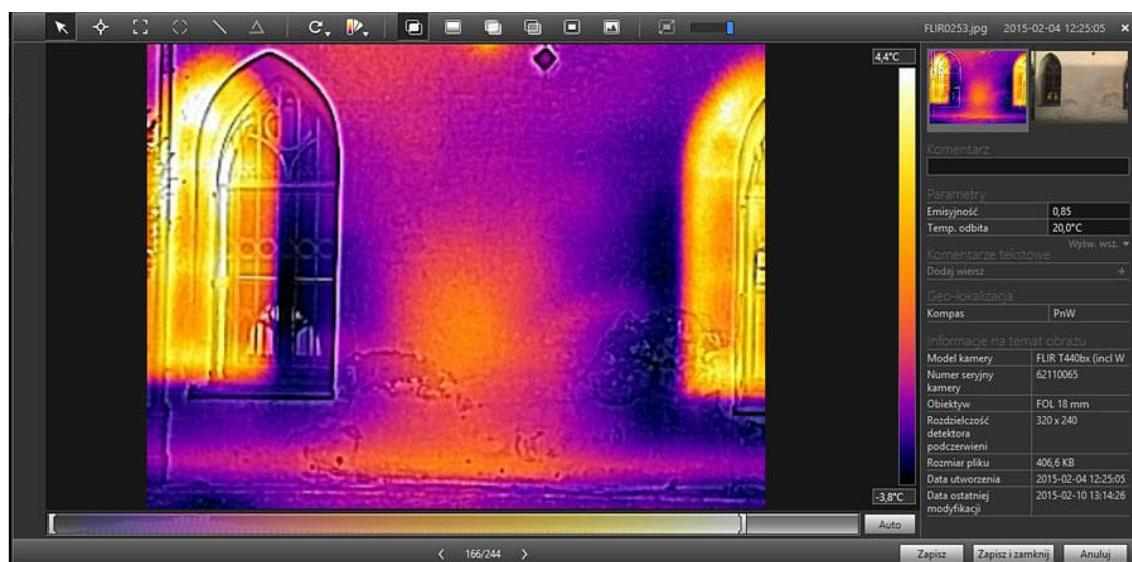
The emissivity of the analyzed area is 0.85 and thus it is lower than in interior examples. It is justified by the fact of higher exposition to daylight from one point of view and by the rough gray surface from the other one. The ambient air temperature is about -4°C and the distance is closer than previously – that is 1 m which helps to reduce reflections. The direction of taking the measurements is important especially in the case of exterior images because of possible sunlight exposition. In this case it is south-west direction which is usually advantageous because it helps avoid reflections naturally. In this example of a patio, the direction is not so meaningful.

It is visible that in between the two windows the area of higher temperature appears. There are some symptoms visible in Figure 9 but not sufficiently justifying the temperature difference of 8°C [5]. Again, there is no technical documentation to this part of the building and only the owners recall a former back door entrance

to the building in this place. Definitely, the work performed was not of high quality and the interior heat leaks out from the corridor there. Moreover, the horizontal bright line in the bottom of the wall suggests there is no proper soil insulation and there is a heat leakage spot too. Additionally, some moisture can remain in this place without proper removal.

Moreover, the windows also show their secrets. Generally, the technique of installment of the new type of windows is well known and properly performed but the details which are not so common are often poorly performed. This is the case of cone-shaped details more visibly presented in multispectral shift – the brighter frame area is wider there and thus the heat leaks more through the wider section. Definitely, this thermal contact resistance could be analyzed in micro scale and the results could help to improve the performance of similar elements.

Fig. 6. Multispectral image of the building exterior

On the basis of the presented examples one can formulate a list of damages occurring in building facades and improper thermal insulation in the investigated object elements. The refurbishment seems necessary and at the time the paper is formulated it really happens. But the main idea to formulate the paper is to analyze different aspects of thermal visualization at research and/or during the doctoral stage of academic education (so called the third level). The indirect measurement methods require high proficiency in theory and need practicing to acquire high level of performance. It should be stressed that exclusively optical verification is not appropriate in this visualization method.

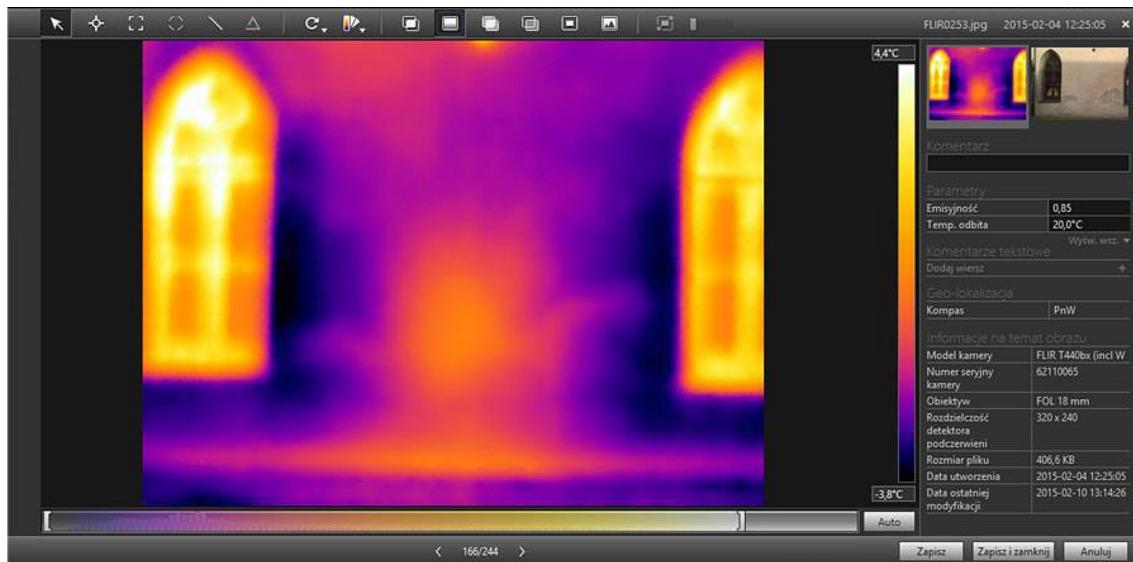
Thermal vision presented in Figure 7. confirms the multispectral effect but does not contain meaningful surface details. In the multispectral image, these details are shifted geometricaly from the thermal indication but this does not harm the conclusion. The visible deterioration of the façade shows that it has already become infested by wet rot. This image shows the area of sunlight reflection from the parts of window frames, especially in this case – from the left vertical one. Thermal fusion (Fig. 8) brings this information but at the same time removes parts of important temperature distribution, which shows that it is not always useful method of thermal imaging.

Fig. 7. Thermal Vision example

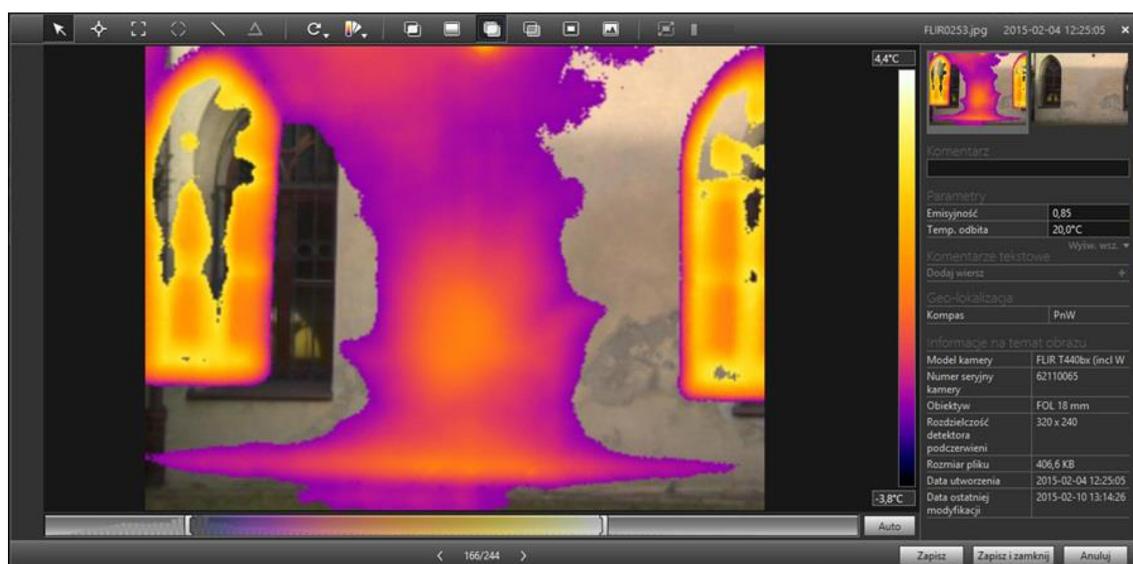
Fig. 8. Thermal Fusion example

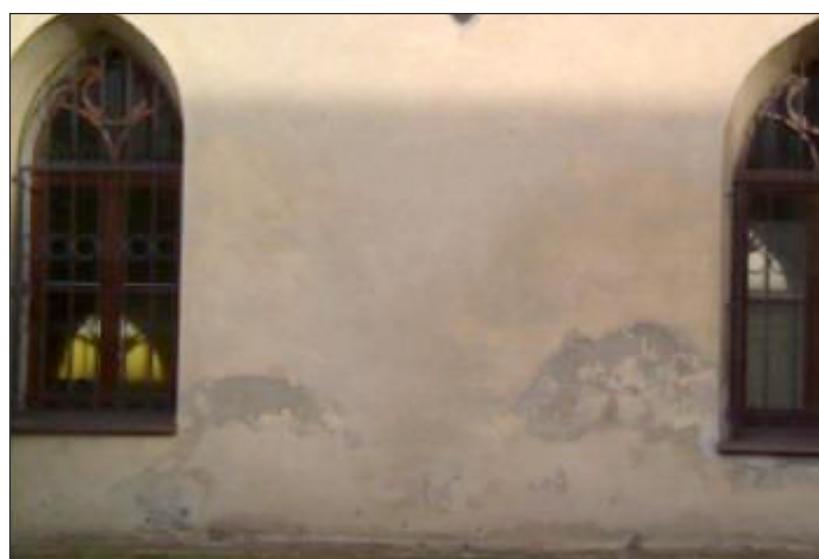
Fig. 9. Digital image of the wall in the analyzed patio
