ANALYSIS OF AXLE SHAFT FATIGUE FAILURE AND ANTI-FATIGUE SYSTEM DESIGN

In this study, an axle shaft subjected to static deformation and fatigue damage was considered by using computer-aided engineering. This shaft system was modeled with CATIA and subjected to dynamic fatigue analyses with Ansys workbench. The damaged fracture surfaces of the shaft have been examined. Thus, the fatigue and damage was revealed in greater detail. For the present system, a design with a minimum cost, short production process, minimum weight was sought together with methodical construction principles. By means of CATIA and ANSYS, the product development design with reasonable tension and deformation values was formed for endless life fatigue. A design was produced in a short space of time with the help of 2D CATIA drawings and field tests were carried out. The design was used through 560.000 cycles and damage was not observed.

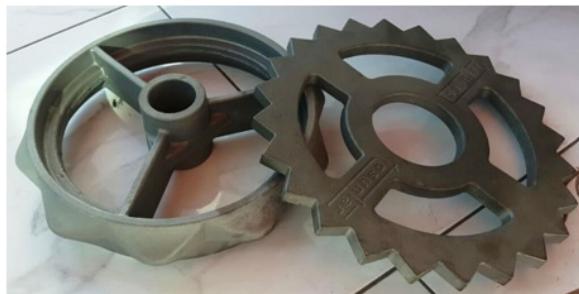
Fig. 1. Cambridge type roller unit

The axle shaft examined in this study beds 22 Cambridge type roller units. A roller unit has two main elements. The first is the roller with more oval gears in contact with the shaft (which can be seen in Fig. 1 on the left) and the other one is the shaft with frequent and pointed gears that does not touch the shaft. The total weight of the roller unit is 22 kg with an outer diameter of 38 cm. and a width of 90 mm.

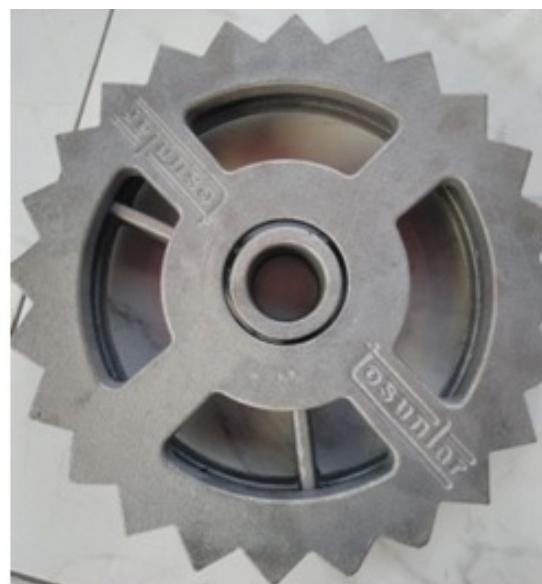
Fig. 2. Installation of the roller unit

exposed to the shaft and its inner diameter is 80 mm. The roller with narrow sharp gears moves with 5 mm spaces on the hollowed shaft of the large roller (Fig. 2).

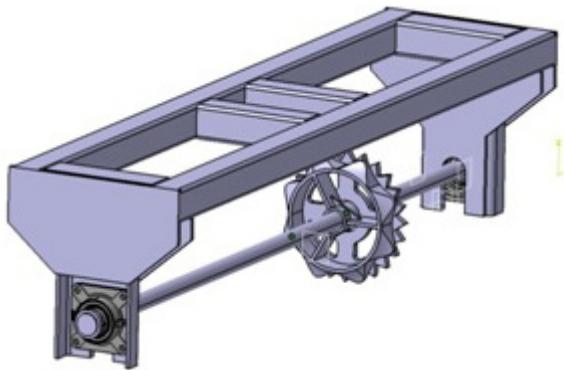
Fig. 3. Roller carriage chassis, beds and a roller unit

The system where shaft fatigue damage was formed is modeled with CATIA software. The mounting of a roller unit with a shaft of 50 mm diameter is shown in Fig. 3. It was supported with a flange-bearing unit from the shaft end who's parts are 2.4 meters long. In the case of the roller system chassis, assemblies are seen. Fig. 4 shows the current system. There are 22 roller units on the shaft.

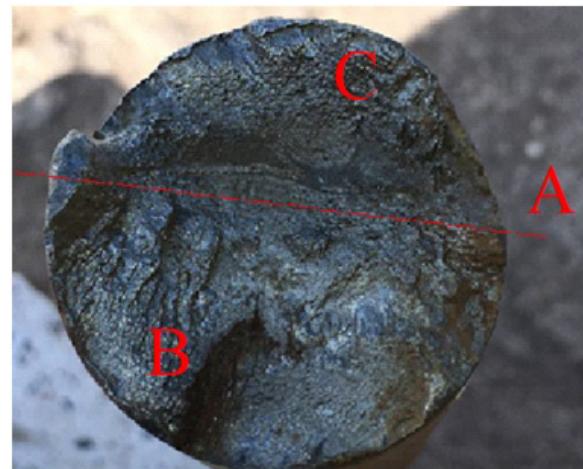
Fig. 5. Shaft fatigue & surface damage

Due to fatigue damage, the surface damage that deepens along the axis of the shaft is revealed. This ductile is the appearance of a fatigue fracture. Fig. 5 shows the benchmarks.

A: fatigue-bending axis. B: indicates tearing in the perpendicular direction to the axis of fatigue. C-fracture area.

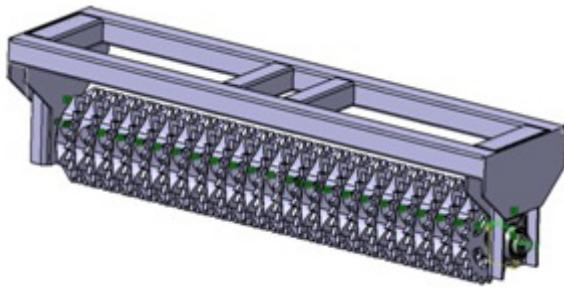
Fig. 4. Pre-damage system solid model

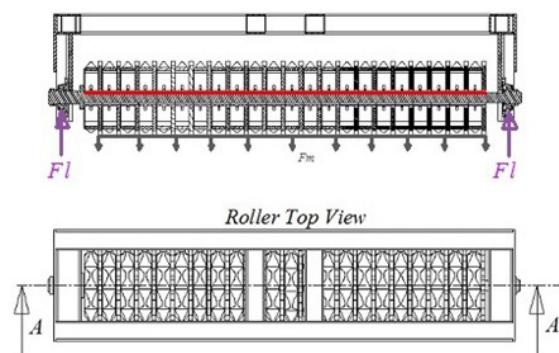
There is no rotation of the shaft in this case. Fig. 6 shows the cross-section of the roller system. The rollers touch the top part of the shaft, along the red line (Fa). Fl: It is the lifting force applying to the shaft. Here, Fm is the weight effect of the rollers. Sw is the weight of the shaft and is 37 kg.

Fl, in the road condition was taken as support. In case of Fa's support, there will be no bending of the shaft. $Sw = 370 \text{ N}$, $Fm = 4840 \text{ N}$. $Fa = Fm + Sw$. $Fa = 5210 \text{ N}$. In the static analysis carried out in the road condition, the maximum stress was obtained as 68.95 MPa (Fig. 7) and the maximum deformation was calculated as 2.04 mm (Fig. 8).

Fig. 6. Extensive loading on shaft

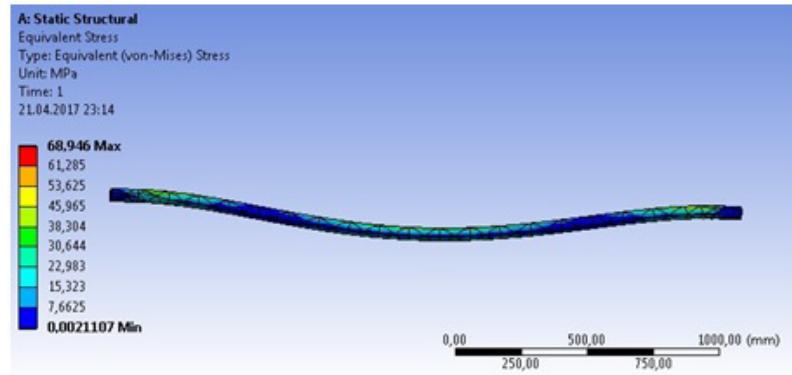
Fig. 7. Maximum stress in shaft in the road condition

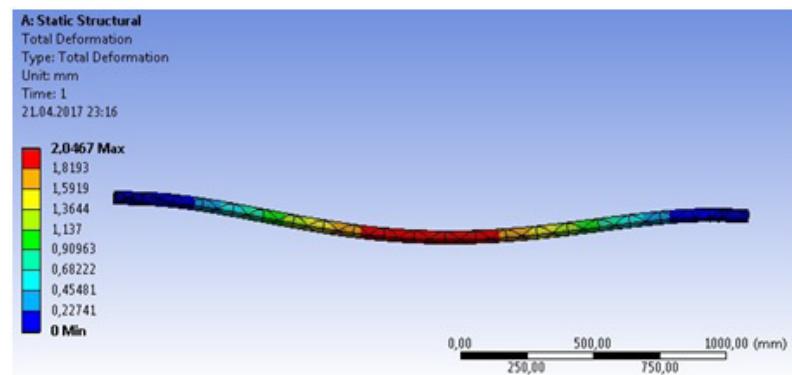
Fig. 8. Maximum deformation in the shaft in the road condition

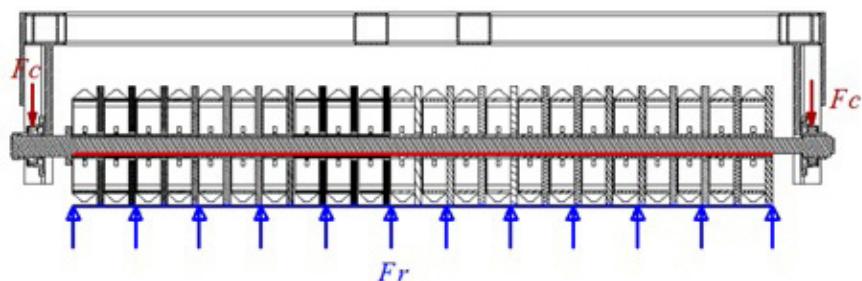
The rotation speed of the roller system was accepted as 150 rpm. The forces acting on the shaft are shown in Fig. 9, in the section of the roller system. Fc is the weight of the entire roller system (pressure force) and Fr is the ground contact reac-

Fig. 9. Cross-sectional view of the general working state of the roller system

tion force. $F_c = F_r$. $F_c = 14 \text{ kN}$. $F_a = F_r - F_m - S_w$ when F_c is taken constant. $F_a = 8790 \text{ N}$. In this case, the maximum tension on the shaft is 131,79 MPa (Fig. 10). The maximum total amount of deformation is 3.86 mm (Fig. 11). The fatigue life is 118200 cycles (Fig. 12). The Fatigue Safety Factor value is 0.65 as shown in Fig. 13.

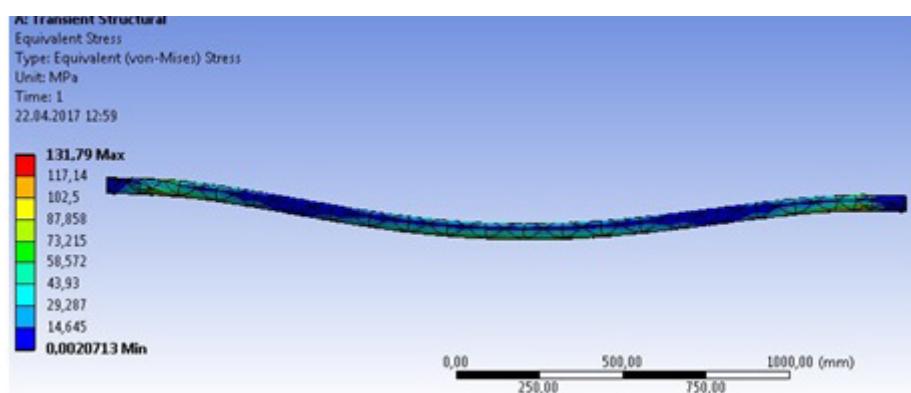
Fig. 10. In the case of general operation, shaft dynamic fatigue analysis: Von Mises tension

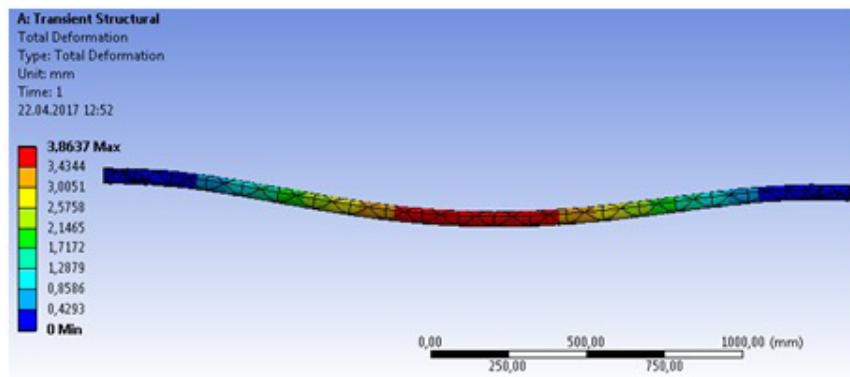
Fig. 11. In the case of general working, shaft dynamic fatigue analysis: total deformation

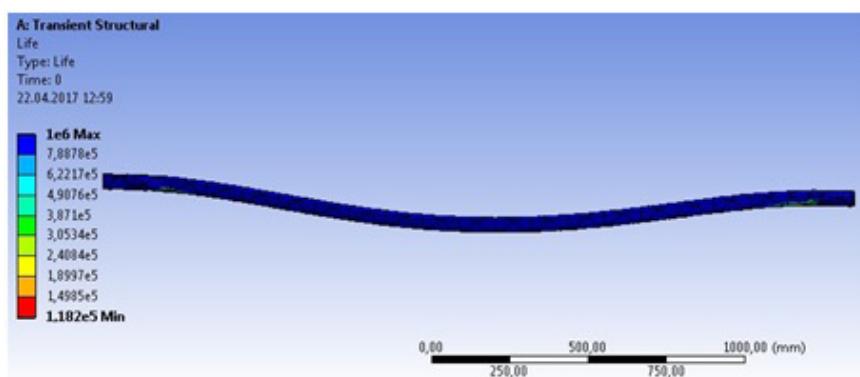
Fig. 12. In the case of general working, shaft dynamic fatigue analysis: life

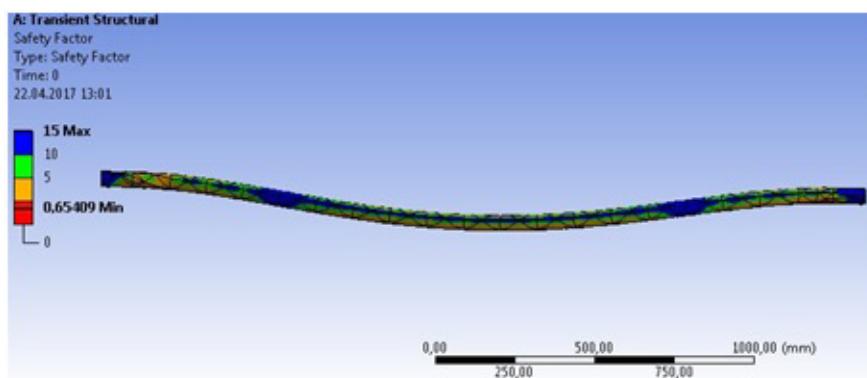
Fig. 13. In the case of general working, dynamic fatigue analysis: safety factor

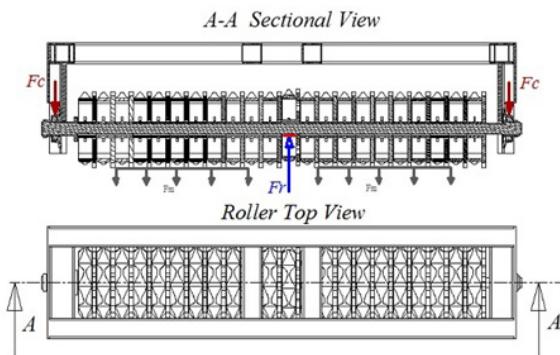
ing load: The “shaft maximum bending loading state” was formed by the forces acting on the shaft is seen in the section of the roller system in Fig. 14. When the system was operated under normal conditions, the shaft hit a hard floor from the center of the shaft by a roller unit that touches the shaft at a width of 9 cm. The shaft was subjected to visible deformation under the influence of these forces (Fig. 14). $F_c = F_r = 14$

Fig. 14. Shaft maximum bending load, deformation event

kN. F_c was kept constant in the analysis. $F_m = 10 \cdot 22$ kg. In this case $F_a = F_r - F_m - S_w$. $F_a = 11430$ N. The maximum stress acted on the shaft for a short period. This time duration for a speed of 12 km / h (roller's forward speed) is 0.075 sec for a 25 cm hard floor touch. The maximum Von-Misses tension strength under these conditions is 296.25 MPa (Fig. 15). The total deformation is 9.41 mm (Fig. 16).

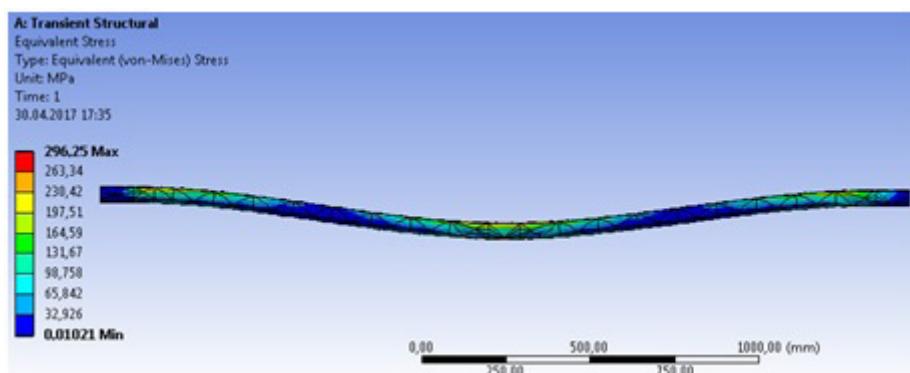
Fig. 15. In the case of maximum bending load: Von-Mises Stress

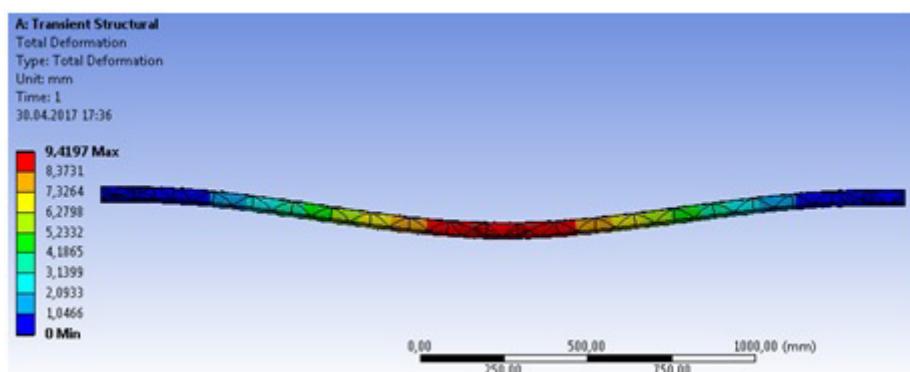
Fig. 16. In the case of maximum bending load: total deformation

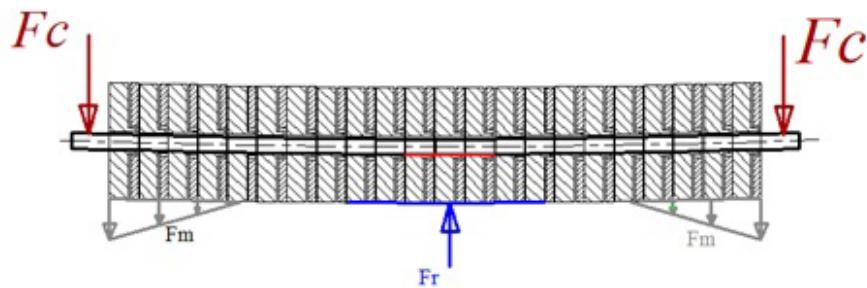
The amount of deformation of the shaft was obtained by stress analyzes and shaft's approximate deformation measurements were obtained. This measurement was carried out with the optimum combination of broken shaft surfaces and with the help of a gauge. It was considered that the deformation was due to bending of 12 mm in the middle of the shaft (Fig. 17). Dynamic fatigue analysis was performed with the shaft that was formed in the case of the solid model 12 mm deformations. $F_m = 18 \cdot 22 = 396$ kg. $F_c = F_r = 14$ kN. $F_a = F_r - F_m - S_w$. $F_a = 9670$ N. In this analysis, loading was performed at a rate of fatigue damage surface distance (Fig. 5). While the variable loading was acting on the area where bending occurred in the shaft, the ratio was 1 and while it was acting in reverse direction the ratio was accepted as 0.2 (Fig. 18). Dynamic stress analysis and fatigue analysis results for the deformed shaft geometry with Ansys were obtained at a rotational speed of 150 rpm. The maximum von-mises stress is 233.88 MPa (Fig. 19). The

Fig. 17. Loading on deformed shaft

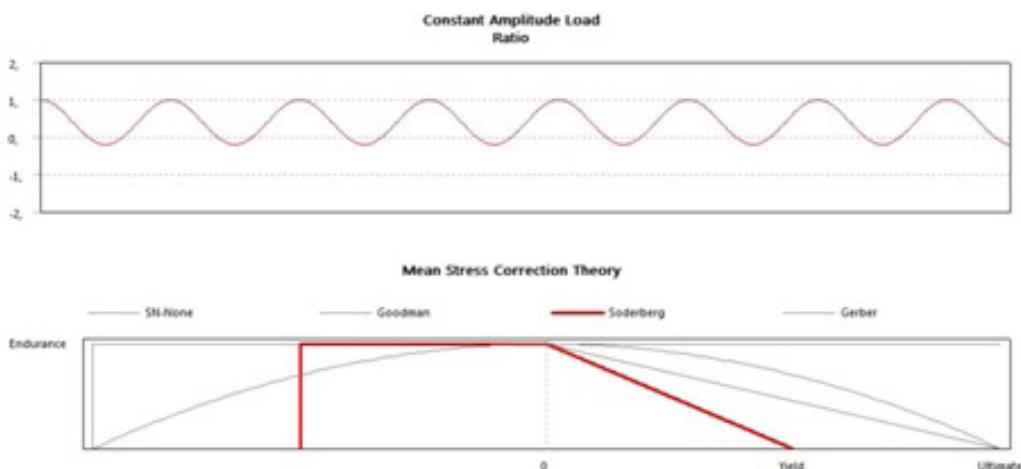
Fig. 18. Variable loading state on deformed shaft

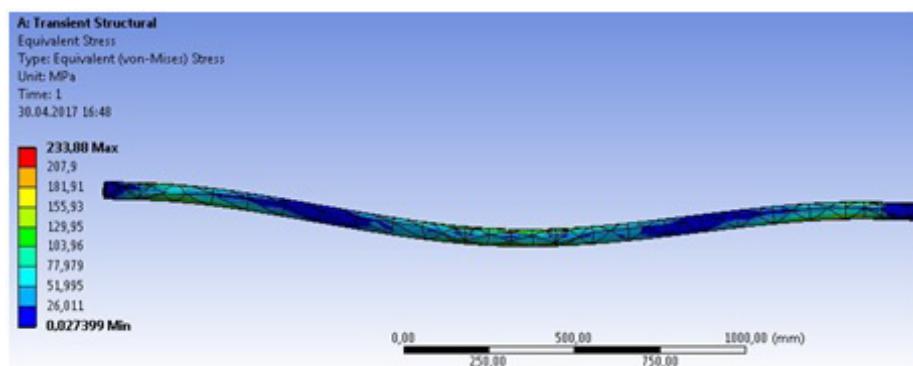
Fig. 19. For deformed shaft geometry: Von Mises stress value

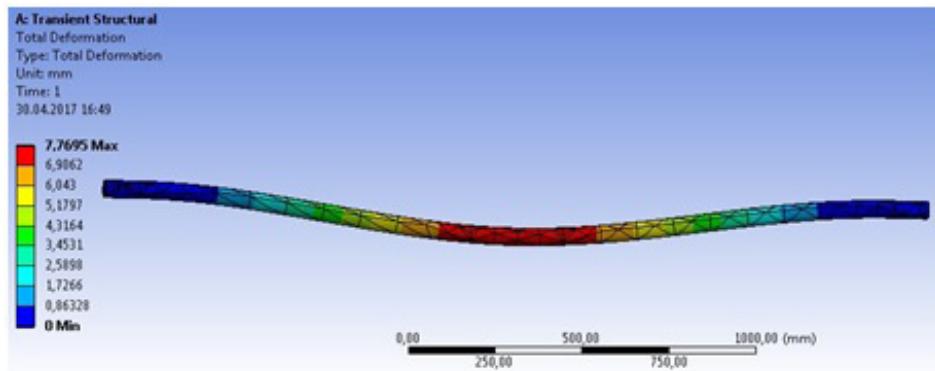
maximum bending deformation is 7.76 mm (Fig. 20). The fatigue life is 17040 cycles (Fig. 21). The fatigue safety factor value is 0.49 (Fig. 22).

Fig. 20. For deformed shaft geometry: total deformation

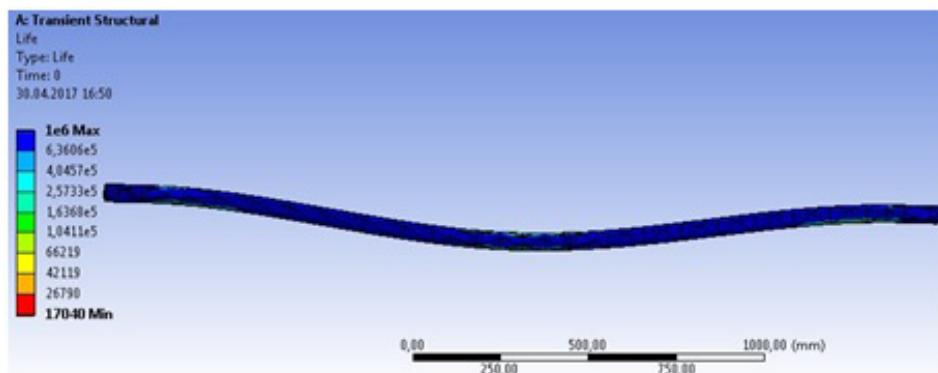
Fig. 21. For deformed shaft geometry: fatigue life

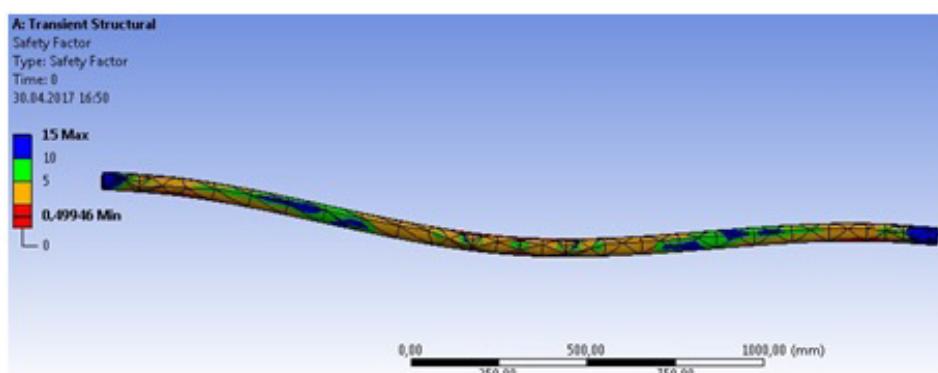
Fig. 22. For deformed shaft geometry: fatigue safety factor

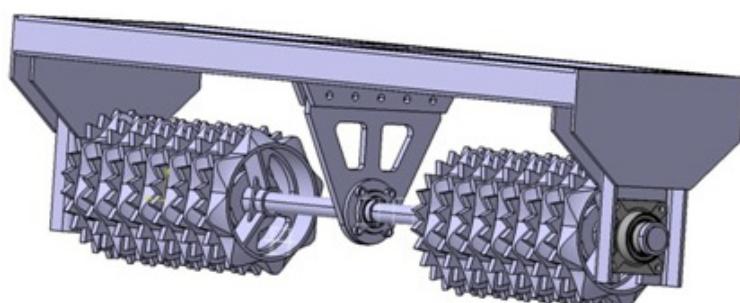
Fig. 23. Roller system improved design assembly

This approach is construction systematic Design targets that were determined in this context: production in short time, minimum weight, minimum cost, and modular design. In this context, the shaft was bedded with an additional bearing from the middle. The bed is a circular bearing unit. The ball bearing unit was connected to the plate formed in the plasma-cutting device with four bolts using the 2D drawing created with Ca-

tia. The carrier plate is 20 mm thick and is connected to the chassis with 5 M 20 bolts. The formation of the bolt joint ensures that this chassis is used in a different operation. The assembly of the design is shown in Fig. 23. The rollers were hidden in the middle so that the bed design that was created can be clearly seen. Fig. 24 shows the improved roller system assembly sections and forces. F_a1 and $F_a2 = 4395$.

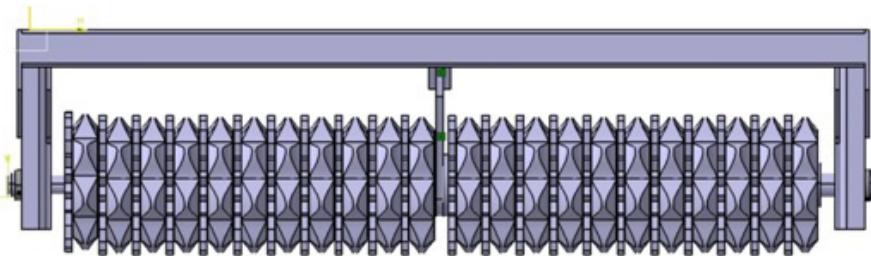
Fig. 24. Roller system improved design assembly section

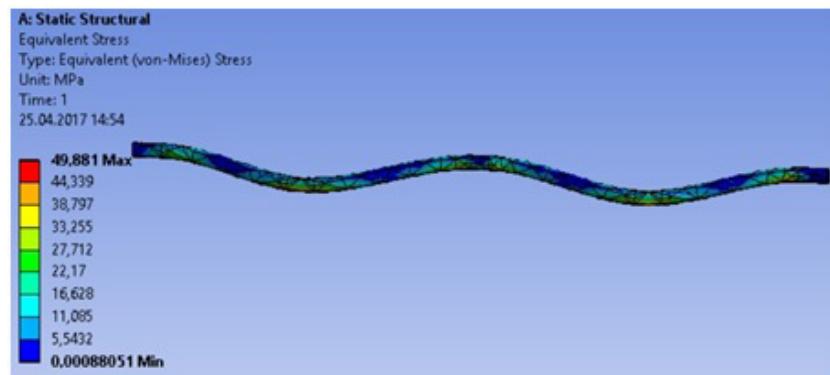
Fig. 25. New anti-fatigue system design: Von-Mises stress value

The maximum von-Mises stress value for a three-bearing system is 49,88 MPa (Fig. 25). The total deformation value is 0,45mm (Fig. 26). Fa-

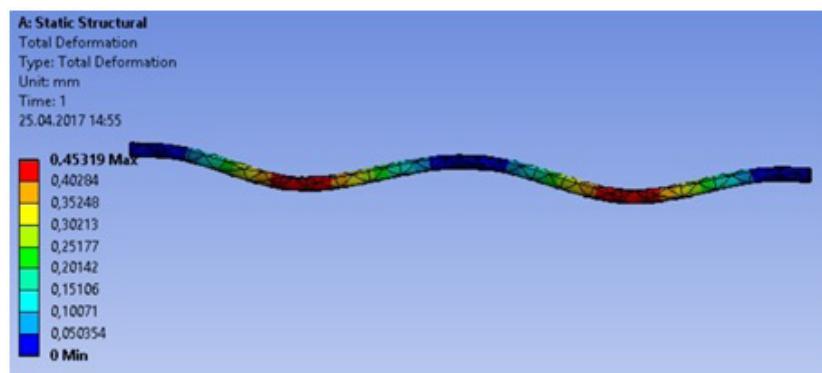
Fig. 26. New anti-fatigue system design: total deformation

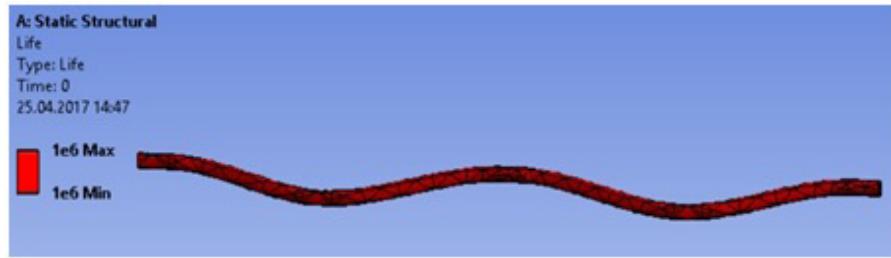
**Fig. 27.** New anti-fatigue system design: fatigue life

tigue life is minimum $1 \cdot 106$ (Fig. 27). The fatigue safety factor value is 1,78 (Fig. 28).

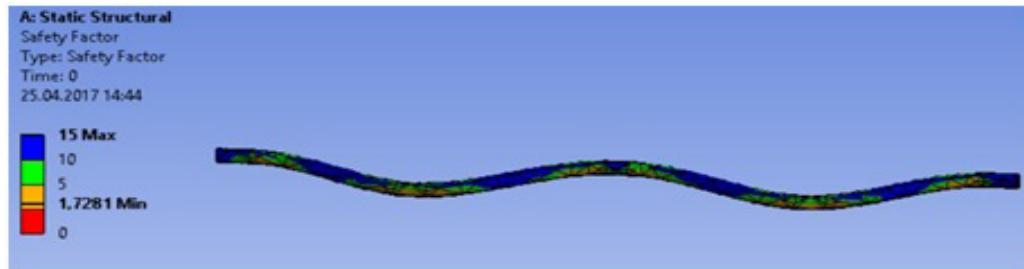
**Fig. 28.** New anti-fatigue system design: fatigue safety factor

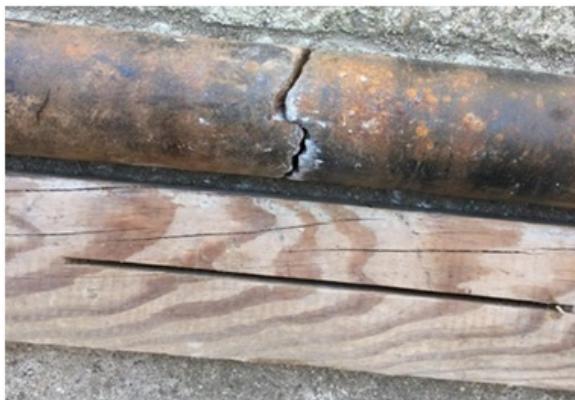
- Fatigue Damage happened with the occurrence of Case - 2, Case - 3 and Case - 4 respectively. Case - 2 continued up to about 72000 cycles. In this cycle value (Case - 3), the deformation occurred. After the damage, fatigue in the damaged shaft continued for 1240 cycles and damage occurred (Fig. 29). The shaft was broken by bending under the effect of static deformation and fatigue loads.

Fig. 29. The shaft broken by bending under the effect of static deformation and fatigue

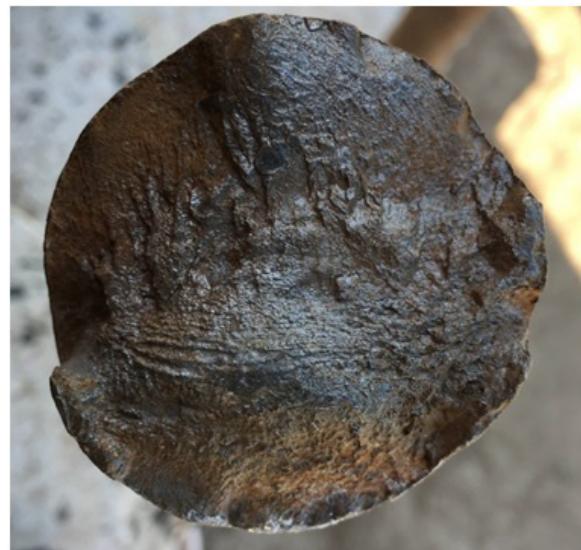
Fig. 30. The beach remarks of fatigue damage

- Fatigue has occurred in the position where the maximum displacement occurred. When the fracture surfaces are examined important information about the fatigue is obtained. This is a bending fatigue as seen from the shafts outer surface cracks. The outer surface cracks have moved towards the center. The ductility of the material exposed to fatigue is clearly understood from the fractured surface. In this study, there are depths of fracture along the axis of the shaft in the examined shaft fracture zone. The small number of benchmarks clearly demonstrates that the post-deformation fatigue damage occurred in a very short time [11]. The high level of bending the shaft is the basic cause of fatigue damage (Fig. 30)

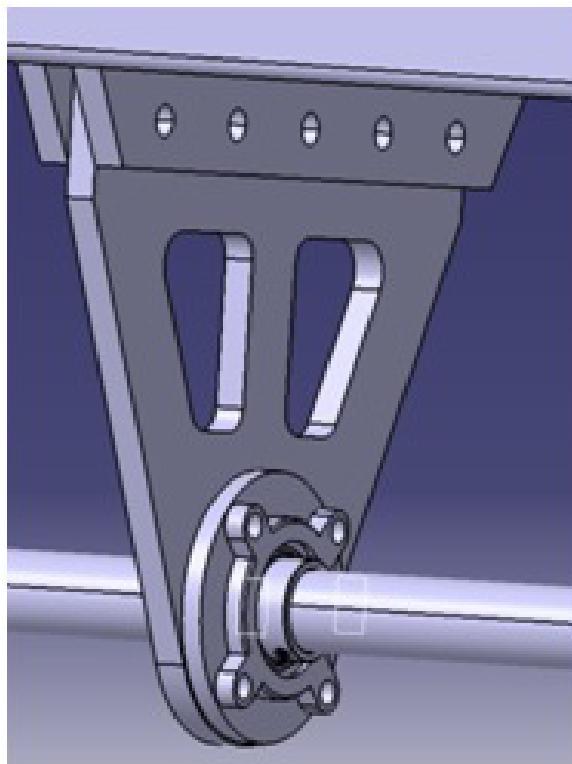
Fig. 31. Shaft modular bearing design

- The data of the computer aided engineering design process is quite important in a standard production (Fig. 31). Designed bed carrier plate was converted to 2D with CATIA drafting module the design, which was formed according to the selected bed unit connection nests and holes, was formed by a plasma-cutting device. Plasma cutting process time was 1.5 minutes and CAD data provides benefits in the production process and in performing modifications in a short time (Fig. 32).

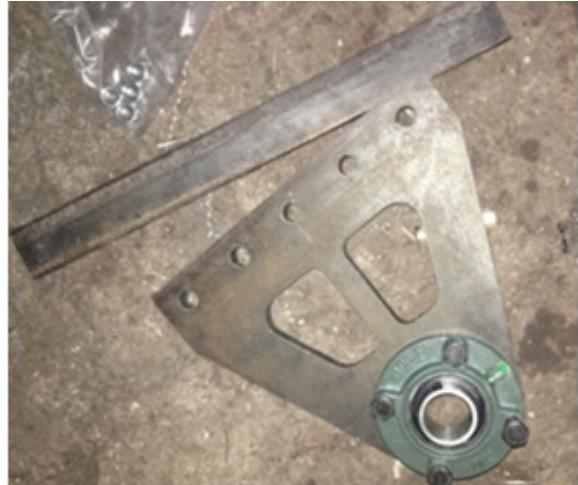
Fig. 32. Production of design

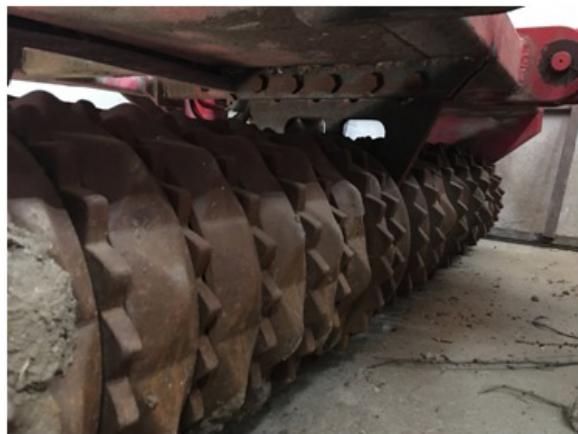
Fig. 33. The system as a result of shaft modular bearing design installation and field tests

The system design was completed in 6 hours, including the assembly process (Fig. 33).
