DIAGNOSTICS OF THE PASSENGER LIFT GEAR

Kamil Szydło¹, Rafał Longwic¹

ABSTRACT

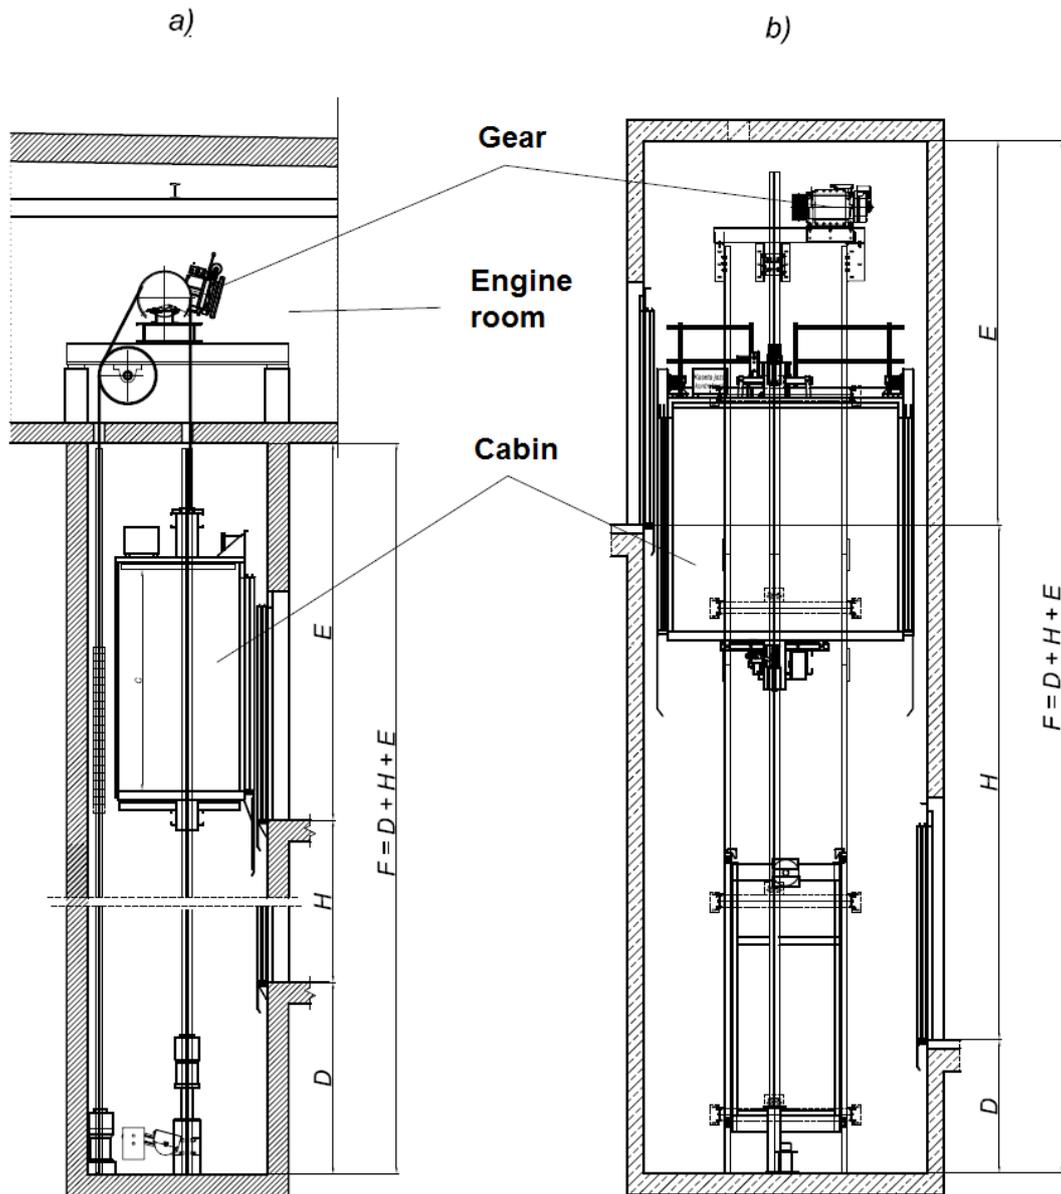
Fig. 1. The simplified cross section of the passenger lift shaft: a) the system with the engine room, b) the system without the engine room.

The lifts equipped with electrical drives where the drive units can be installed in a special technical room professionally called the engine room or directly in the shaft, must possess such a drive unit whose operation would not have the impact on deterioration of acoustic and vibration comfort both of the lift passengers and the occupants of the building where the lift is installed. Typical lift system is presented in the Fig. 1.

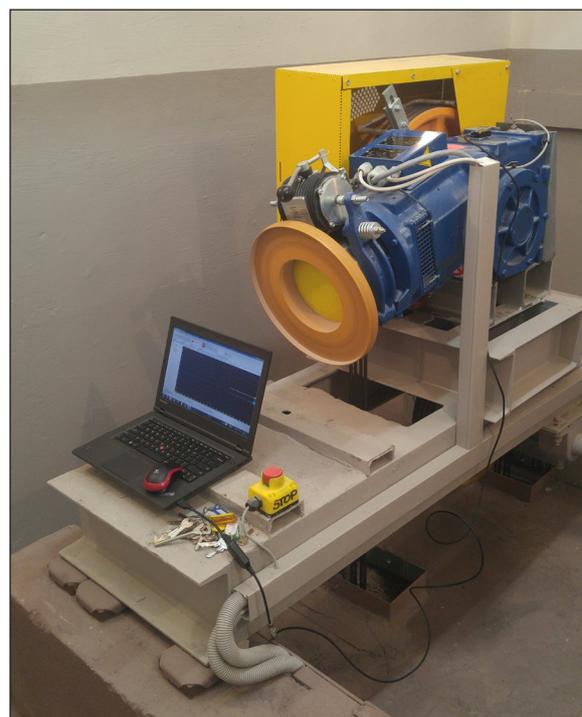
Fig. 2. LEO geared gear by SASSI company is installed in the upper engine room of the lift.

The geared gear is subject to the tests. It is installed in the residential building in Gdynia at Zbożowa Street. The mechanism parameters are presented in Table 1. The device view and the place of installation are presented in Fig. 2.

Accelerations in X, Y, Z axes are measured with Sequoia FastTracer device after its installation (it is positioned and leveled) on the gear body as presented in Fig. 2 and 6.

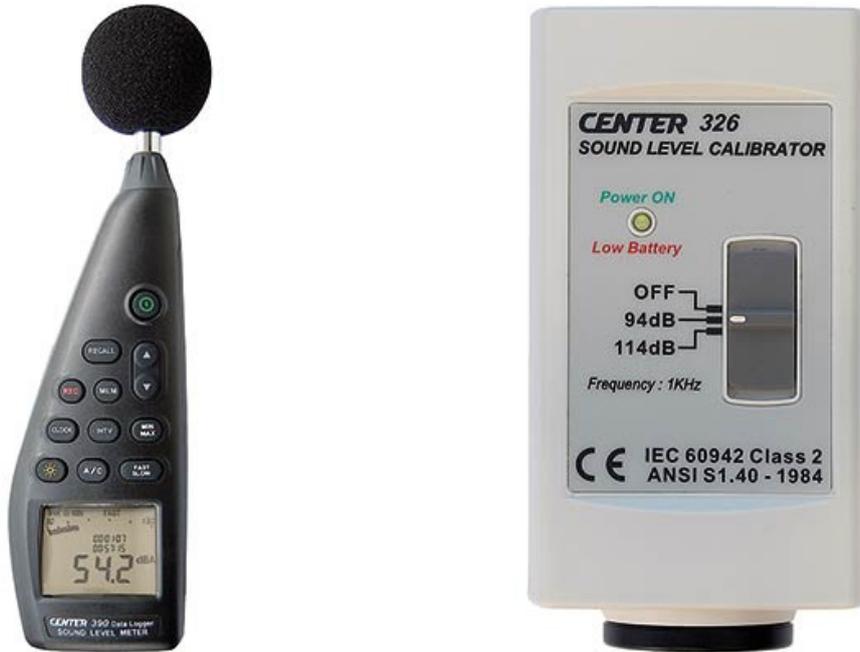
Fig. 3. Center 390 sonometer with Center 326 calibrator.

- Center 390 gauge is used to measure the level of sound volume. The measurement range is from 30 to 130 dB. The frequency of measured signal is within the wave from 20 Hz to 8 kHz. The measurement accuracy is $\pm 1,4$ dB in the reference conditions when the level of sound intensity is 94 dB and the signal frequency equals 1 kHz. The measuring device is set at the averaging curve (SLOW) (it is proper when the average level of sound emitted by source is to be measured). The measurements are done using A-weighting curve which reflects specific features of the human ear to highest extent. Center 390 device appearance is presented in Fig. 3.

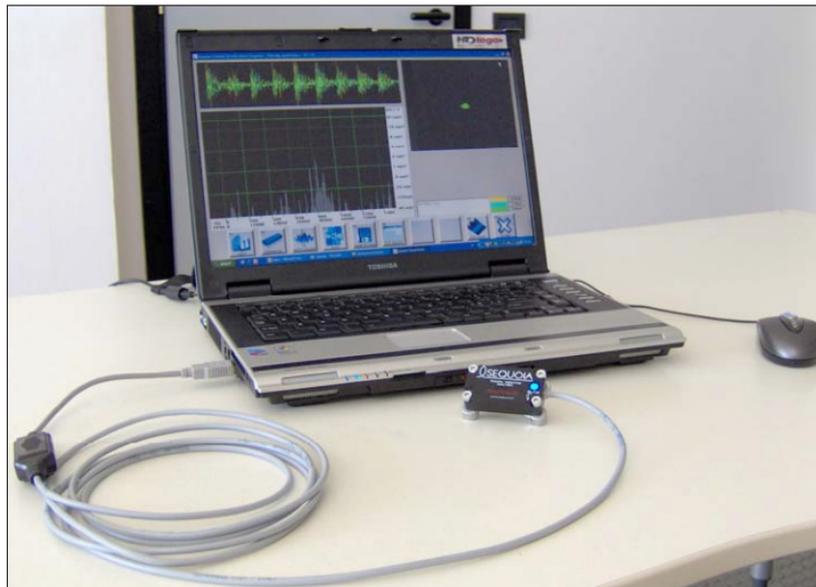
Fig. 4. Fast Tracer accelerometer with dedicated FFT Analyzer software.

- Measurements of accelerations (vibrations) are done with Fast Tracer accelerometer by Sequoia company and dedicated FFT Analyzer software. The application draws frequency courses from time perspective, it measures RMS values, acceleration, speed and displacements. Fast Tracer accelerometer is present-

ed in Fig.4. The basic data of the measuring gauge are:

- Configuration Triaxial accelerometer
- Full scale ± 5 g
- Sensors Type MEMS
- Dynamic range 89 dB @ 10Hz
- Bandwidth from DC to 1500 Hz
- Resolution 1 mg @10Hz

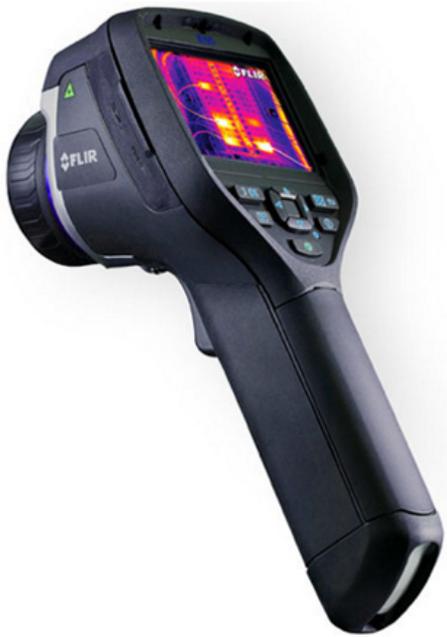
Fig. 5. Flir E50 thermal-imaging camera.

- Shock: Up to 1000 g
- Sampling: 18432 sample/s; 12bit,
- Dimensions: 30x55,5x15 mm,
- Weight: 55g,
- Temperature is measured with a thermal-imaging camera by Flir E50 company. The image obtained from the camera is presented in Fig. 5. The thermal-imaging camera allows to obtain temperature uniformity survey via a non-invasive test done from a certain distance. The test allows to read electromagnetic emission of waves which are not visible to the naked eye in a range of spectral spectrum from 7.5 to 13 μ m. Graphic presentation of temperature uniformity survey permits to detect even slight temperature changes in the places which are dangerous and unapproachable. From the received thermogram the actual temperature can be read for each point. It allows to perform detailed analysis of the saved thermal image.

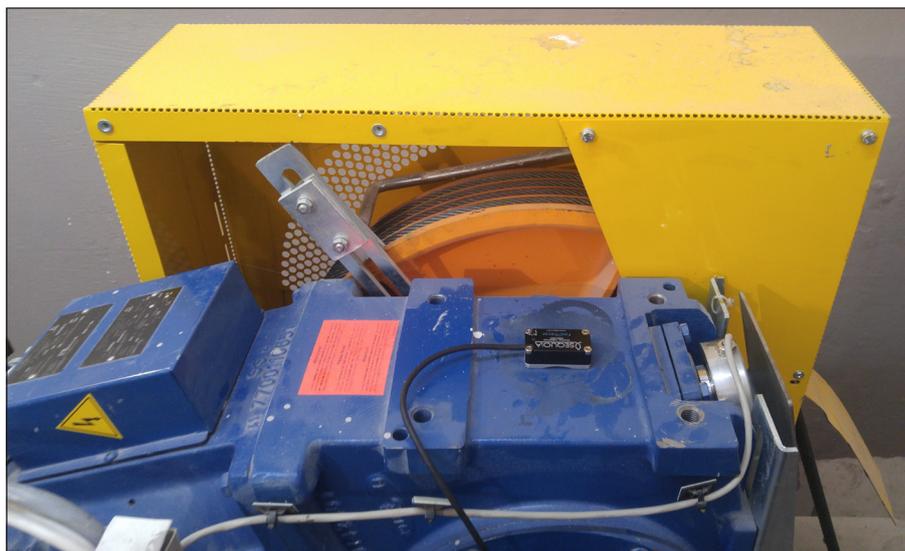
Fig. 6. The location of Fast Tracer accelerometer.

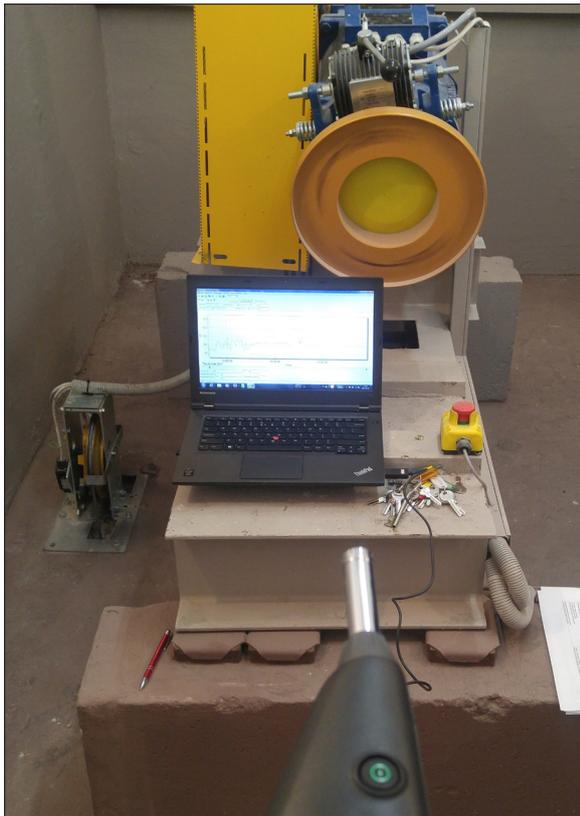
Fig. 7. Sound volume measured with Center 390 sonometer.

Sound volume is measured from the maximum distance allowed by the lift engine room size and it is app. 3 meters from the sound source. It is reflected in Fig. 7.

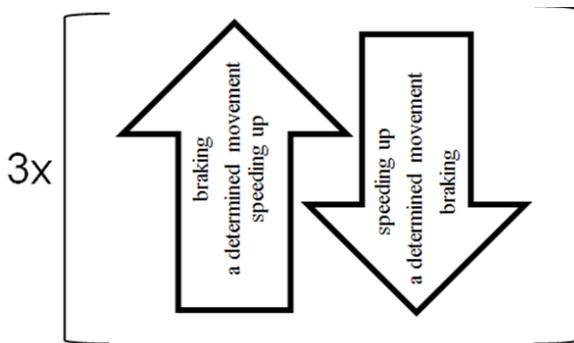
Fig. 8. Sequence of the rides during the measurements execution.

Tests of the body accelerations (vibrations), sound volume and the gear temperature are done to diagnose the reasons of excessive noise as per the lift passengers' subjective opinion. The sound volume measurement is done to check if its level of intensity exceeds acceptable standards whereas the measurement of the body accelerations (vibrations) and the gear temperature is conducted to identify possible design malfunctions that can impact the level of emitted sound volume. The measurements of accelerations and the sound volume are conducted in parallel and repeated three times as per the sequence presented in Fig. 8.

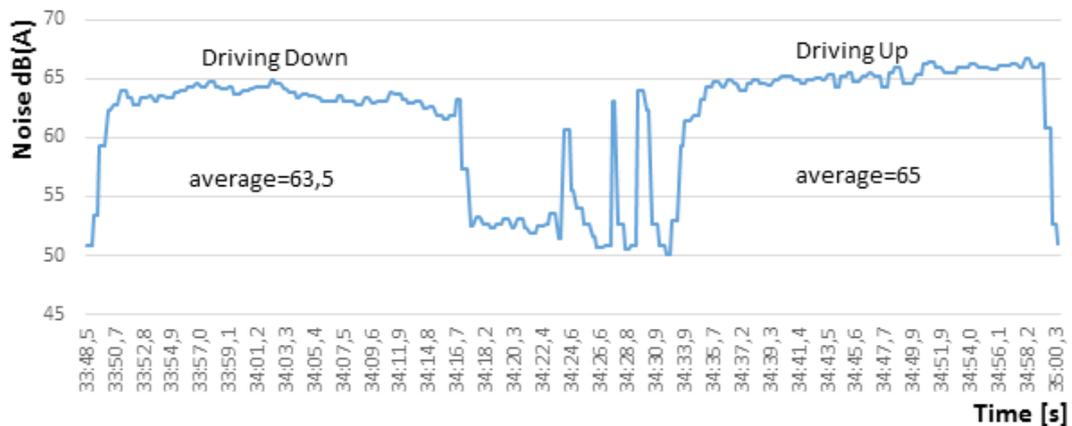
The sound volume measurements are recorded in an engine room where the lift drive unit is installed and they are presented in Fig. 9 in a graphic way. Fig. 9 displays that when the cabin drives downwards, noticeably more silent operation of the gear is observed (the value drops by 1.5 dB(A) in relation to the upwards movement). The louder operation of the gear when the cabin moves upwards can result from the fact that the counterweight, which is heavier than the empty cabin, "pulls downwards" so the gear and the

Fig. 9. Sound Emission of the gearbox in the engine room. Distance from the source – 3m.

gear unit must re-brake the system. When the cabin drives downwards the heavier counterweight is lifted as a result of which the features of operation for the machine and the gear are better. The graph also shows the moment when the system stops what results with the drop of sound volume. Peaks visible during the stop come from the operation of contractors in the control cabinet when resetting for the opposite direction (“upwards”) takes place.

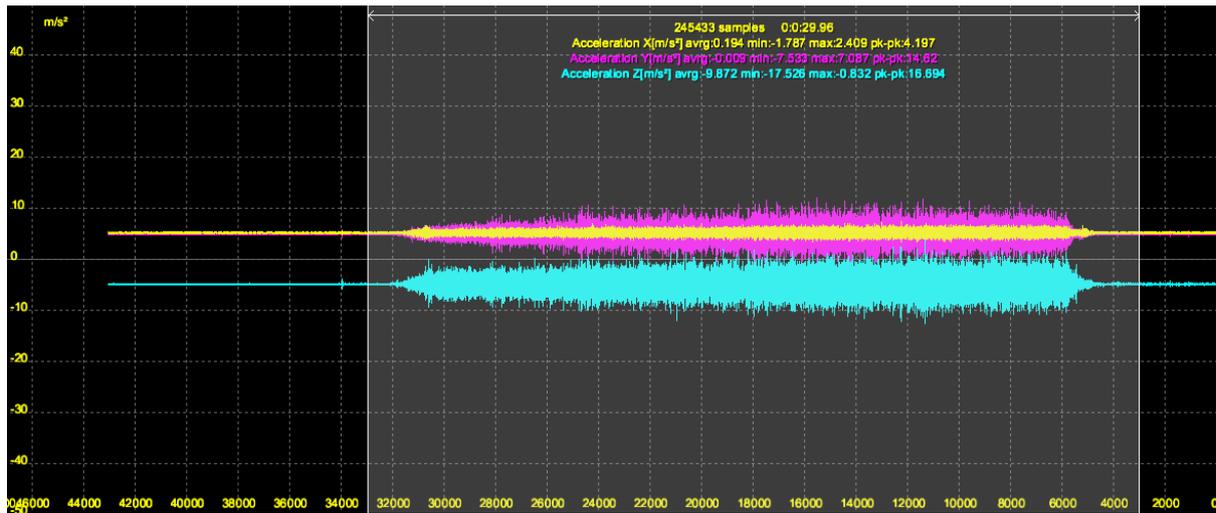
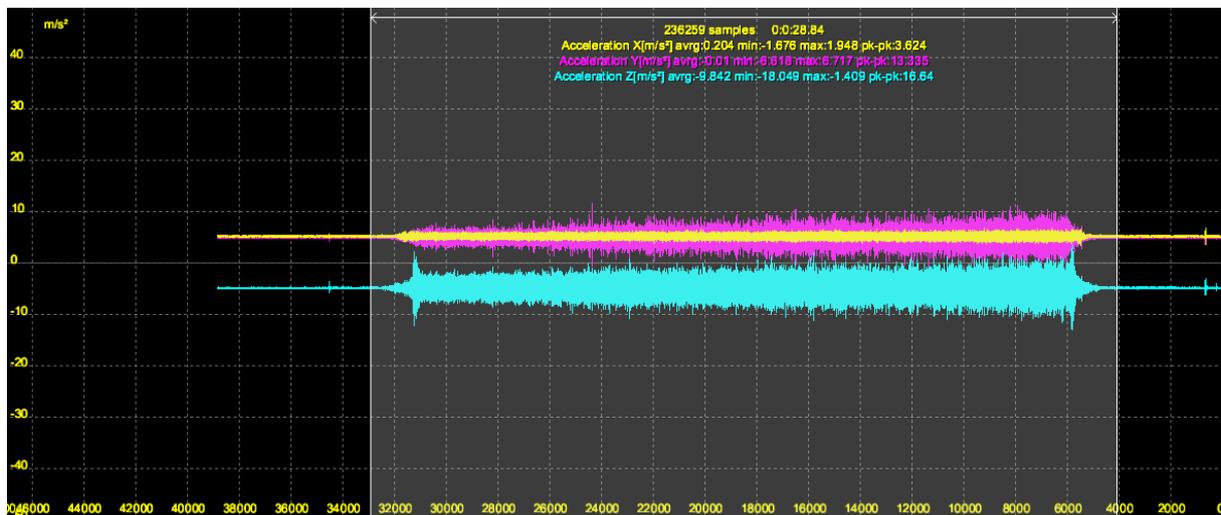
When analysing the results of obtained accelerations presented in Fig. 10 and 11 it can be noticed that accelerations in Z axis in the movement downwards are slightly higher. It is a natural phenomenon connected with the fact that during the downwards movement of the cabin the gear must „pull” the counterweight upwards. The mass of counterweight when the cabin is empty is bigger than the frame mass with the cabin by 45%. FFT frequency analysis of displacements presented in Fig. 12, 13 as well as FFT frequency analysis of the speed presented in Fig. 14, 15 indicate that the gear and its bearings do not show any features of wear and tear which is proven by the lack of displacements at frequencies exceeding 100Hz.

Fig. 10. Axes&Modules driving down.

Fig. 11. Axes&Modules driving up.

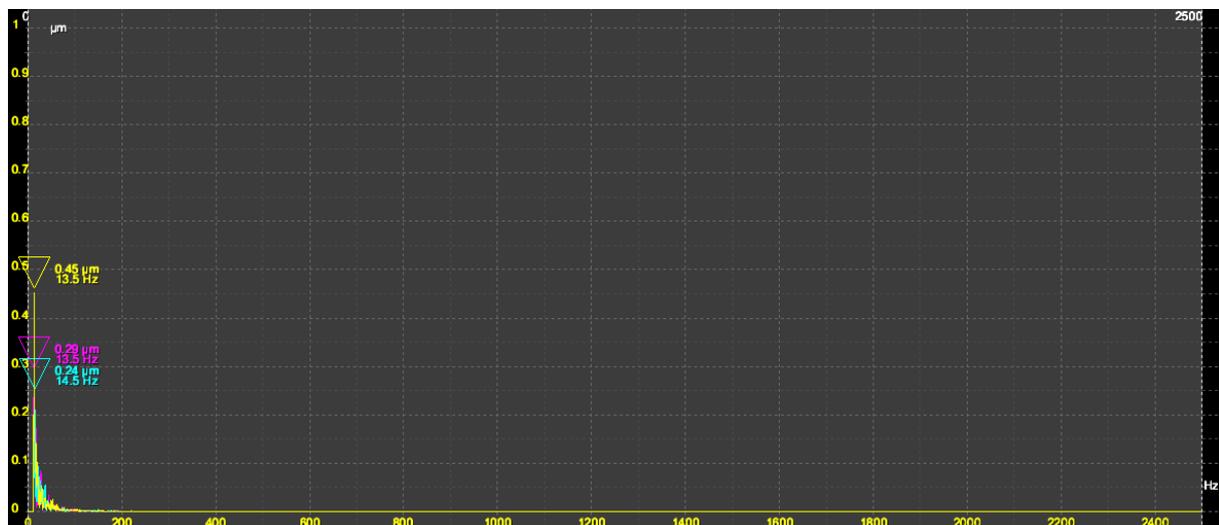
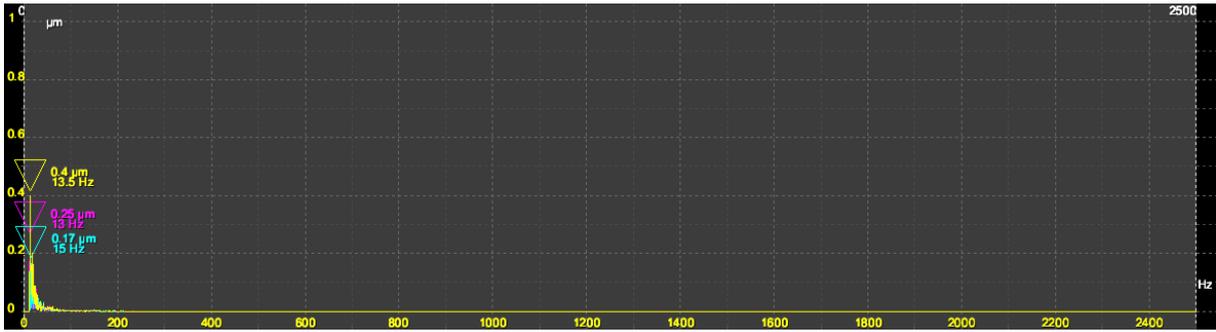
Fig. 12. FFT displacement driving down.

Fig. 13. FFT displacement driving up.

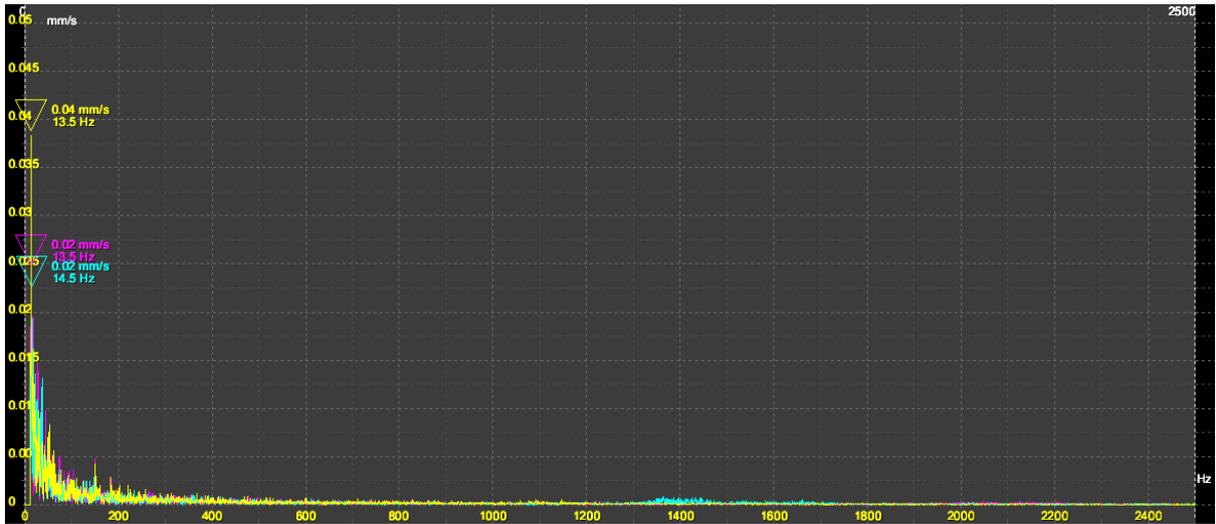
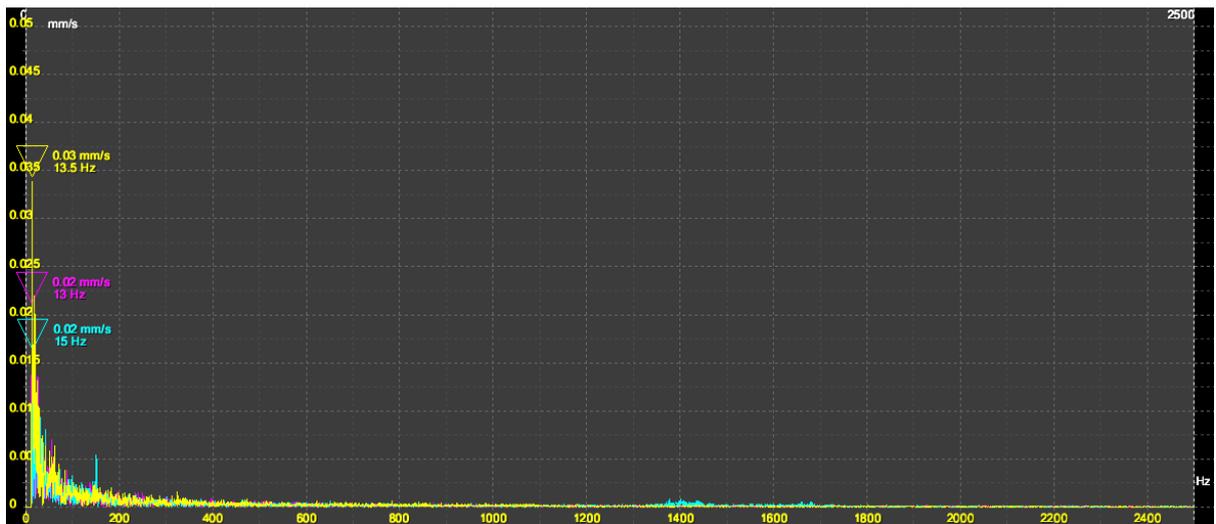
Fig. 14. FFT velocity driving down.

Fig. 15. FFT velocity driving up.

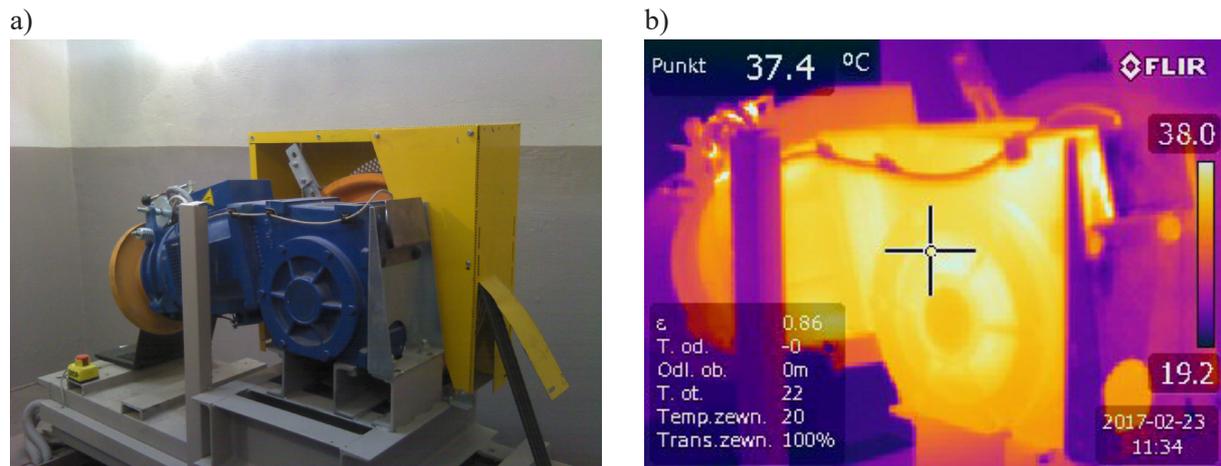
It is confirmed by the test done with the thermal-imaging camera. The gear photos and their thermal images do not display any anomalies from the drive unit operation point of view. Thermal image of the gear body presented in Fig. 16 and recorded after app. 1800s of uninterrupted operation as well as the recorded maximum point of 37.4°C value indicate the normal temperature of the drive unit operation with oil lubrication applied [13]. Thermal photo clearly shows that the area around the bearing centers do not possess temperature higher than the remaining parts of the body what additionally confirms the proper operation of those elements.

Fig. 16. Measurement of the gear body temperature: a) the body photo, b) thermal image of the body.

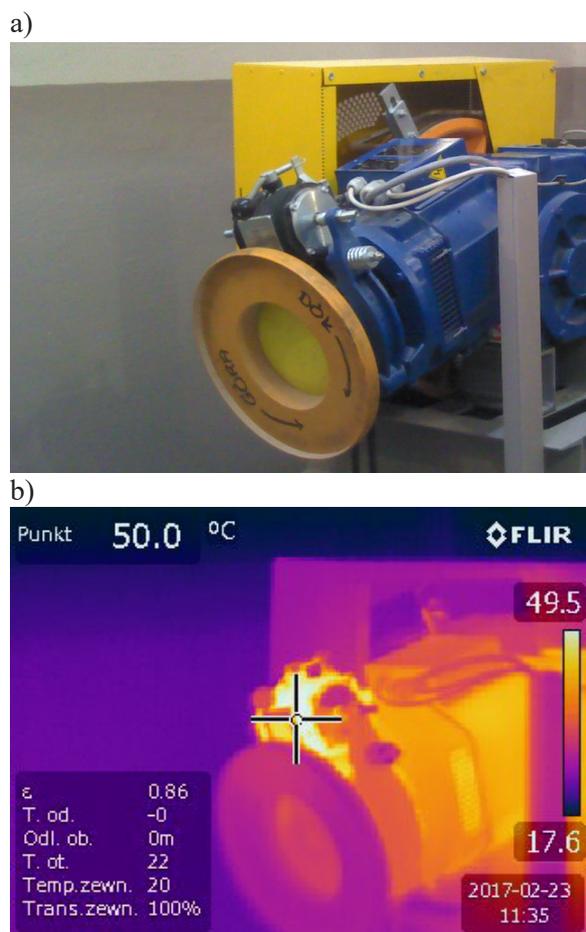
Thermal image of the gear brake and recorded 50°C temperature presented in Fig. 17 are also the example that the unit works properly – the raised temperature of the brake is a natural phenomenon taking place during its operation. The coil, responsible for releasing the brake when the system

moves, is in the working position and it gets hot as it defeats the force of clamping springs. Thermal image of the gear encoder with 51°C temperature recorded is presented in Fig. 18. It is temperature higher than temperature typical to the regular encoder operation. While examining the encoder it is noticed that the encoder axis is not balanced. Also axial beating of the entire encoder is observed what probably can have the impact on its raised temperature.

Fig. 17. Measurement of the brake temperature: a) the body photo, b) thermal image of the body.

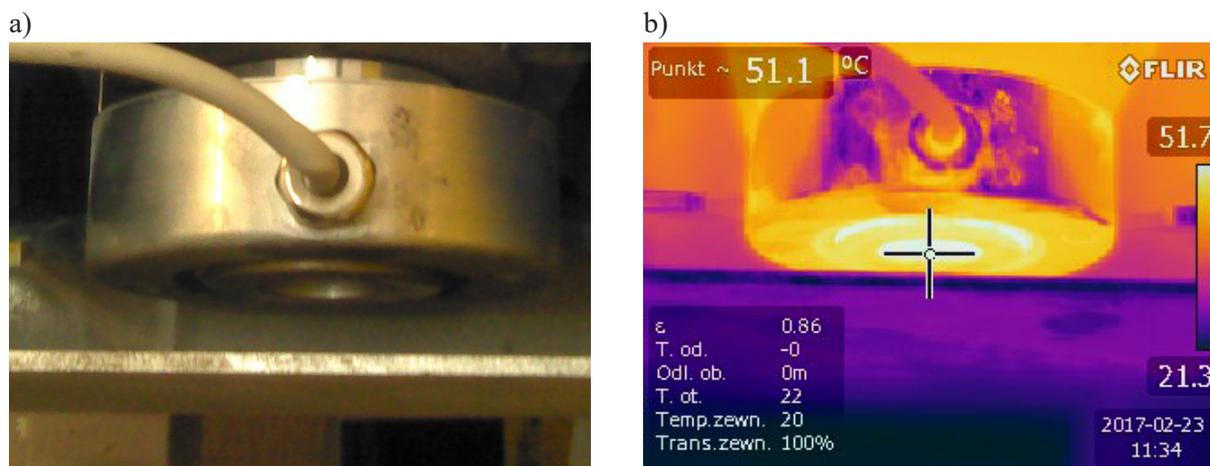
Fig. 18. Measurement of the encoder temperature: a) the body photo, b) thermal image of the body.

- High level of sound volume and audible low tones during the gear operation can come from the control system of the inverter gear – the encoder.
- Diagnostics of the passenger lift gear using the joined methods to measure the vibrations, sound volume and thermovision results with a complete image of the device technical condition and complement each other. It seems that diagnostics methodology of these types of mechanisms should be based on the above mentioned methods associated together.
