## An Impact of Technological Conditions on Surface Burning in Grinding of the Orbit

**Keywords:** grinding, orbit, quality, burning

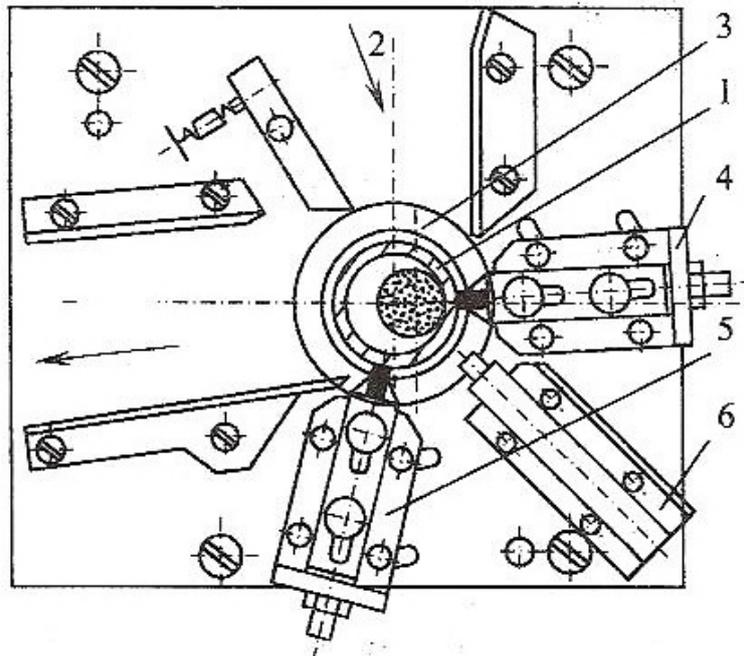
Fig. 1. Sliding rests in the orbital grinding machine  
1 – ring, 2 – input, 3 – fixture, 4,5 – sliding rests, 6 – extractor [5].

All more modern orbital and hole grinding machines machine after one ring, mostly in sliding rests to increase accuracy of an operation and a position of bearing surfaces. Positioning of sliding rests in the orbital grinding machine in fig. 1. The machine has the range of the ground hole  $\varnothing 18 \div 80$  mm. A maximum rotation of a working headstock is  $20^\circ$  [9,4].

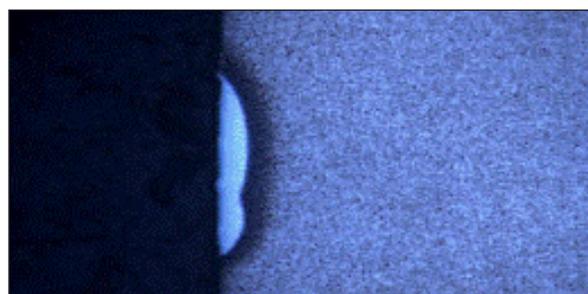
**Fig. 2.** A burning of the orbital path into the depth 0.035 mm, the machining allowance is 0.55 mm

Moreover, in case of the allowance over 0.40 mm the production period starts to increase

and even burned workpieces appeared (fig. 2). Rz exceeded 3 μm. In case the allowance exceeded 0.60 mm, the system BKS 2 aborted a cycle of grinding. These pieces can be ground up to the required quality only in slower displacements which would prolong the production period.

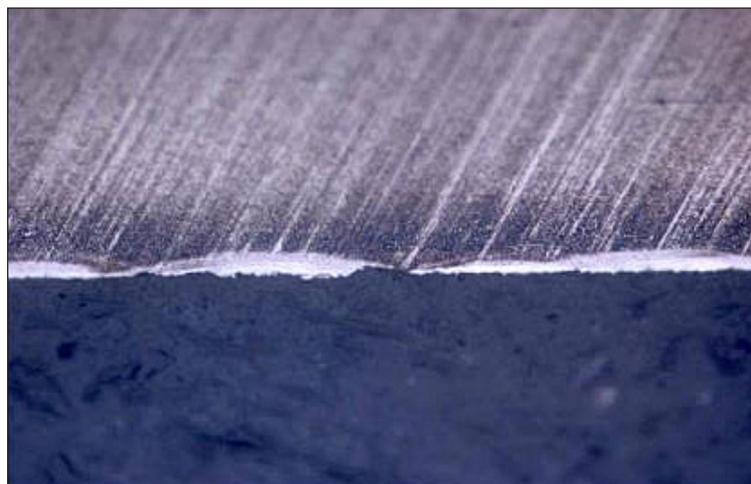
Fig. 3. The burning of the orbital path into the depth of 0,020 mm by the cutting speed  $v_w = 47.1 \text{ m.s}^{-1}$

In the stated technological conditions and maintained production periods the cutting speed of the grinding wheel changed. In case of a lower cutting speed 28.3 ÷ 37.7 m.s<sup>-1</sup> burned spots did not take place on the orbital path, but Rz was above 3 μm, which is insufficient. In case of higher cutting speed of the wheel 40.7 ÷ 50.1 m.s<sup>-1</sup> burned spaces took place on the orbital path (fig. 3, 4, 5) although

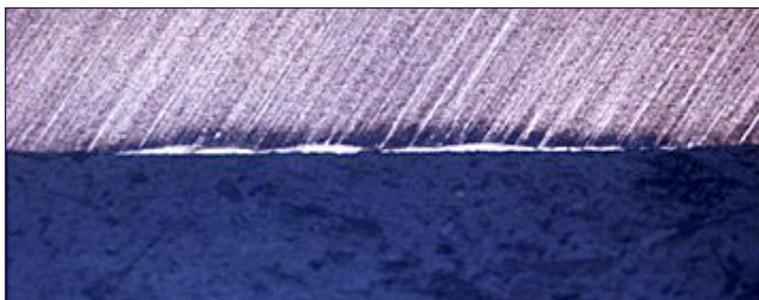
Fig. 4. The burning of the orbital path into the depth of 0.012 mm by the cutting speed  $v_w = 43.9 \text{ m.s}^{-1}$

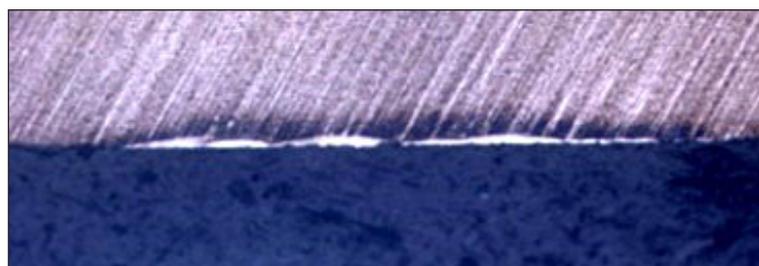
Fig. 5. The burning of the orbital path into the depth of 0.010mm by the cutting speed  $f v_w = 40.7 \text{ m.s}^{-1}$

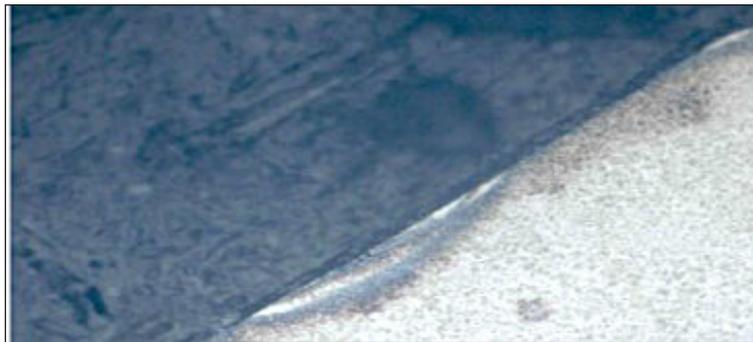
**Fig. 6.** The burning of the orbital path into the depth of 0.017 mm by the cutting speed  $v_w = 47.1 \text{ m.s}^{-1}$

According to the results of verification stated in Table 3, we may assume that as in the case of the previous wheel no burning spots took place by the speed  $28.3 \div 31.3 \text{ m.s}^{-1}$ , roughness of surface was on the limit of tolerance. However, by the higher cutting speed  $34.4 \div 50.1 \text{ m.s}^{-1}$  burning

spots started to appear on the orbital path (fig. 6, 7) although Rz improved.

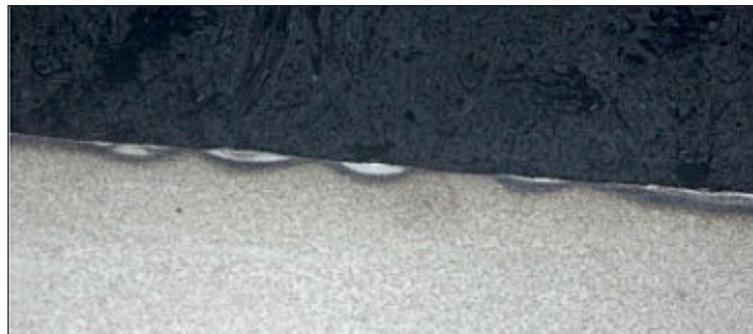
**Fig. 7.** The burning of the orbital path into the depth of 0.012 mm by the cutting speed  $v_w = 43.9 \text{ m.s}^{-1}$

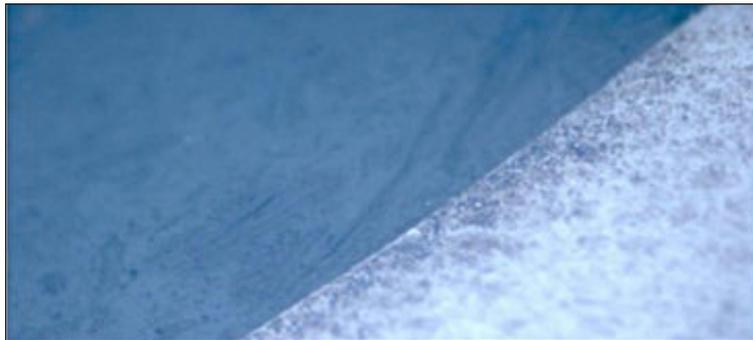
**Fig. 8.** The orbital path without a burned spot by the cutting speed  $v_w = 31.3 \text{ m}\cdot\text{s}^{-1}$

During a verification process we found out that by the cutting speed  $31.7 \div 37.7 \text{ m.s}^{-1}$  no burned spots took place on the orbital path and Rz was below the level  $3 \mu\text{m}$ , Fig. 8, 9. By the higher cutting speed  $40.7 \div 50.1 \text{ m.s}^{-1}$ , however, Rz

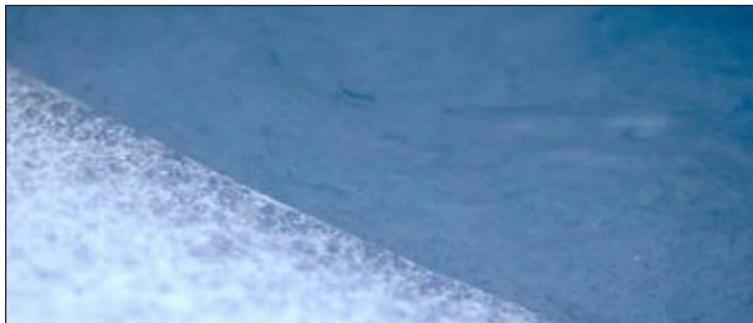
**Fig. 9.** The orbital path without a burned spot by the cutting speed  $v_w = 34.4 \text{ m}\cdot\text{s}^{-1}$

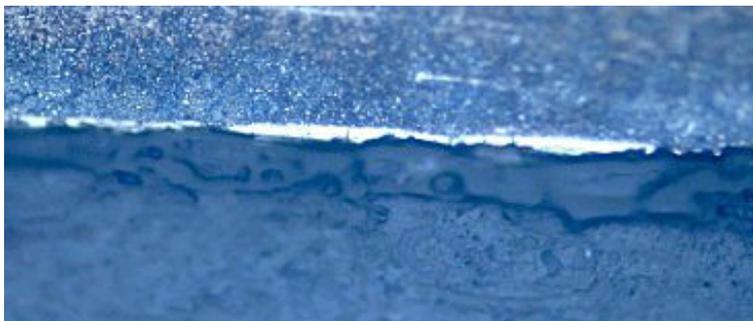
**Fig. 10.** The orbital path without a burned spot by the cutting speed  $v_w = 34.4 \text{ m}\cdot\text{s}^{-1}$

was very good but there took place burned spots on the path, Fig.10, 11. We obtained satisfactory results with this wheel by the cutting speed of  $34.4 \text{ m.s}^{-1}$  and they are suitable for an application in the production process.

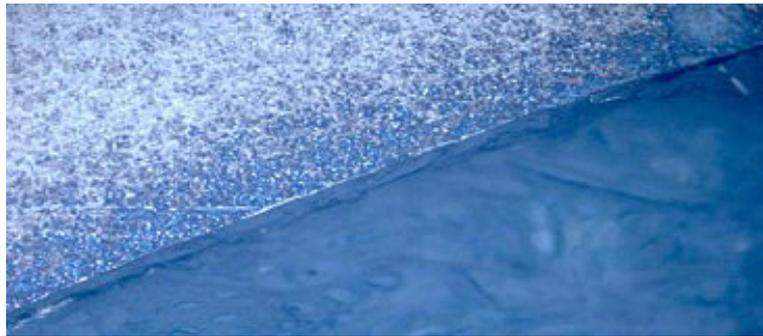
Fig. 11. Burned spots of the orbital path into the depth of 0.002 mm by the cutting speed  $v_w = 40.7 \text{ m.s}^{-1}$
