Effect of cover thickness on reinforcement corrosion in large plate elements exploited in two different exposure classes – A case study

This article presents research results on the assessment of the corrosion hazard of pre-fabricated element reinforcement in large slab structures in the context of the location of the reinforcement and the influence of environmental conditions on the applied thickness of the cover in these elements.

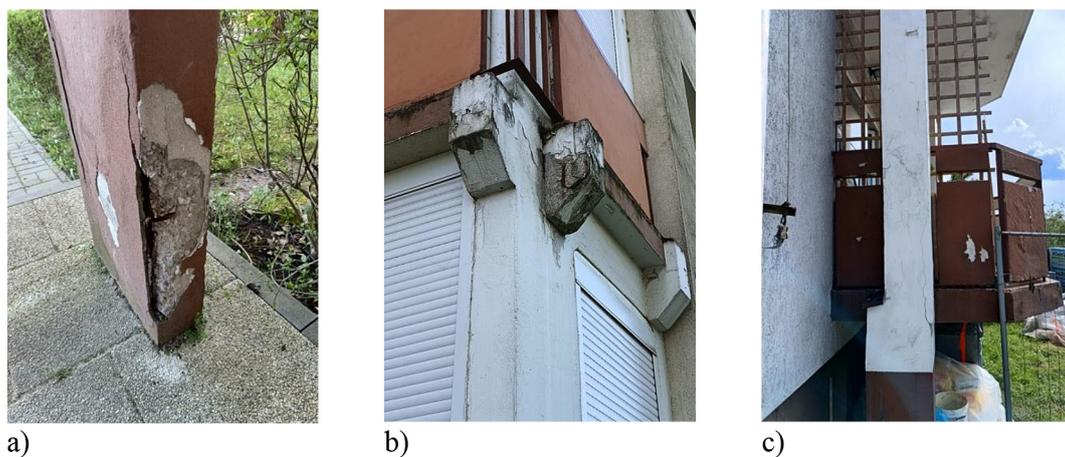
Therefore, it also does not meet current standards. As a result, numerous damage and corrosion can be observed in the reinforcement in many structures. This is especially visible in external elements exposed to the negative impact of atmospheric factors (Fig. 1).

Figure 1. Damage images in structural elements of large-panel blocks: a) column at the entrance to the building, b) reinforced concrete bracket at the loggias, and c) column supporting the balcony

loggia wall, but also the walls of the facade, balcony slabs, or load-bearing columns, which are exposed to direct atmospheric conditions. Currently, this problem is partially solved with thermomodernisation of buildings (resulting from the desire to reduce CO₂ and achieve savings in heating - energy certificates), whereby additional layers of insulation separate facade walls from external environmental influences and reduce the risk of corrosion. However, this problem still affects elements that are not subject to thermomodernisation, such as flaccid exterior columns, which in the long term can reduce their load-bearing capacity and reduce the safety of the entire structure (Fig. 1c, Fig. 5).

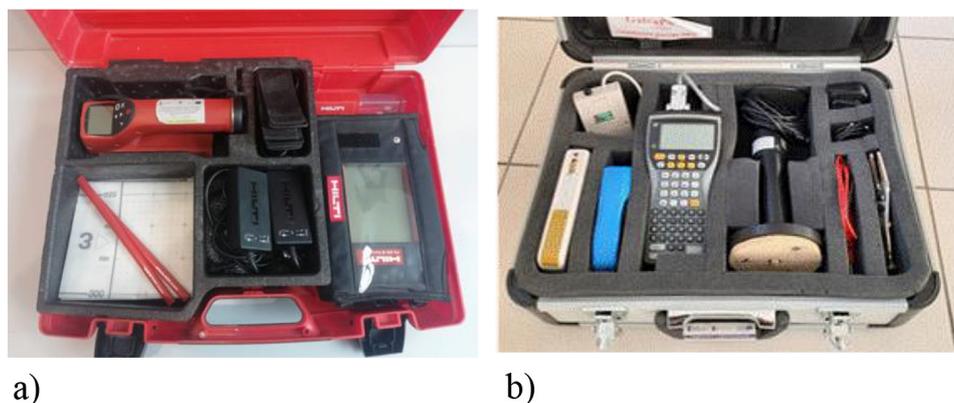
Figure 2. a) Ferrosan Hilti PS 200 b) GalvaPulse™

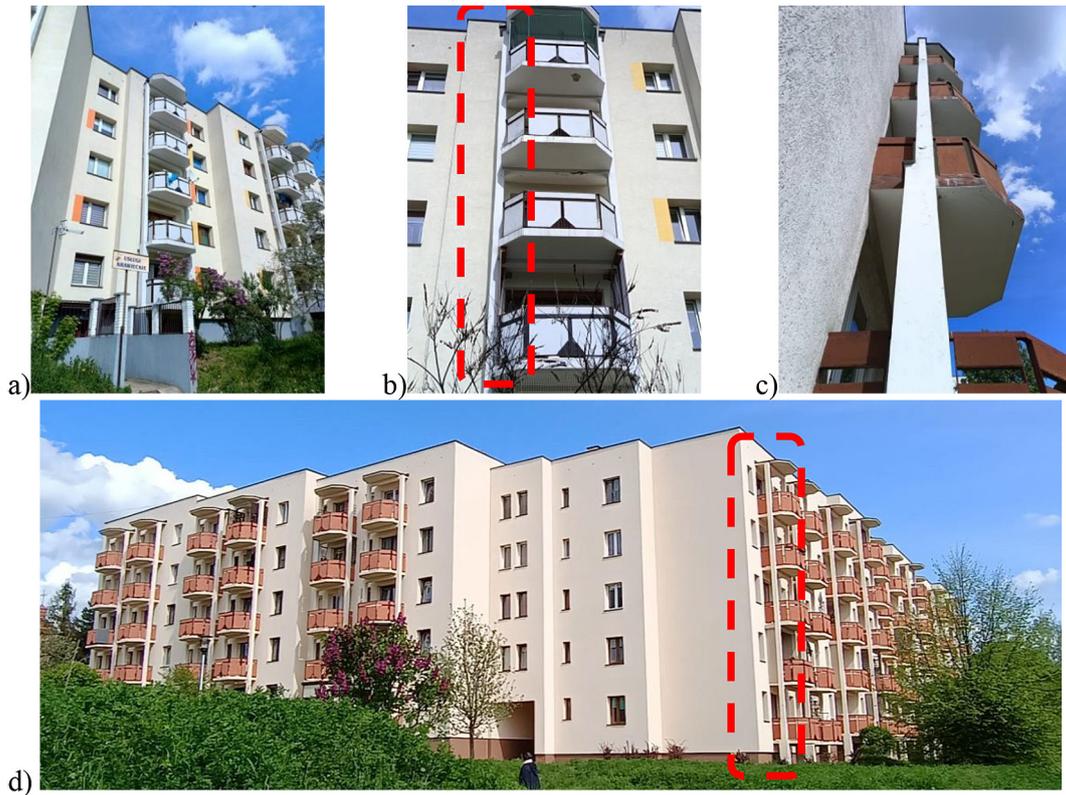
Figure 5. Flaccid columns supporting balconies in a buildings erected in large panel system
