The restitution coefficient value and damage of composite shields protecting the chassis of a rail vehicle

ABSTRACT

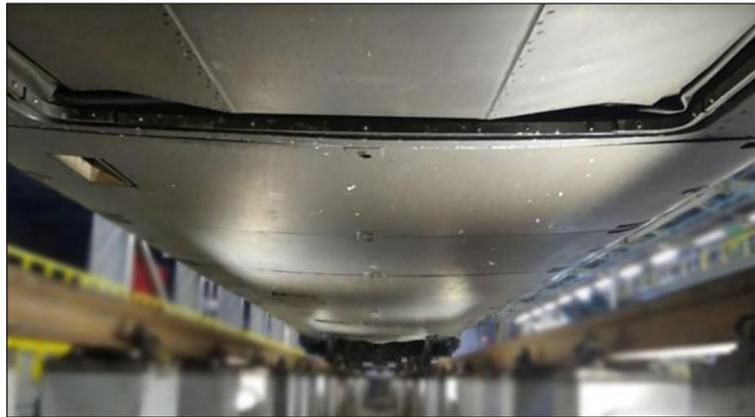
Figure 1. Chassis of a railway vehicle equipped with protective guards

For accessibility and ease of use, the guards are divided into sections, dimensionally adapted to the area to be protected.

Each casing is peripherally equipped with gaskets which, when compressed by tightening them to the chassis structure, acoustically isolate the space from external factors. Shields itself may also have properties improving acoustic insulation in case it is built of polymer composites, especially with sandwich structure [18,19]. Noise sources in the wagon interior can be either stones hitting the chassis or air.

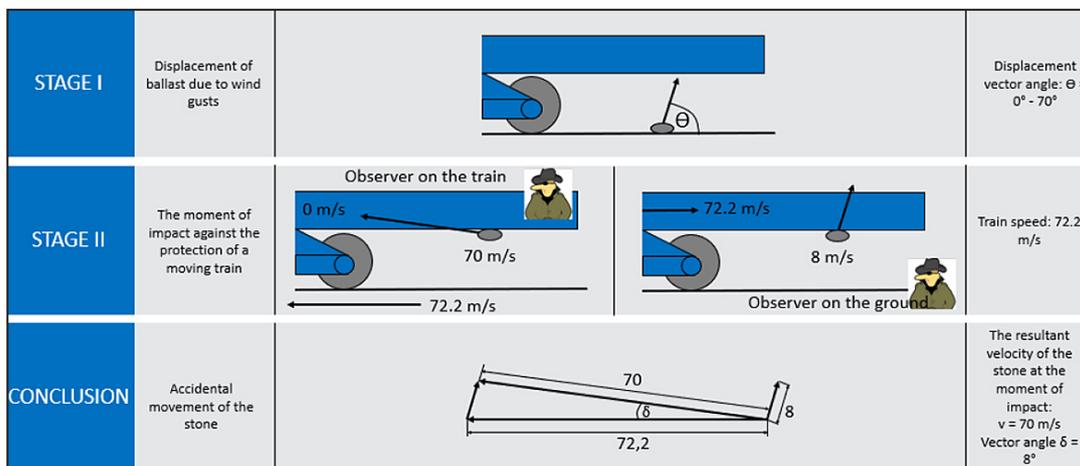
Figure 2. Vector representation of the stone pick-up phenomenon

It has been studied that the velocity of a gust of wind caused by a train moving at 300 km/h reaches approx. 25 m/s in the vicinity of the rail head [23]. Assuming that the train in the case under consideration is moving at a maximum speed of 72.2 m/s, the maximum speed of the stone at the start of lift from the track was estimated as 20 m/s. Since only some of the stones carried by the gust reach the undercarriage of the passing vehicle, their speed at the moment preceding the impact is strongly reduced due to transformation of the kinetic energy of the stone with the increase in height into potential energy. Based on this value, it was assumed that at the moment

of impact with the chassis this value does not exceed 8 m/s. Therefore, the main factor influencing the impact parameters is the horizontal speed of the moving train. The distribution of the components can be observed in Figure 2. Taking into account an assumed speed of the moving train of 260 km/h (expressed in Figure 2 as 72.2 m/s), the distribution of vectors was used to determine the impact angle θ of 8° and the accidental impact speed of 252 km/h (expressed in Figure 2 as 70 m/s), which corresponds almost to the speed of the moving train.

To sum up, a case is considered in which the velocity of stone impact against the chassis shall be 252 km/h and the angle of impact shall be 8° to the chassis surface. The mass of the stone, as an impact element, shall be 60 g and be due to the average mass of the ballast which makes up the ballast. The energy of a single stone at the moment before impact is $E_k = 147$ J. It should be emphasised that on the basis of the observation of damage on the chassis of rail vehicles, it was found that the direction of impact of stones is always consistent with the direction of a moving train.

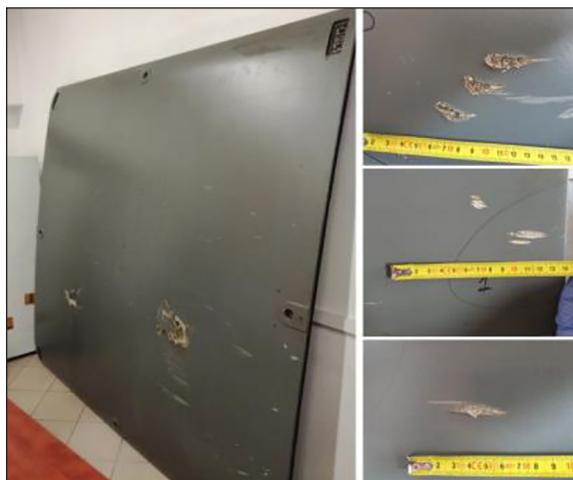
Figure 3. A cover from an electric multiple unit withdrawn from service due to multiple erosion damages and perforations. On the right side a detailed view of exemplary damage with dimensions

were then isolated by cutting them out. Based on the analysis of the classified damage, 2 predominant types were distinguished:

- a) regular, repeated, shallow erosion damage, all facing the same direction relative to the direction of vehicle movement.
- b) irregular damage in the form of punctures, resulting from an incidental impact of a rigid element such as a bar, plate or other metal part. In this case, full penetration of the laminate, and sometimes even of the entire composite, occurred.

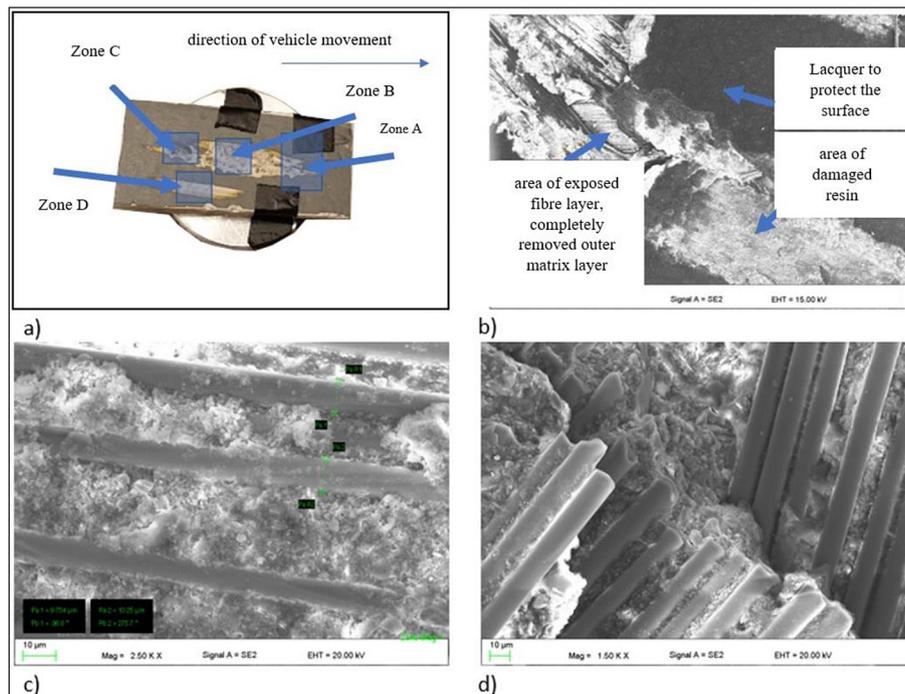
Figure 4. A fragment of a damaged shield under observation. (a) sample prepared for testing (b) Zone A, over 100x (c) Zone B, over 2500x (d) Zone C, over 1500x

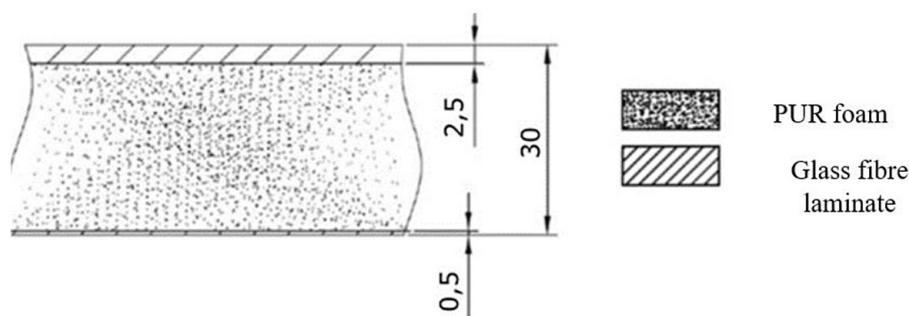
Figure 5. Macroscopic cross-sectional drawing of the existing shield

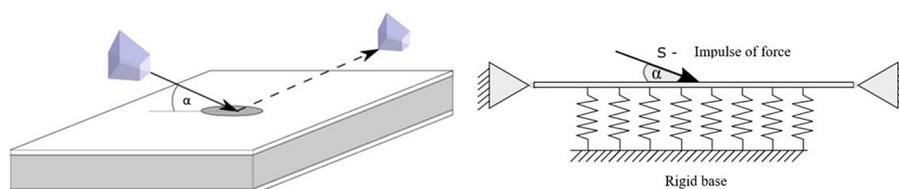
Figure 6. Phenomenological model of the impact process

The striking element in real operating conditions are stones, i.e. brittle objects with sharp edges, striking the chassis at high speed [9, 28]. In order to reproduce the impact in a reproducible manner and feasible also under experimental conditions, a sleeve-shaped object with high rigidity was adopted as the impacting element. Since the impact angle $\alpha = 8^\circ$, the impact is made by means of the outer edge. The actual impact energy calculated in analysed example is 147 J, which corresponds to the impact energy presented in the standard [17] for class K8, namely 170 J (Fig. 6).

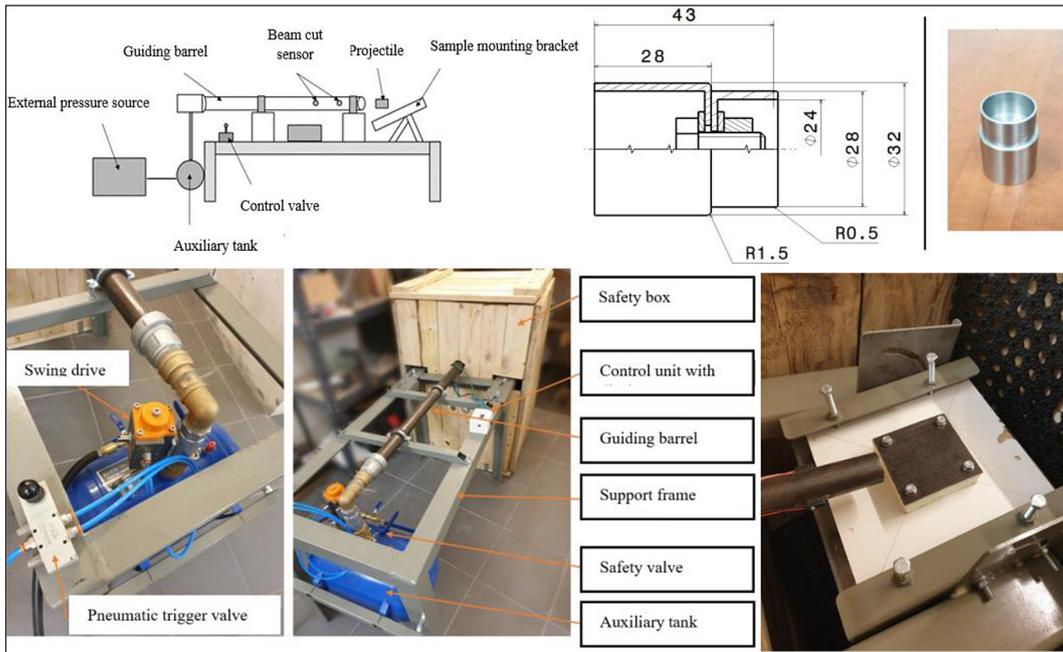
Figure 7. The striking element used in the work. On the left a cross-section of the element with dimensions, on the right the actual object

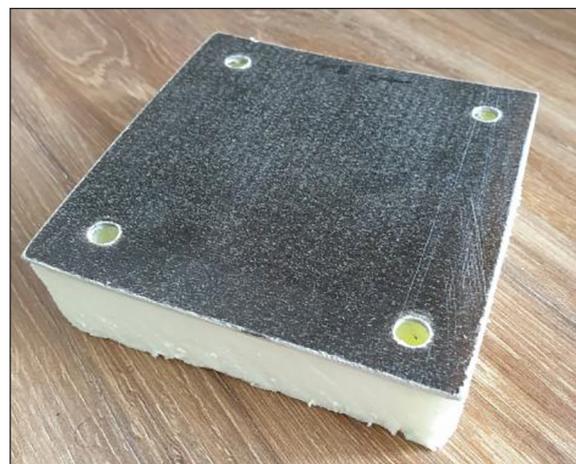
Figure 8. Composite sample with XPS core

by testing. The mounted sample in the test bench is shown in Figure 8.

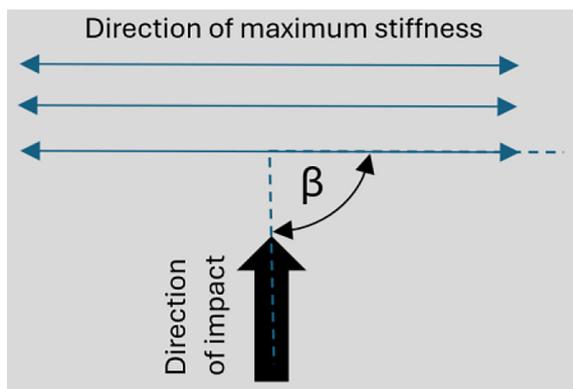
Figure 9. Representation of the angle β defining the main direction of the stiffness of the interior layers of the specimen relative to the direction of impact, in this case $\beta = 90^\circ$

The factor, denoted as 'b', determines the direction of impact relative to the direction of greatest stiffness of the layers to be damaged. It is denoted as follows:

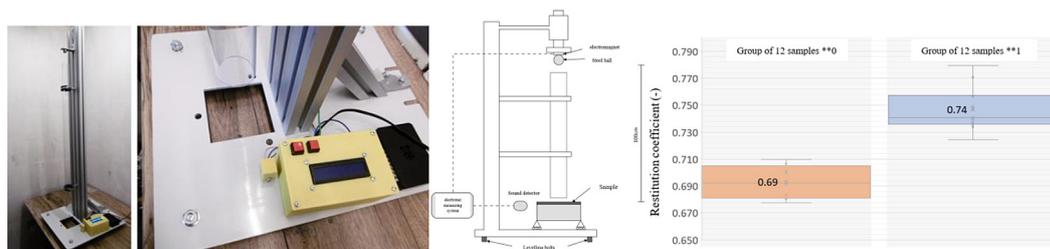
Figure 10. Schematic of test rig for determining the coefficient of restitution and box plot showing the distribution of restitution factor measurements for 24 samples. Noticeable the division into 2 groups according to the type of core (**0, **1)

In order to carry out bench tests to determine the coefficient of restitution, the previously prepared 24

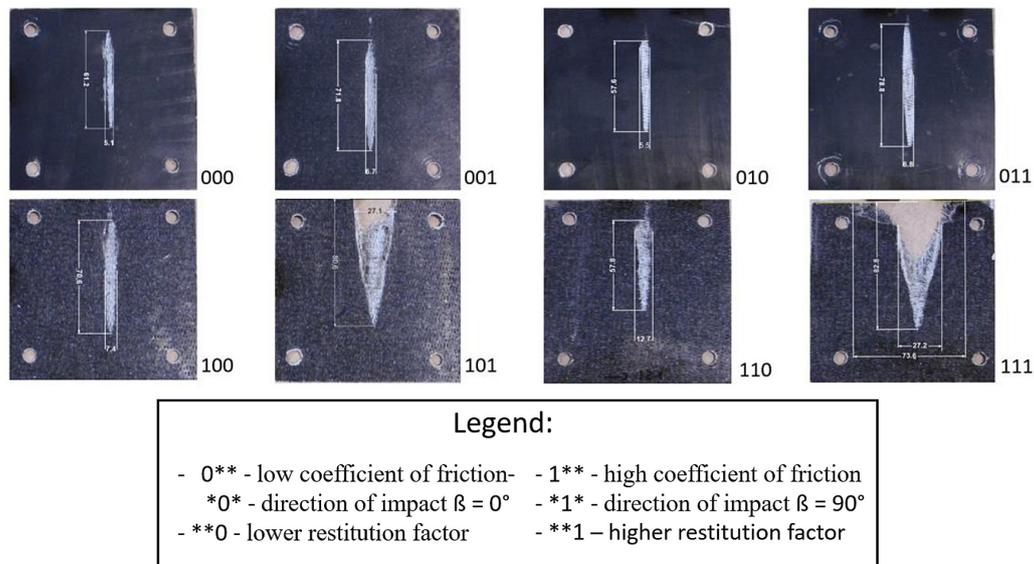
Figure 11. Samples from all groups after impact

In order to visualise the results, one example of a damaged sample from each variant is presented (Fig.11), while a quantitative description of all

In the case of one specimen, designation 001, there was a crack propagating from the axis of impact of the projectile and passing through the axes of the mounting holes, which disqualified the specimen due to complete destruction. There was probably a material defect that contributed to this type of damage.

The damage observed in samples of groups 101 and 111, an example of which is presented in Figure 11, is slightly different. These samples are based on a rigid core and have a higher friction coefficient. In this case, a damage shape resembling the letter “V” can be observed, and moreover, in the case of both samples, complete penetration occurred in the final part. This variation in results may come from differences in material quality. Indeed, in the case of laminated composite materials, there is no repeatability known from materials such as metal.
