Modeling switch rail wear using laser profilometry for predictive maintenance

The safe and uninterrupted operation of trains through railway turnouts depends significantly on the reliability and maintenance of track infrastructure, particularly in critical components such as switch and stock rails. This study presents the results of innovative field measurements conducted using a laser profilometer to assess vertical and lateral wear in operating turnouts subjected primarily to passenger traffic. The experiment was performed on a commonly used 60E1-500 turnout configuration under real traffic conditions, with rolling stock axle loads totaling 18 teragrams (Tg) and 27 Tg, respectively. The primary aim of the research is to develop a predictive framework for the degradation of turnout rails by correlating empirical wear measurements with specific operational parameters, such as axle load accumulation, switch geometry, and accessibility for tamping. By utilizing high-resolution cross-sectional rail profiles and examining wear distribution along the length of the curved switch rail, the study identifies areas most susceptible to premature degradation – particularly near locking device

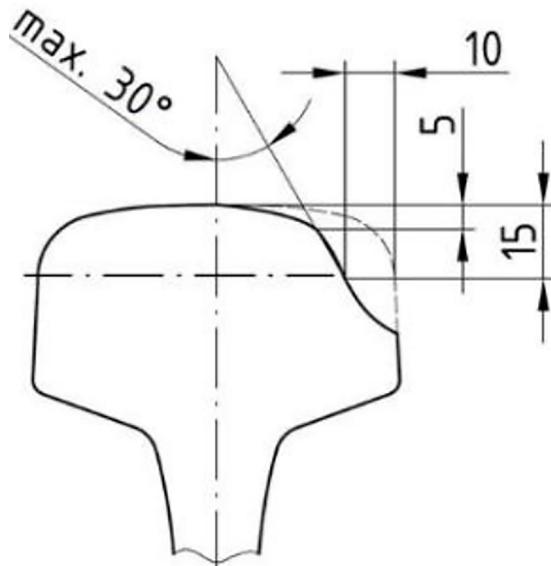
Figure 2. Maximum wear of turnout rail elements [6]

When the maximum allowable wear may be specified in track maintenance instructions or technical standards issued by the rail infrastructure manager and is usually expressed in mm. As stated in the instructions Id-4 [6], maximum vertical wear of the switch rail in the main tracks is 8 mm and the maximum lateral wear of the switch rails that qualifies for replacement is 10 mm, provided that the track gauge tolerance is not exceeded within the switch section. An additional important parameter is the lateral wear angle measured at a height of 5 mm and 15 mm from the rail head and cannot exceed 30° for main lines as shown in Figure 2.

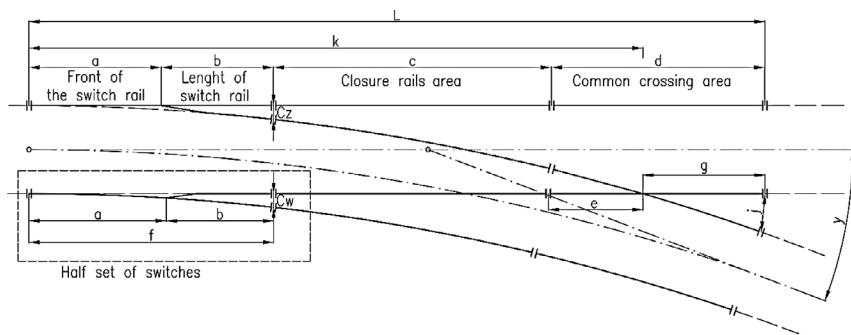
Figure 3. Geometric layout of the turnout type 60E1-500-1:12

The basic task of a switch section is to be able to change the direction of travel of the rolling stock from the main track to the diverging track [12, 13]. The operation is carried out by means of movable elements of the switch, which are a straight switch rail and a curved switch rail [14]. The change of the switch rails position from the closed to the open position is carried out using the point machine via the locking devices [15]. Depending on the turnout radius, the switch may be equipped with one or multiple locking devices [16]. In the tested turnout, the switch was equipped with two locking devices.

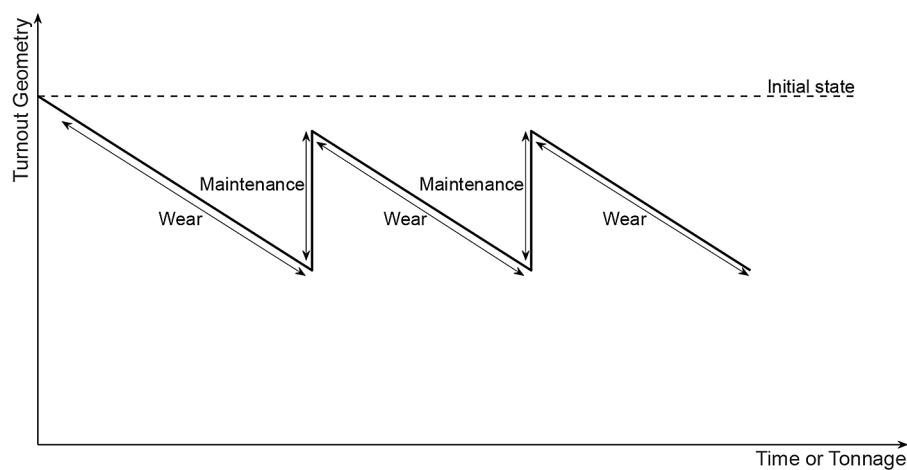
**Figure 4.** Track degradation and maintenance

Observing the development of damage to the rail infrastructure along with the measurements taken is currently the basic method of monitoring the technical condition of the railway track in use. In order to accurately assess the technical condition of the turnout and predict potential future changes occurring in the product life cycle, it is necessary to implement diagnostics of the places most exposed to damage and contact-fatigue defects. The operating costs of turnouts throughout their entire life cycle largely depend on meeting these conditions, the main factor of which is the expenditure on repairing or replacing the track infrastructure. The evaluation of the turnout degradation during operation is presented in Figure 4.

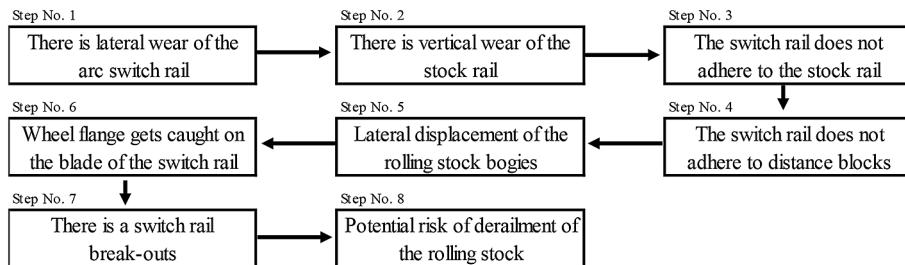
Figure 5. Development of damage from a minor defect to derailment of the rolling stock

Transitions between a minor fault and a derailment hazard most often occur due to failure to detect the fault in its early stages of development or failure to perform appropriate preventive or corrective maintenance. A typical example, often occurring in railway lines, is the vertical and lateral wear of the stock rail profile and the switch rail profile at the point with its the smallest cross-section, also in the area of cooperation with the locking device. Failure to detect or neglect actions at the initial stage of defect development results in increased impact of the rolling stock on the stock rail in the switch, which in turn leads to flow of stock rail material and further negative impact on the switch rails. The consequence of the previous actions is the lack of contact between the closed switch rail to the stock rail and the potential lack of contact between the switch rail and distance block. The above causes a lack of train movement stability with a tendency for lateral displacement of the rolling stock bogies and

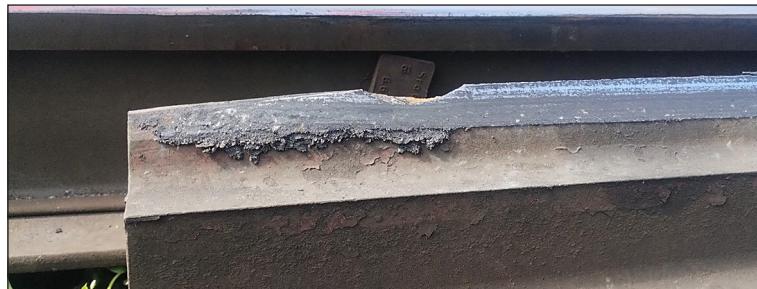
Figure 6. Example of breakouts on the switch rail

An example of fatigue-related damage in the form of material flow and breakouts in the switch rail zone is presented in Figure 6, where typical symptoms of rolling contact fatigue (RCF) are visible. These include surface cracking, localized plastic deformation, and disruption of the rail profile continuity. Such defects lead to the loss of proper geometric alignment between the switch and stock rails, potentially resulting in poor closure, loss of contact with spacer blocks, and increased derailment risk if not detected and addressed through preventive maintenance.

One of the key observed damage mechanisms is contact fatigue, visible as material flow and local spalling in the switch rail zone. These failures, if not identified in the early stages, escalate the lateral forces exerted by the wheels, leading to severe plastic deformation of the stock rail and further impacting the switch rail condition. This can ultimately result in poor closure of the switch rail, loss of contact with spacer blocks, and cracking or fragmenting of the switch tip – all contributing to derailment risk.

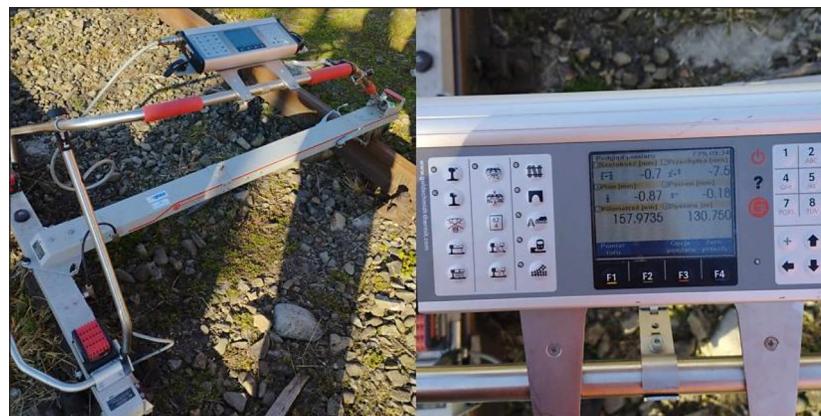
Figure 7. Digital track gauge

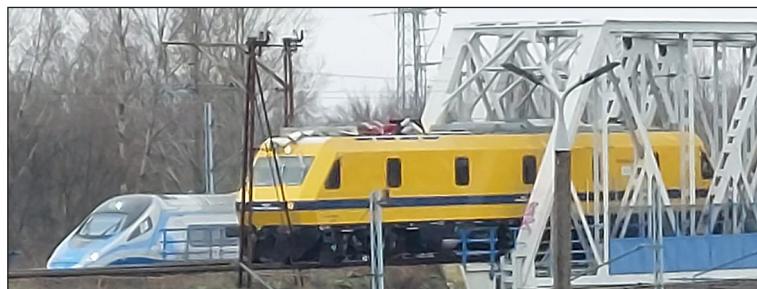
Figure 8. Diagnostic vehicle type DP-560.00 no. 01

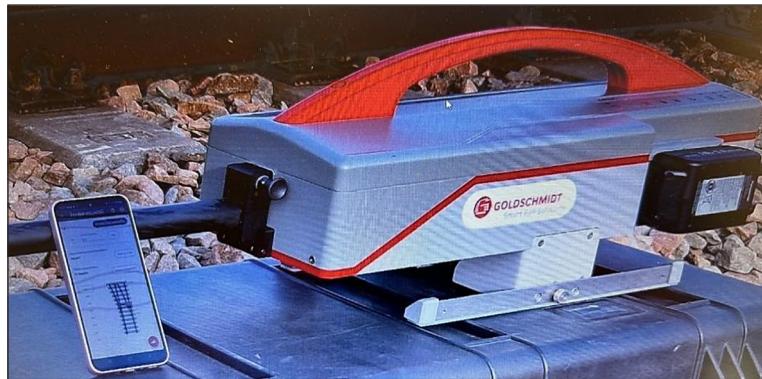
Figure 9. Laser profilometer „Railprofile 2D” SN005/23

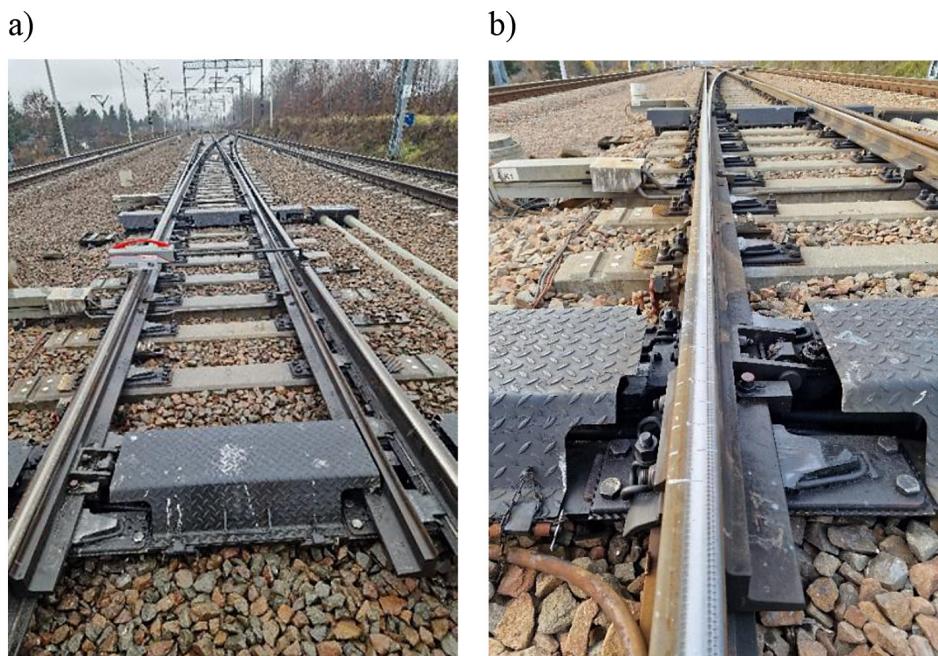
Figure 10. Tested switch: a) measurement of the curved switch rail, b) measurement locations

in the operation of turnouts, taking into account the impact on the curved elements of the turnout. The research results will be a precursor to building a database for the development of predictive diagnostics in the operation and maintenance of rail infrastructure for conventional railway lines and, in subsequent steps, also for high-speed railway lines. The cross-sections of the new half a set of switches, which is the reference base for the measurements, are shown in Figure 11 with the locations of the tested places every 200 mm from the blade of the switch rail.

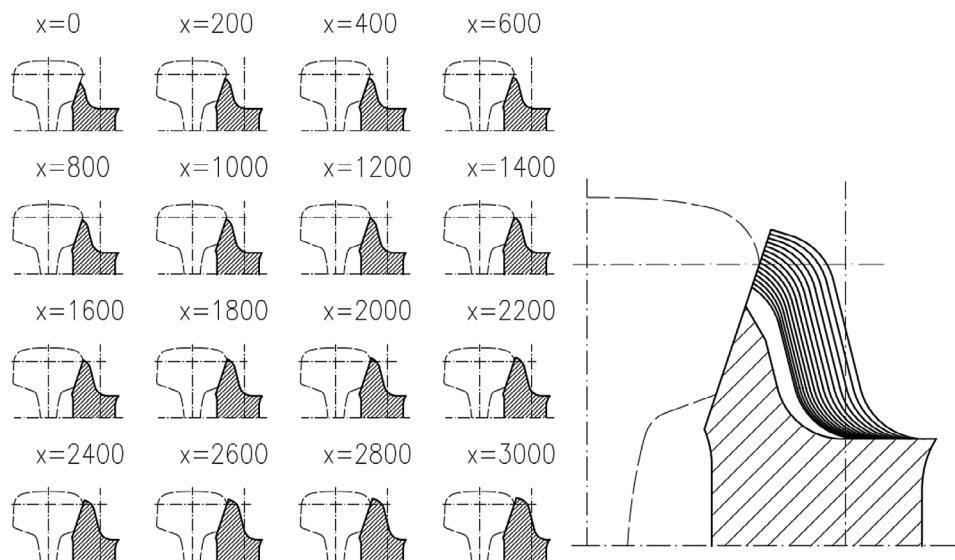
Figure 11. The cross-sections of the new half set of switches type 60E1-500

capture vertical and lateral wear. The position of each measurement is expressed in Figure 11 as ‘x’, which indicates the distance from the beginning of the switch rail, measured in millimetres.

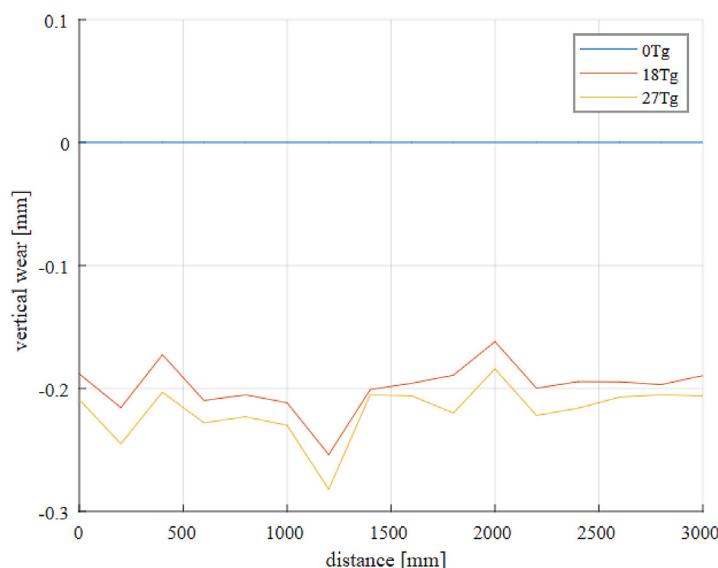
Figure 12. Vertical wear of switch rails type 60E1-500

Summary of observations: Wear tends to increase progressively from the blade tip along the curved switch rail. Notably, higher wear values appear near the first locking device – likely due to restricted tamping access. These localized effects suggest the need to factor tamping accessibility into predictive wear modelling.

The distribution of vertical wear of half-set switches rails in the operated turnout after passing a rolling stock with a total weight: 18 Tg and 27 Tg is shown in Figure 12.
