Analysis of Hard Facing Material Designed for Application on the Forestry Tools

Miroslava Ťavodová¹, Michaela Hnilicová¹, Izabela Miturska^{2*}

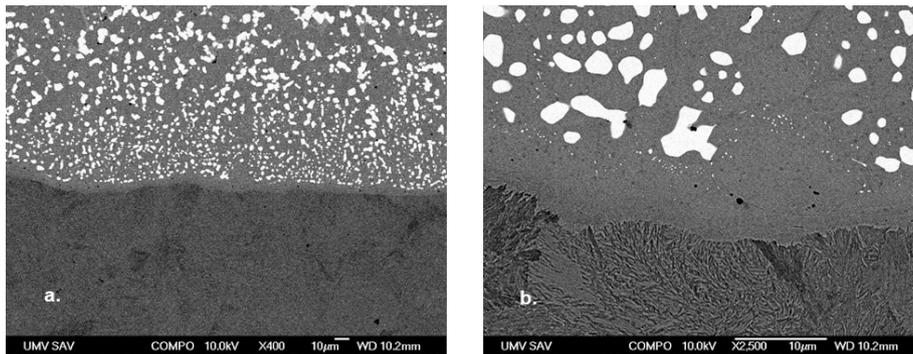
The Figure 10 shows the SEM images for the carbides in the Fe matrix of the weld deposit, in the chemical contrast mode (COMPO). The bright areas represent an elements with a higher atomic number (WC carbides). Figure 11a shows the interface of the base material and the weld deposit RD571 and Fig.10b shows the detail of this interface.

Fig. 10. Tool material interface; weld deposit (a); interface detail (b)

analysis (Table 5 – Point “2” of EDX analysis). There is probably a diffusion connection but without the presence of the carbides. This probably confirms that the materials were not mixed at the interface. The importance of performing the point analysis is given by the fact that the area analysis could also capture locations outside the observed lighter zone in the weld deposit and base material. This could distort the information about the likely zone of mixing

that can cause the weld deposit inconsistency with the base material.
