Analysis of Mechanical Traces Left Probably by Ball Lightning

Wiesław Z. Polak¹

¹ Department of Applied Physics, Lublin University of Technology, Nadbystrzycka Street 38, 20-618 Lublin, Poland

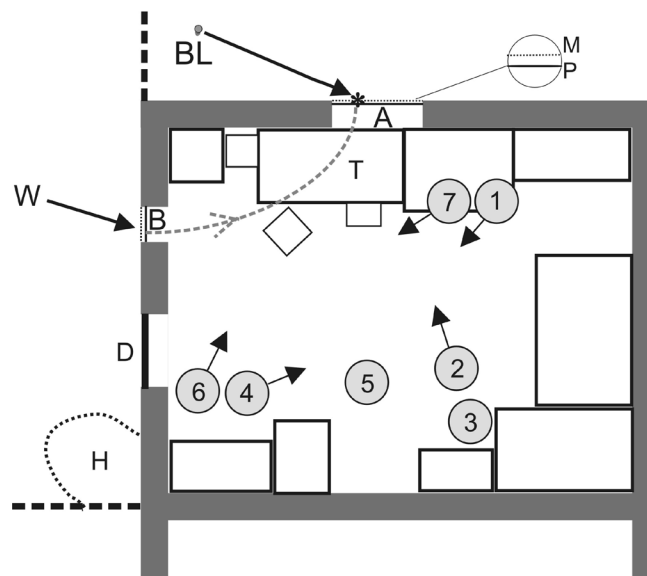
Fig. 2. Plan of the room with location of: window A and B, door D, table T and the witnesses (each marked by circle) with their view direction (arrow) during destruction of the windows panes. Location of the window mesh M in respect to the pane P is shown in magnification. Directions of the wind W and the hypothetical ball lightning BL (deduced from material signs) are illustrated by arrows, while hypothetical trajectory of BL from window B to A, according witnesses' reports, is marked by dashed curve. Location of the hole in the window glass (star), hole in the ground H and fence (dashed thick line) are shown.

(see Fig. 2) fortunately skipping people. However, when questioned during individual talks, nobody confirmed to have seen or felt the movement of an object. Moreover, they could not explain why net curtains on the windows inside the room have not been bored by the thunderbolt though they confirmed that both windows had been covered by the curtains during the incident. According to the answers to the questionnaire, the window panes A and B were almost simultaneously broken just after witnesses enter the room, but two of them were sure that window B was broken first. After having heard a typical sound of breaking glass panes accompanied with hiss or swishing noise (4 among 7) or a bang (1 among 7), glass pieces from both windows were thrown into the room. One person even stated to have seen red glow in the window A during the break.
