Research on the Causes of Cracking of Pipes Derived from Recirculated Polyethylene

The objectives of the research was to determine the causes of cracks in pipes made of high-density polyethylene (HDPE) regranulate during their storage. A visual assessment of the cracks was carried out and their fatigue nature was found. Due to the insufficient information on the composition and properties of the processed regranulate, tests were carried out on the density distribution and mass flow rate of plastic samples taken from various areas of the pipe wall. Comparative tests were performed using infrared spectrophotometry of a plastic sample taken from a pipe, commercial HDPE and commercial polypropylene (PP) by attenuated total reflection/Fourier-transform infrared spectroscopy (ATR-FTIR), thermogravimetry (TG) and differential scanning calorimetry (DSC) method. There were differences in density and flow rate depending on the distance from the outer surface of the pipe, reaching several percent. Based on the conducted spectroscopic, thermogravimetric and differential scanning calorimetry studies, none of the expected plastics contamination, mostly PP, has been found in recirculated polyeth

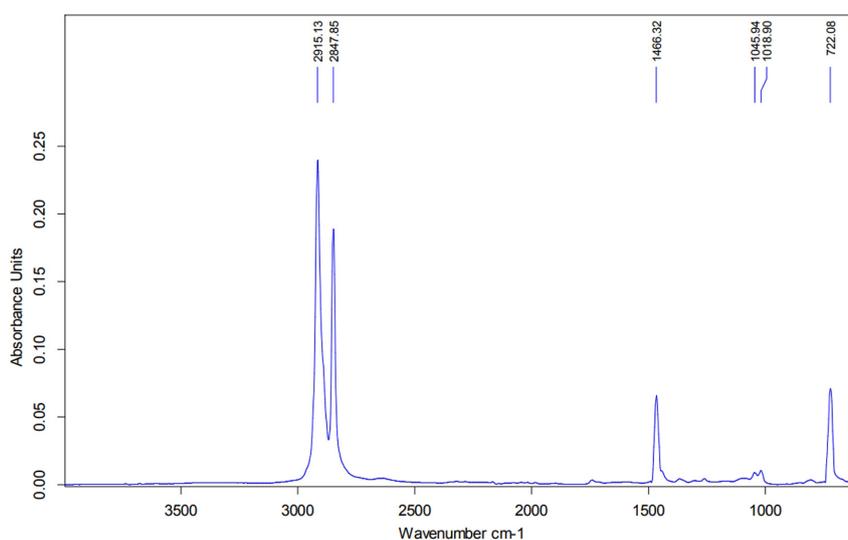
Fig. 4. Spectrum of ATR-FTIR HDPE Hostalen ACP 9255P

The infrared spectra obtained by the attenuated total internal reflection (ATR) method of the tested samples are presented in the following Figures 4–6. The absorption bands in the spectra (Fig. 4, 5) in the region of 2915 cm⁻¹ and 2847 cm⁻¹ are bands related to asymmetrical, symmetrical and C-H stretching vibrations in the -CH₂ group. The band at the length of 1455 cm⁻¹ is characterised by asymmetric deformation C-H vibrations. A band in the range of 722 cm⁻¹ indicates the presence of aliphatic -C-C-C- backbone bonds. The spectra recorded for the polyethylene sample taken from the tested pipe did not differ significantly from the spectra recorded for the porcine polyethylene sample. Figure 6 shows the spectrum for the tested polypropylene,

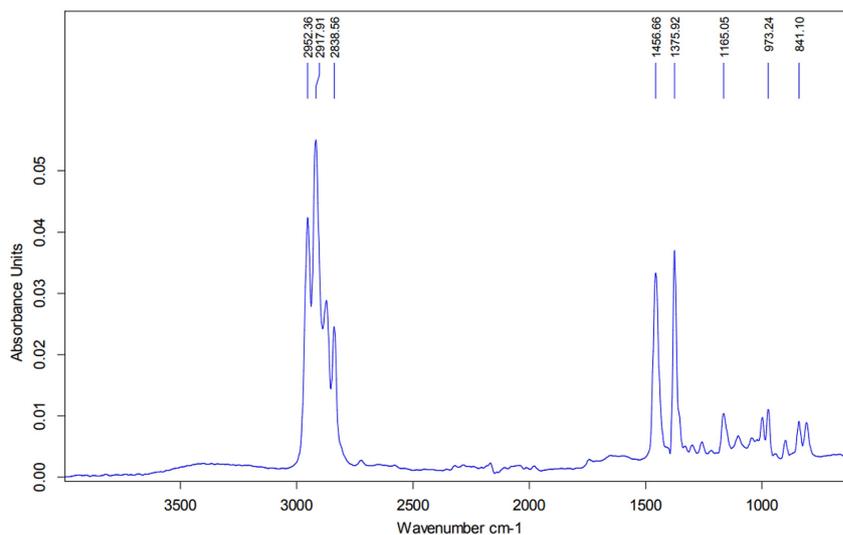
Fig. 6. ATR-FTIR spectrum of PP Moplen HP456J

where the 2952 cm^{-1} and 1375 cm^{-1} bands are noticeable, which are responsible for the vibrations of the CH_3 group characteristic for polypropylene. The absence of these bands in the sample of polyethylene constituting the pipe material indicates no contamination with polypropylene.
