## Structure and Properties of the S49 Rail After a Long Term Outdoor Exposure

Jarosław Konieczny<sup>1\*</sup>, Krzysztof Labisz<sup>1</sup>

<sup>1</sup> Department of Railway Transport, Faculty of Transport and Aviation Engineering, Silesian University of Technology, ul. Krasińskiego 8, 40-019 Katowice, Poland

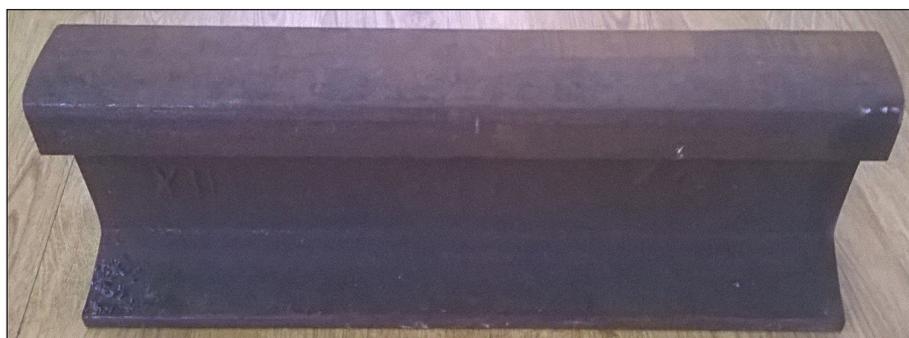
Fig. 1. Fragment of the investigated S49 rail

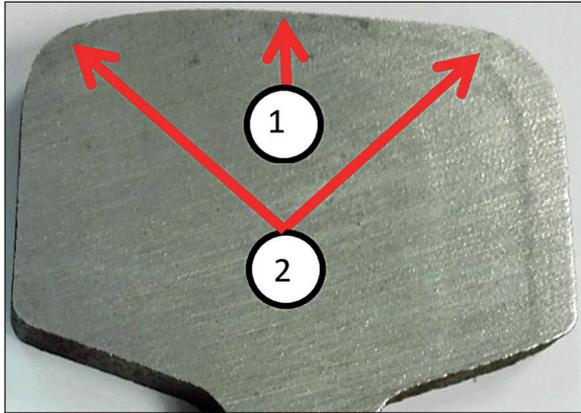
Figure 6 shows the places from which samples were taken for tests on the microscope. Decarburization occurred in form of closed ferrite mesh is visible in the area of 400–500 µm from the rail head surface.

Fig. 6. Cross-section of the head of the tested S49 rail, where the material for sampling is taken
