Use of magnetic flux leakage detection in diagnostics of coated elevator ropes

The aim of this article is to present the active magnetic method used in diagnostic tests to locate damage and determine the technical condition of flat steel-polyurethane cables and plastic-coated steel ropes used in lifting equipment. This article discusses the diagnostic equipment developed at AGH University of Science and Technology for magnetic testing of ropes in lifting devices. The results of tests conducted over the course of several years of operation of cables are presented. The changes in amplitude and signature of signals recorded during successive tests of selected flat steel-polyurethane belts are compared.

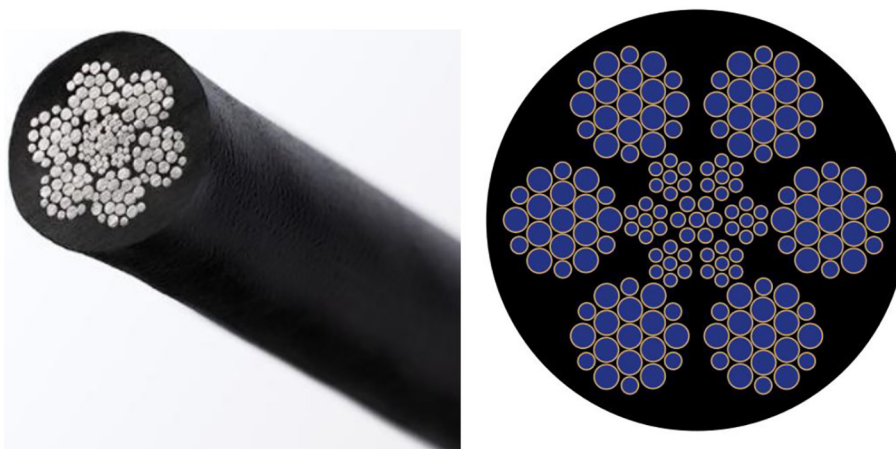
Figure 7. Example cross-section of a Brugg CTP type rope [20]

rope solely based on signs of wear observed on its external surface. The presence of broken wires can be detected when they penetrate the PVC warp. Figure 8 presents examples of operational damage to the wires in a CTP rope.

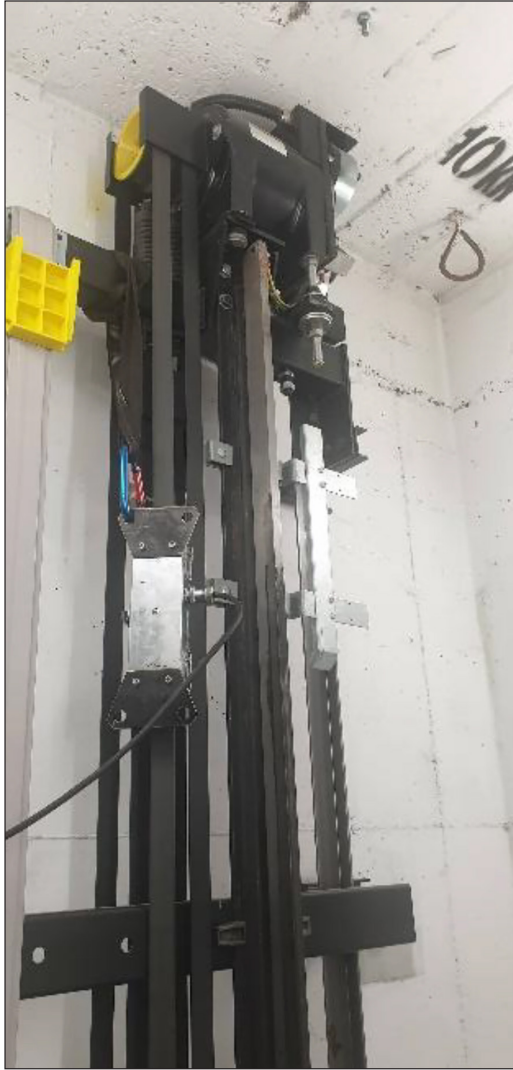
Figure 14. Measuring head during the test of the belt (elevator no. 1)

In the results recorded on the first elevator (Figure 14, Figure 16), over a distance of approximately 21 m to 28 m, which corresponds to the cabin’s position at the bottom of the shaft, changes in the amplitude of the recorded signal are visible. For the second elevator, the voltage signal from the belt test, recorded during the cabin’s entire lift, is shown in Figure 17. At a distance of approximately 18 m from the start of the measurement, three diagnostic signals are visible, located close to each other. The changes in signal amplitude are associated with the occurrence of magnetic field disturbances, the source of which is loss of the metallic cross-section of the tested cables, e.g., cracks in wires embedded in the plastic matrix. A visual inspection of the indicated areas revealed no protruding wires, deformation, or other damage to the outer coating of the cable.
