## Investigation of failure causes in a modern single-axis solar tracker structure

The paper presents a recent failure that occurred during the construction phase of a utility-scale photovoltaic power plant with a total capacity exceeding 20 MW. Modern single-axis tracker structures and PV modules were damaged during a severe summer storm. The study includes an analysis of the construction work carried out on site, as well as an assessment of the available design documentation. To verify the correctness of the applied structural solutions, numerical models of the investigated system were developed. A frequency analysis and an assessment of possible torsional galloping occurrence were performed. Based on the conducted investigations, it was concluded that the failure resulted from a combination of factors, including incorrect assumptions regarding design loads, design and execution errors, and excessive simplifications adopted in the structural modelling process. Complex soil conditions at the construction site were also found to be a significant contributing factor. The conducted analysis indicated that the requirements of current standards were not satisfied with respect to both

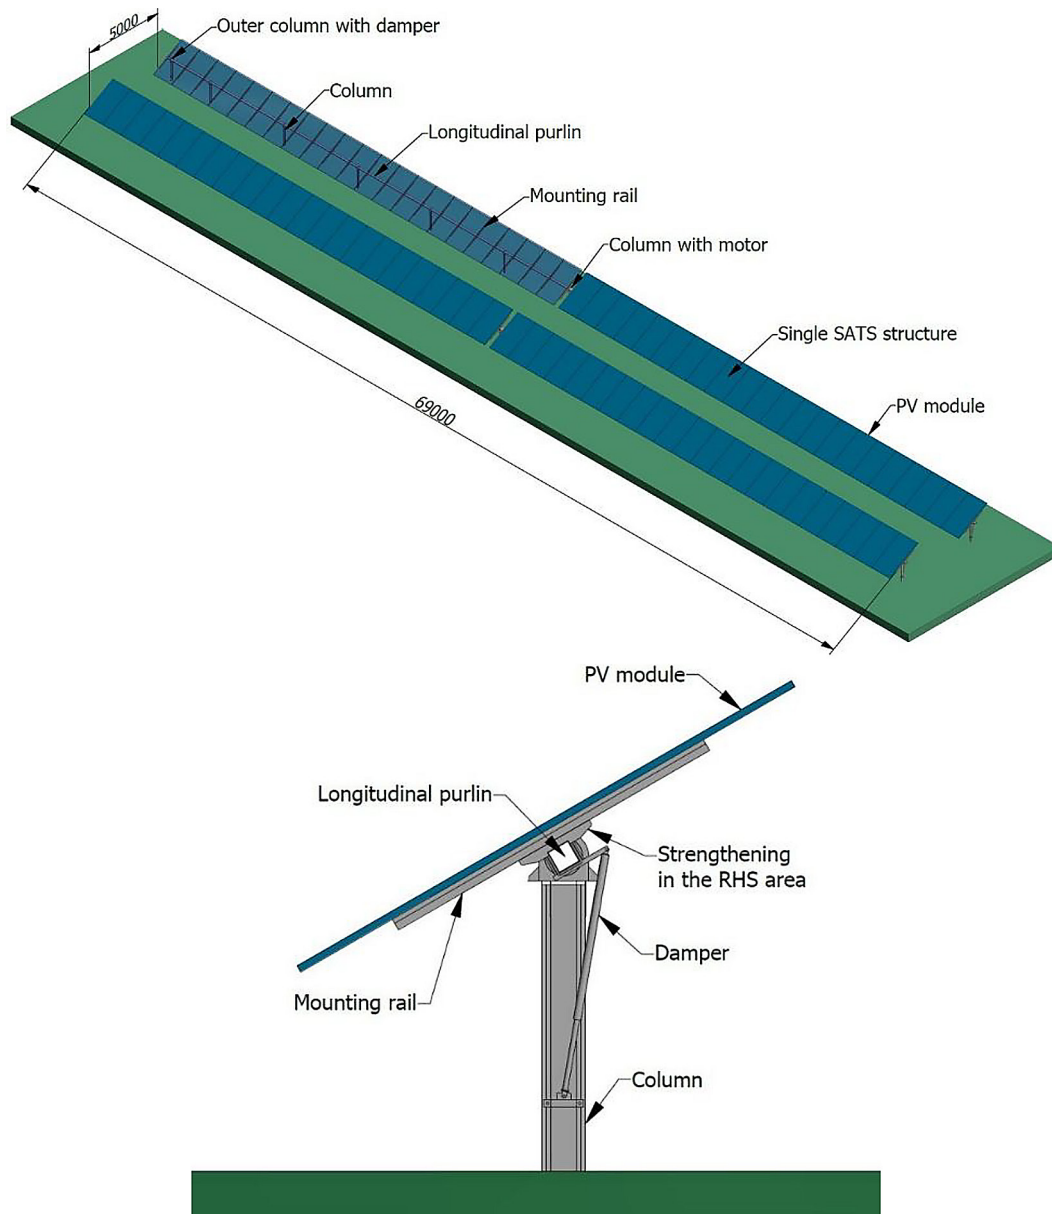
The maximum length of a single SATS structure was 69 m. Standard columns were made of individually designed cold-formed channels with a height of 105 mm, flange width of 50 mm and a thickness of 3 mm. These columns were spaced at a maximum distance of 5300 mm. A motor-support column made of a built-up, cold-formed I-section was installed at the mid-length of each structure. A longitudinal purlin made of SHS 100×3 was placed on the columns, and appropriate bearings were introduced to enable rotation. It should be noted that the use of SHS is a common solution, with similar sections applied in [4] and [12]. Panels with dimensions of 1303 × 2384 mm were mounted to the purlin using profiles with dimensions 52 × 99 mm. These profiles were additionally reinforced in the vicinity of the purlin. All components were manufactured from standard structural steel S350 GD. At each end of the structure, a damper was mounted. In the event of a sudden increase in load, these dampers were intended to lock the rotation of the purlin. The maximum load capacity of a single damper was 17 kN. The C-section columns were driven directly into the soil to a depth ranging from 1500 to 2000 mm. The embedment depth was determined based on field tests involving pull-out tests and measurements of horizontal displacements under loading. However, no direct measurement of driving force was performed during pile installation. Selected structural details of the tracker are presented in Figure 1.

**Figure 1.** Solar-tracker structure: a) general view of two consecutive structures b) side view

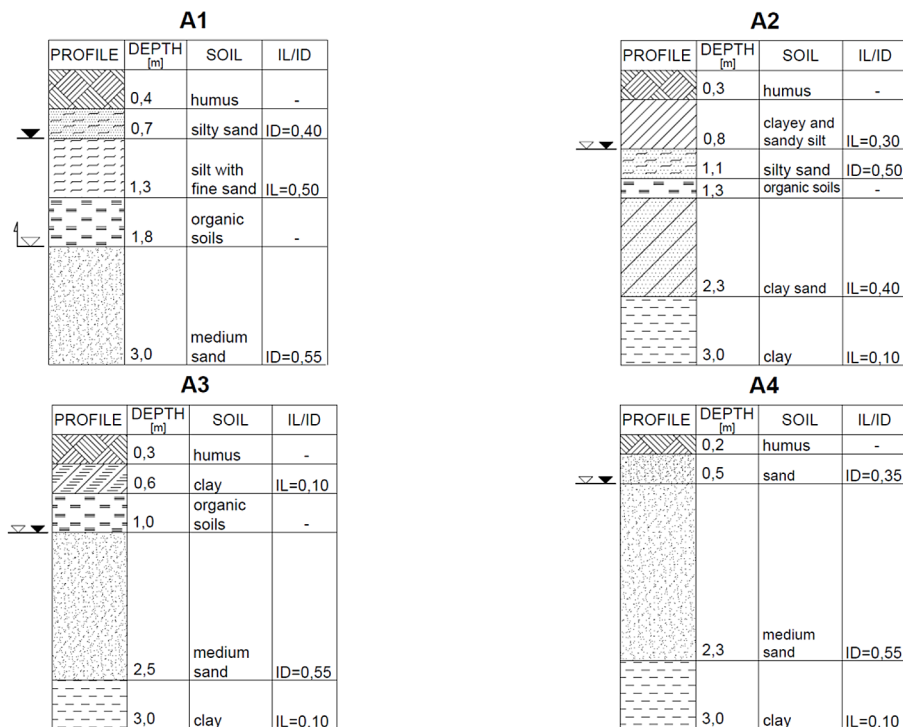
**Figure 4.** Selected geological data (A1–A4)

investigation raised additional doubts. Site investigation boreholes were executed at 70 m spacing. Such a large spacing did not allow for a precise determination of soil conditions, which were characterized by significant variability. According to national regulations, the soil conditions had to be classified as complex (plastic soils, high groundwater level, locally occurring organic peat soils). However, the project did not specify the method by which the soil parameters were determined. The tracker manual also stated that the structure may fail at a wind speed of 22 m/s. This value corresponds to the basic wind speed for the wind zone in which the photovoltaic farm is located. Nevertheless, it is not a value that can be directly applied in calculations intended to demonstrate the potential failure of the structure.

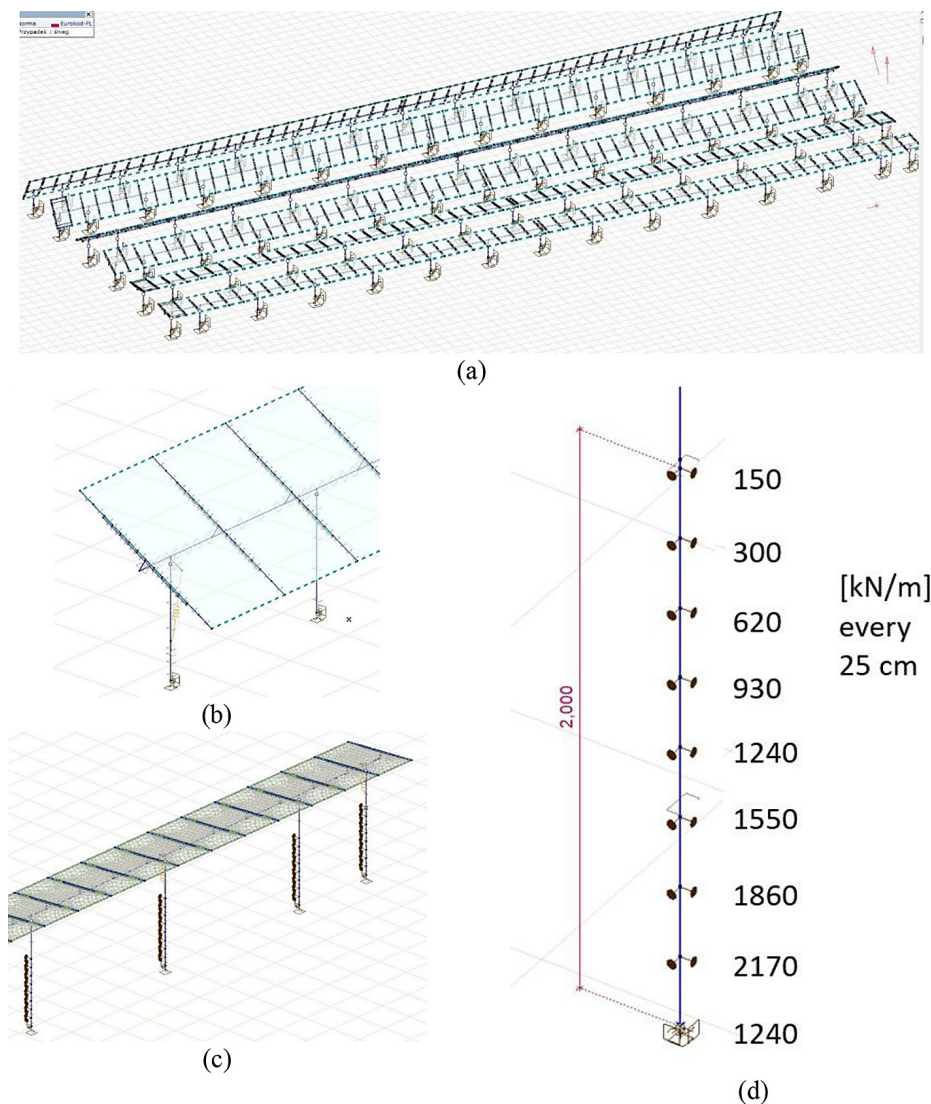
**Figure 6.** Details of the applied computational model: a) models for various angles of PV panels, b) detail of the end section of the structures, c) model with elastic supports and panels modelled using shell elements, d) values of spring stiffness

and [25]. Buckling modes of cold-formed members were determined using separate shell models. In the case of the natural frequency analysis, the panels were modelled using shell elements with a thickness of 35 mm. Variant analyses were performed for Young's modulus values ranging from 70 GPa to 165 GPa and with a Poisson's ratio equal to 0.22 [26]. Verification calculations were also carried out for the state of the structure at the moment of failure, i.e. with the dampers not installed. Selected details of the computational model are shown in Figure 6.

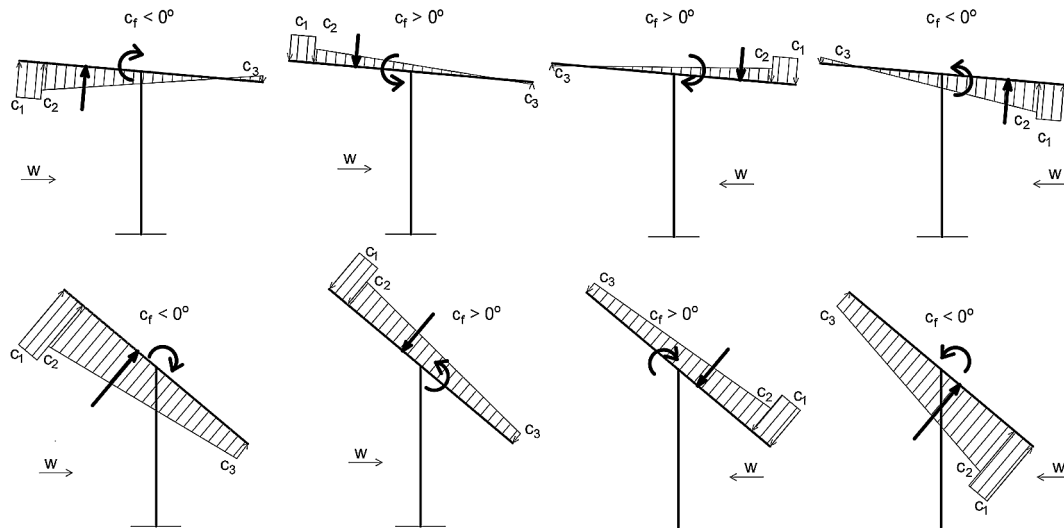
A much more significant issue was indicated by the calculated values of displacements and rotations. As already mentioned, the full wind load was considered only for the 5° position. For the remaining inclination angles, the load corresponding to a wind speed of 14 m/s was assumed, which resulted from the applied protection systems. Due to its flexibility the structure was not capable of maintaining the safe 5° position under wind loading. As a consequence, the panels could be subjected to the full wind load at an inclination angle reaching even 40°, which clearly results in a substantial increase in the applied loads. A comparison of loads acting on the structure for inclinations of 5° and 40° is presented in Figure 7. It should be noted that the presented loads are based on standard recommendations. Therefore, susceptibility to dynamic actions is not directly taken into account. Moreover, it was observed that in the state of the structure at the time of failure (without the dampers), the purlin rotation angle was even greater than that presented in Table 2 and reached up to 61°.

**Figure 7.** Comparison of loads for inclinations of 5° and 40°. Wind speed 22 m/s
