## The use of 3D scanning to assess the technical condition of passenger car bodies

Jarosław Krzysztof Gonera<sup>1\*</sup>

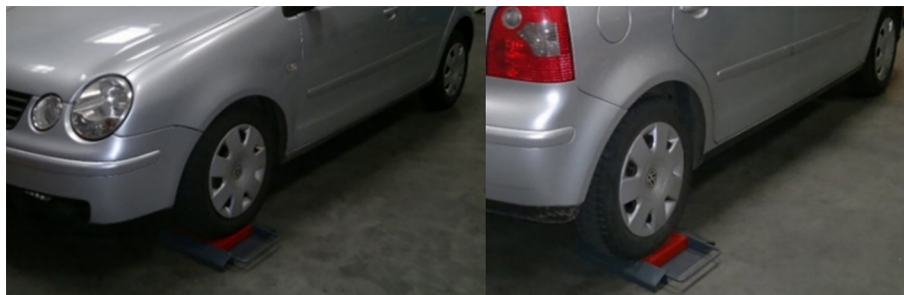
**Figure 3.** Plates allowing additional loads to be applied to the bodywork

In order to identify the condition of the body in terms of body rigidity control, additional loads were applied to the vehicle, particularly to its body. For this purpose, two wheels of the vehicles (the front left and rear right wheels) were lifted by driving onto specially prepared plates (Figure 3). During the tests using 3D scanning, the geometry of the right side of the bodywork was compared with the left side. Any discrepancies in shape and differences in position between symmetrical parts of the vehicle bodywork may indicate that its technical condition is poor.

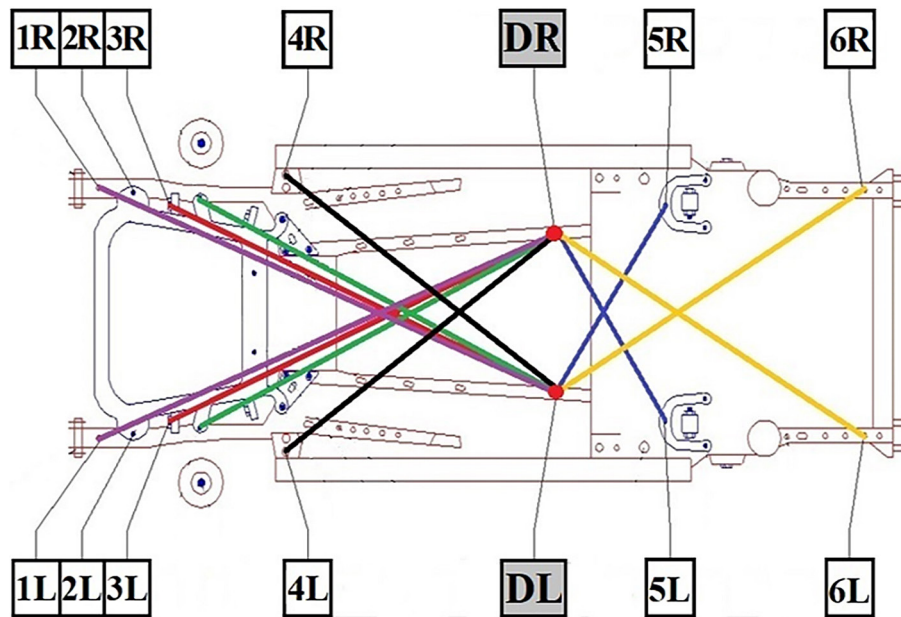
**Figure 4.** Vehicle's floorpan view in Allvis Light software, where: 1 – points in front longitudinal members, 2 – fixing points for the front suspension, 3 – fixing points for front profile, 4 – points in the vicinity of bulkhead wall, 5 – fixing points for rear suspension, 6 – points in rear longitudinal members, D – reference points used during measurements, P – right-hand side, L – left-hand side

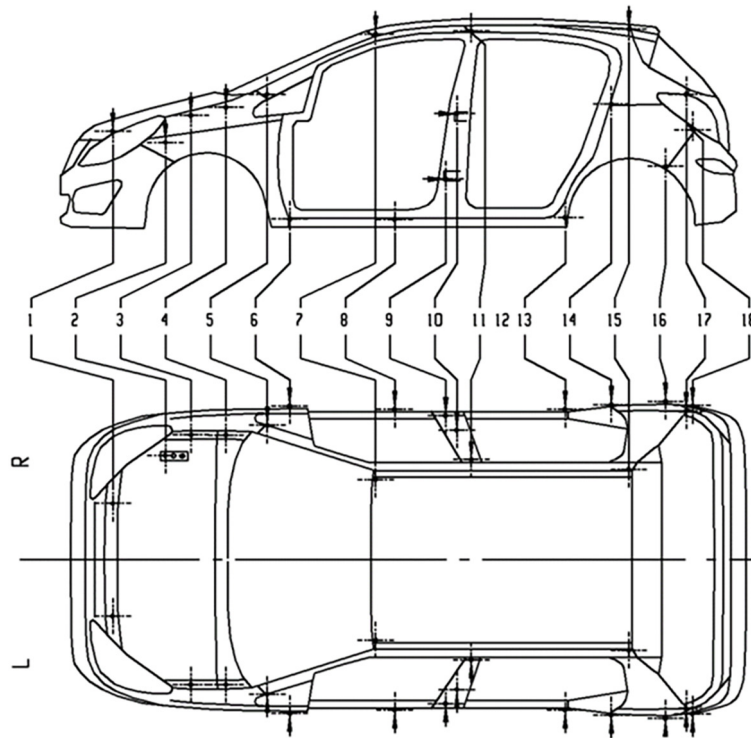
During measurements of the upper body geometry, the position of each of the 15 reference points on the right and left sides of the body was identified in three coordinates relative to the corresponding reference planes. The reference points are shown in Figure 5. For this study, the distance by which each point was displaced was calculated.

**Figure 5.** Measurement points on the upper parts of the bodywork for an example car [example card from the Autorobot Datasheet System programme], where: 1. Front reinforcement; 2. Start of wing reinforcement; 3. End of wing reinforcement; 4. Start of sill; 5. Centre of A-pillar; 6. Top of A-pillar; 7. Bottom of B-pillar; 8. Centre of B-pillar; 9. Top of B-pillar; 10. End of sill; 11. Centre of C-pillar; 12. Top of C-pillar; 13. End of rear wheel arch; 14. Bottom end of rear mudguard; 15. Top end of rear mudguard
