Impact of Vehicle Engine Supply System on In-Service Changes in Body Geometry and Wheel Alignment

ABSTRACT

This study assessed the effects of vehicle mileage on the floor panel geometry and the upper mounting of the McPherson struts, as well as on the wheel alignment parameters. Geometry changes were determined in cars with the same design parameters, differing only in the type of engine supply system. The cars were van-bodied vehicles with compression ignition engines fuelled with diesel fuel and spark-ignition engines fuelled with LPG. The vehicles differed significantly in the weight distribution on their axles. The study is distinguished by its comprehensive approach to identifying in-service body wear. A detailed analysis covered not only the main causes of changes in body geometry, namely the influence of the vehicles' mileage and design parameters, but also the effect of identifying the values of changes in the suspension and steering system geometry parameters. The body geometry and wheel alignment testing was carried out at a mileage of approximately 300,000 km. The study determined the relationships between changes in body geometry and wheel alignment. Changes in body g

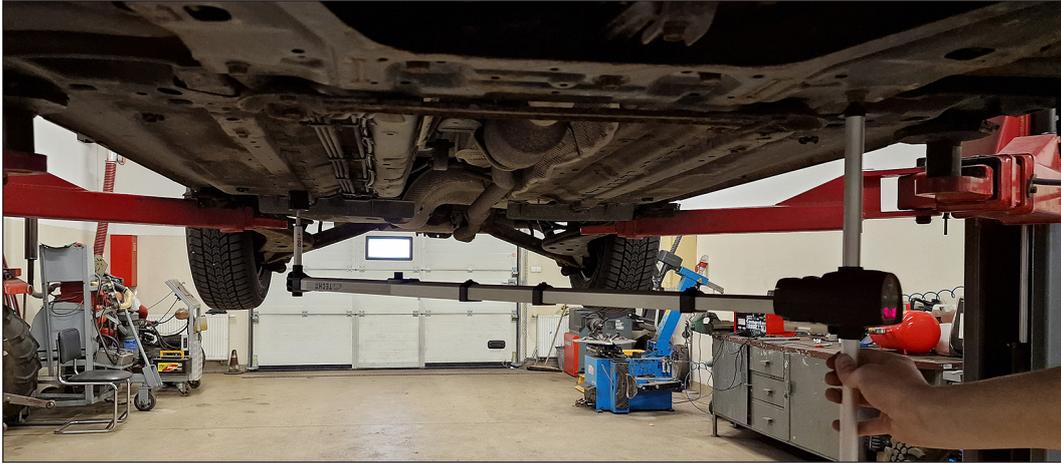
The measurements of floor panel geometry and the upper mounting of the McPherson struts were performed using a Gysmeter instrument manufactured by GYS. This was the Gysmeter Tech model 052093. The instrument was manufactured in 2014. The accuracy of the instrument was 1 mm, whereas the measuring range was between 400 and 2650 mm. During the body geometry measurements, a set of dedicated tips and gauge plungers matching the individual basis points were attached to the instrument. Allvis Light computer software, which included a database with the required basis point positions, was used during the body geometry measurements. Figure 1 shows a view of the floor panel and the body geometry measuring instrument.

Figure 1. A view of the floor panel and a body geometry measuring instrument

For the testing, the following characteristic points of the floor panel and the points representing the upper mounting of the McPherson struts, shown in Fig. 1, were selected:
