Post-failure topographical assessment of carbon fiber reinforced polymer – reinforced S235R steel under tensile loading

The application of the adhesive-bonded CFRP laminates prolonged the durability of steel specimens. This study investigated the influence of carbon fiber reinforced polymer (CFRP) tape reinforcement on the fracture surface characteristics of S235JR carbon steel specimens subjected to uniaxial static tensile load. The steel specimens were reinforced with high strength unidirectional CFRP plates, while one unreinforced specimen served as a reference. To evaluate the topographical and morphological features of all fracture surfaces the 3D optical profilometry and scanning electron microscopy had been used. The chosen ISO 25178-compliant roughness parameters were calculated, including height, functional, and functional volume parameters, as well as non-standard descriptors, such as furrow geometry and texture isotropy. The results indicate that height parameters are not significantly affected by the presence of CFRP, since they are sensitive to localized anomalies. In contrast, the functional and functional volume parameters revealed notable differences: reinforced sp

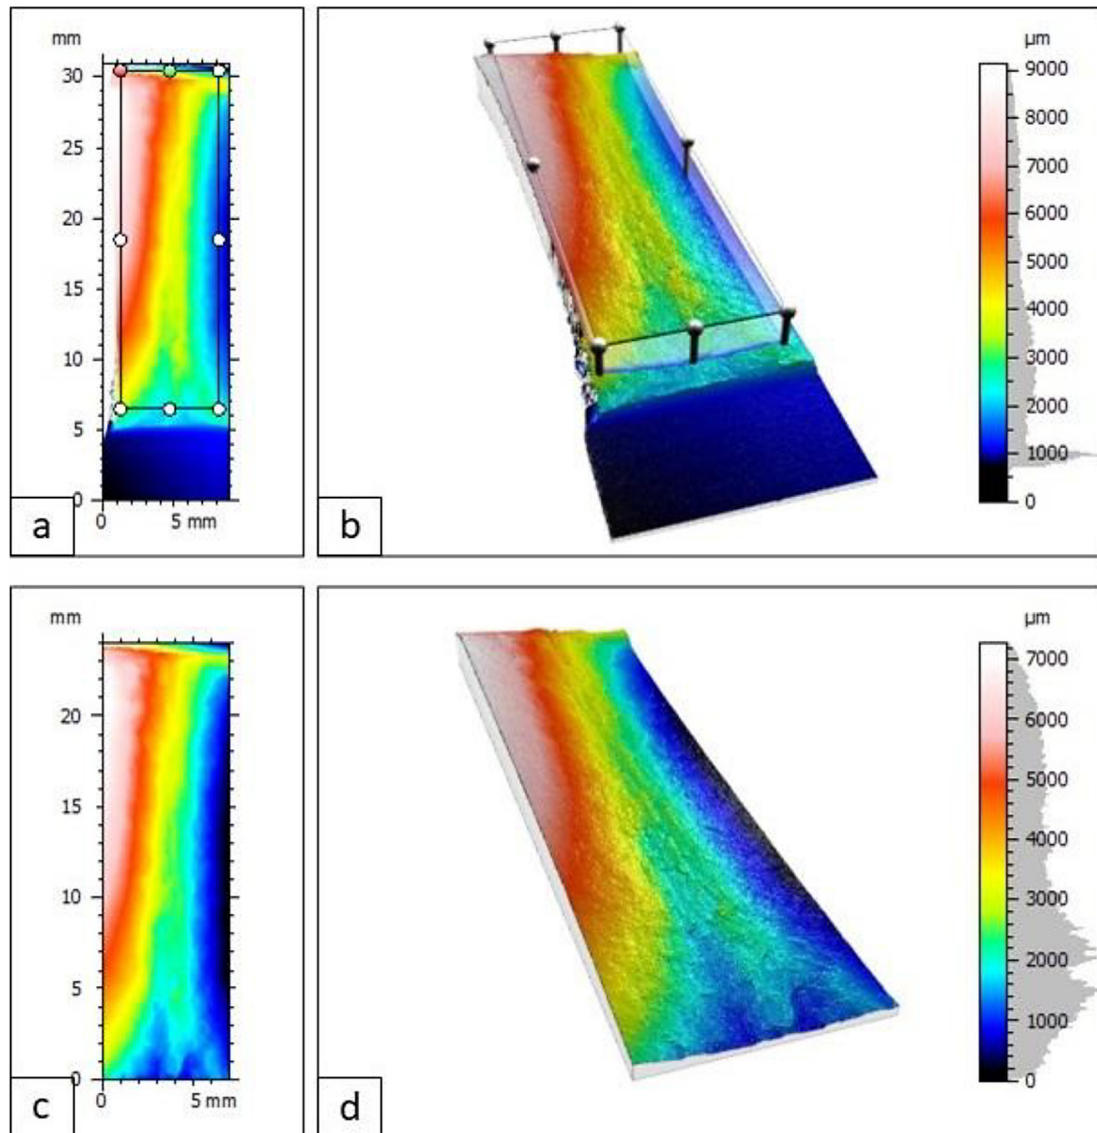
Figure 2. Contour maps present: 2D picture (a) and 3D picture (b) of inspected surfaces with filled NMPs and indication of ROI; 2D picture (c) and 3D picture (d) with the extracted ROI surface

To obtain an analyzed 3D fracture surface topography of each tested fracture, an inspected surface was modified by filling non-measured points (NMPs) through an interpolation method. Next, the region of interest (ROI) was exported from this updated surface. The study area was limited to a rectangle measuring 24 mm by 7 mm. This ROI has the same area for all tested specimens. Figure 2 presents the observed surface (see Figure 2(a) and 2(b)) and its extraction for ROI (see Figure 2(c) and 2(d)).

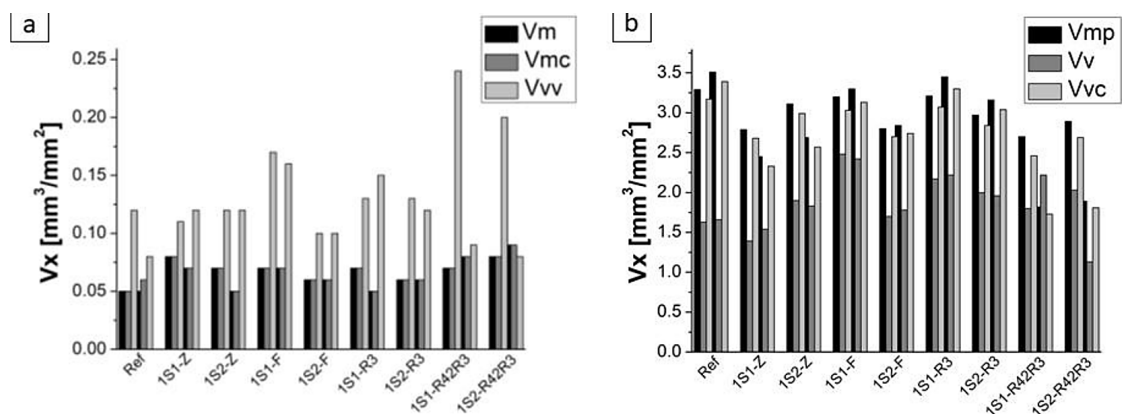
Figure 5. Bar graphs of functional volume parameters – Vm, Vmc and Vvv (a), Vmp, Vv and Vvc (b) for all tested specimens

According to ISO 25178, the functional volume parameters play a key role in the analysis of fracture surfaces by giving in-depth information on surface morphology and fracture features [37]. Figure 5 presents a summary of the measured values of these parameters for two fractures of each specimen.

The slight increase in the values of the Vm, Vmc and Vvv parameters for the reinforced specimens compared to the unreinforced specimens is due to the influence of the more brittle and locally violent nature of fracture, which is typical of materials with CFRP reinforcement. The value of the Vmc parameter is increased for reinforced specimens compared to unreinforced steel. The reason of this are brittle fractures due to the influence of added reinforcement that generates steeper and sharper structures on the surface that increase the volumes counted in 3D analysis, even though they are more local. In the case of the Vvv parameter, a gentle increase was also observed, as deeper and more abrupt valleys are typical

of brittle fractures – fracture occurs quickly and with less extension, leading to deeper voids and micro-cracks. The Vmp parameter is decreased in reinforced specimens, because CFRP reinforcement limits plastic deformation and promotes more brittle fracture mechanisms, in which multiple protrusions and stretches of material are not formed at the fracture surface. In the case of the reference sample, the ductile fracture results in a formation of numerous but mild elevations on the surface, like through micro-cracks, merging of micro-cavities, local outflows of material, and this results in a larger volume of material above the core. In contrast, reinforced specimens manifest cracking more violently and without stretching, have a surface with fewer peaks and heights, resulting in a lower Vmp. When analyzing the Vvc parameter, it is observed that its value decreases for unreinforced samples. Although CFRP reinforcement promotes more brittle fracture, the local valleys are deeper but less extensive in surface area than in ductile fracture. In an unreinforced specimen, the material is stretched and plastic deformation results in more extensive microcavities and valleys below the core. Moreover, even if they are not very deep, they cover a larger area and increase the total volume Vvc. In reinforced samples, although the valleys may be steeper and point-deeper, the values of the Svk and Vvv parameters are increased and they are less numerous as well as have a smaller area by leading to a smaller total volume of voids below the core and a decrease in the value of the Vvc parameter.

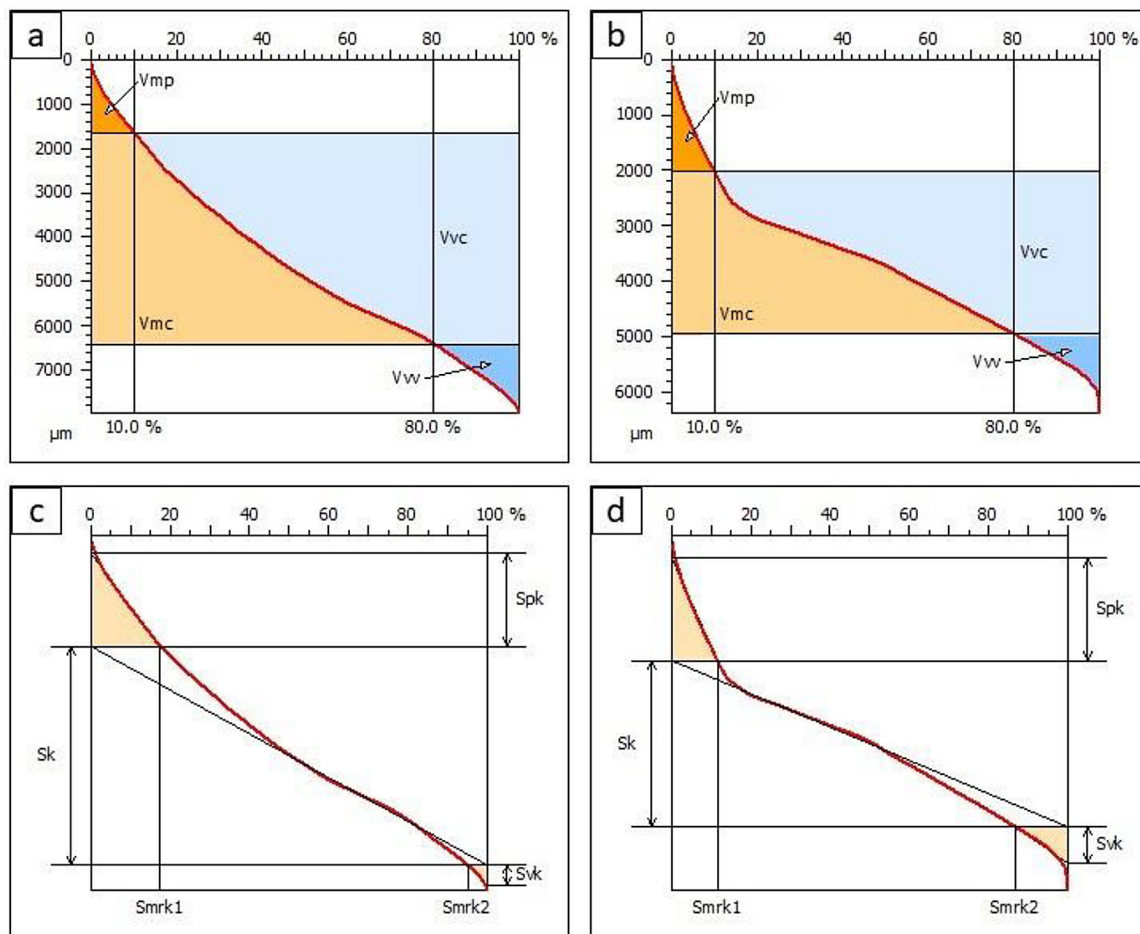
Figure 6. Graphical representation of discussed functional volume parameters (a and b) and functional parameters (c and d) for the unreinforced specimen (a and c) and representative CFRP reinforced specimen – 1S1_R42R3 (b and d)

Figure 6 presents a graphical depiction of functional volume and functional parameters for the reference specimen and a representative CFRP reinforced sample 1S1_R42R3.

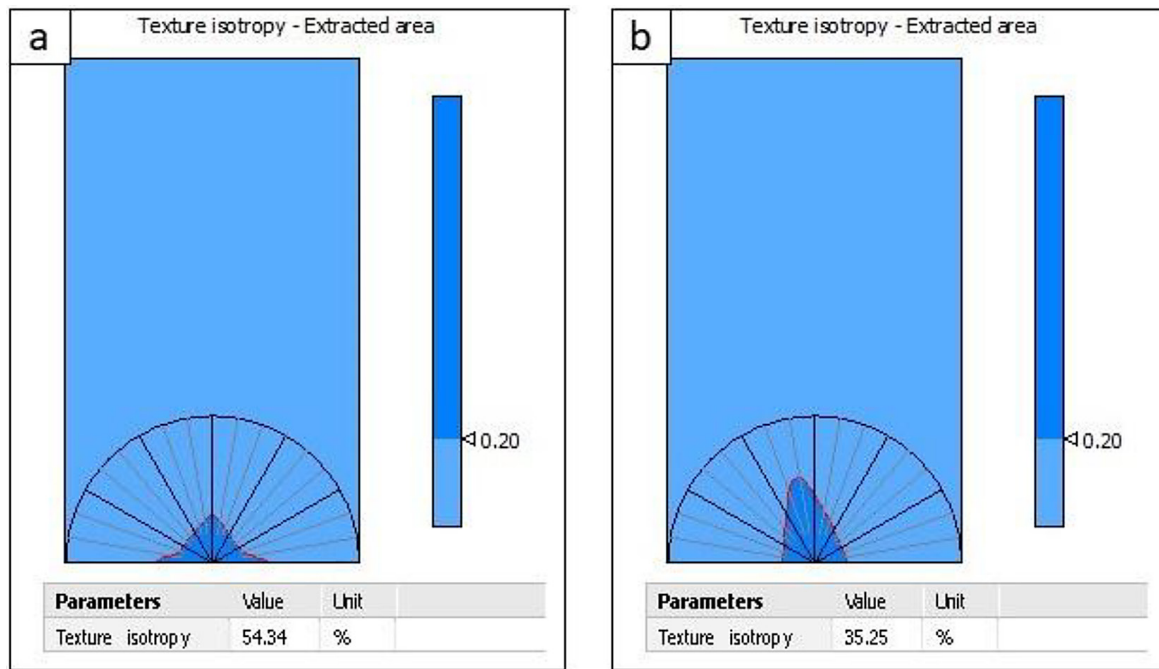
Figure 7. Texture isotropy of the unreinforced specimen and representative CFRP reinforced specimen – 1S1_R42R3

In this study, the texture isotropy parameter referring to the fracture surface topography was assessed. The directional characteristics of the surface texture are shaped by crack propagation and are directly linked to the kinematics of the fracture process [38]. Moreover, an isotropic surface exhibits uniform physical and geometric properties in all directions. In the scope of the presented study, the texture isotropy was determined through the evaluation of the autocorrelation function that assesses the directional uniformity and potential periodicity of the surface. This parameter provides valuable insight into the anisotropy induced by the fracture mechanism. Figure 7 presents the texture isotropy for the reference sample and chosen representative CFRP specimen (1S1_R42R3).

According to the reported evidence, the reinforced specimens exhibited lower isotropy in comparison to unreinforced specimens. Higher isotropy observed on the fracture surface of the

unreinforced specimen can be attributed to the uniform stress distribution within the material during uniaxial static tensile loading. Without the presence of external reinforcements, the S235JR base material undergoes plastic deformation and eventual failure in a relatively homogeneous manner. The fracture propagates without a preferred orientation, resulting in a surface morphology that is more uniform and directionally nature. This leads to a higher degree of isotropy on the fracture surface. In contrast, the specimens reinforced with CFRP tapes exhibit a lower degree of isotropy. The addition of unidirectional CFRP tapes significantly alters the stress distribution within the specimen. Due to the high stiffness and strength of CFRP, as well as its directional nature, plastic deformation in the reinforced region is constrained. This introduces anisotropy in the mechanical response of the specimen, particularly near the CFRP-stiffened zones. As a result, crack initiation and propagation become

directionally influenced, often occurring along the interface between the steel and the composite or in the regions where stress concentrations are elevated due to the presence of the reinforcement. Consequently, the fracture surface becomes more directional and exhibits features characteristic of anisotropic failure.

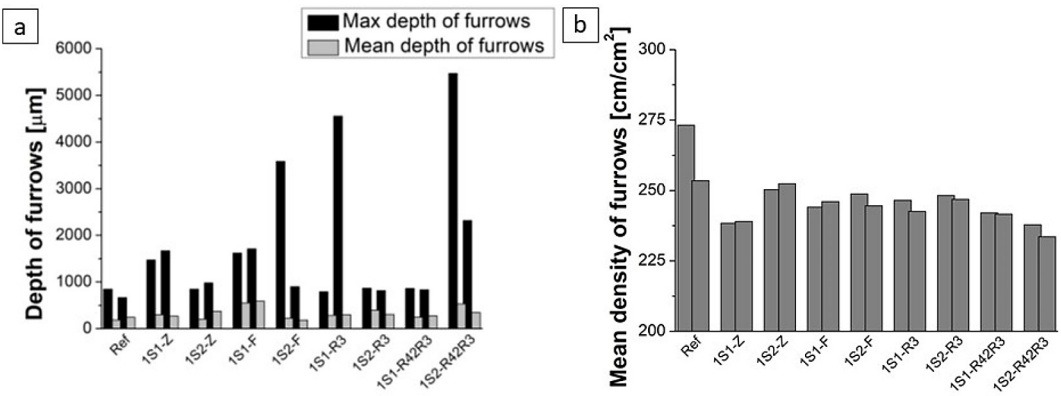
Figure 9. The values of the maximum and mean depth of furrows (a) and mean density of furrows (b) obtained for all the tested samples

The analysis of furrow depth (both maximum and mean) as well as furrow density is essential for characterizing fracture surfaces and for identification of the microstructural response of the material during crack propagation. Greater furrow depths typically indicate more brittle fracture behavior and is associated with sudden energy release along with localized material separation. On the other hand, higher furrow density suggests ductile behavior that involves extensive micro-cracking and plastic deformation. The described metrics provide valuable insight into the fracture mechanism and complement standard surface roughness parameters in evaluating failure characteristics. Figure 8 presents the graphical representation of furrow characteristics of the reference sample and chosen CFRP reinforced specimen, while Figure 9 shows the values of the maximum and mean depth of furrows (a) and mean density of furrows (b) for all the tested specimens.

The unreinforced specimen exhibited lower values of maximum depth of furrows and mean depth of furrows compared to some

CFRP-reinforced specimens, although all reinforced specimens simultaneously show a lower mean density of furrows with respect to the reference one. This can be explained by considering the differences in fracture mechanisms and surface morphology. In the unreinforced specimen, the material failed under relatively uniform tensile stress, leading to a more ductile fracture process with evenly distributed plastic deformation. As a result, the surface of the fracture showed a finer and more homogeneous topography. These furrows are shallower on average and lack deep localized features, leading to lower maximum and mean depth values. However, due to the uniformity of the ductile fracture mechanism, the surface is covered with a greater number of these small features and this causes a higher mean density of furrows. On the other hand, the presence of CFRP reinforcement alters the stress distribution and restricts plastic deformation in specific regions. The increased stiffness caused by the localized constraints (imposed by the CFRP) produce more concentrated and abrupt fracture paths, particularly in the areas near the interface between the composite and the steel substrate. This often leads to more brittle-like failure modes or mixed-mode fracture, which produce fewer but significantly deeper furrows due to sudden crack propagation and localized material separation. Consequently, the maximum and mean depth of

furrows increase, while the overall number of furrows decreases, leading to a lower mean density.

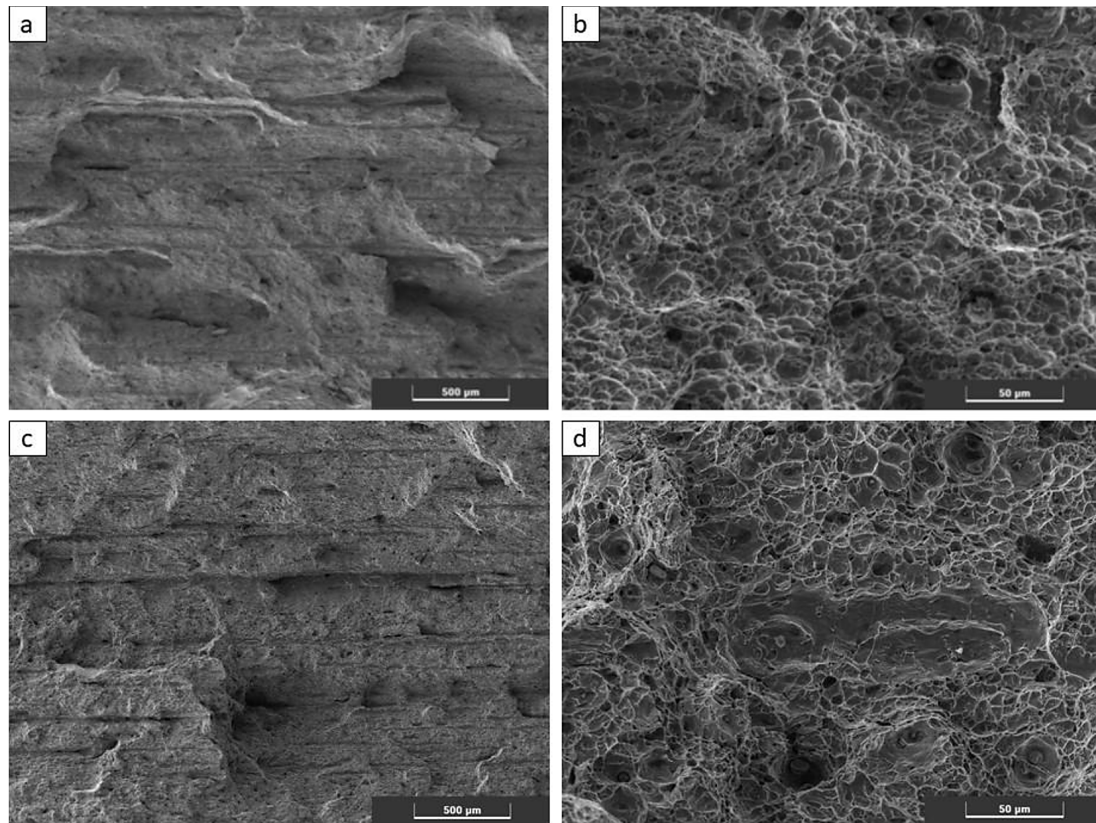
Figure 10. SEM pictures of the unreinforced specimen (a and b) and representative CFRP reinforced specimen – 1S1_R42R3 (c and d)

The tested samples were also observed with the use of high-resolution scanning electron microscope. Figure 10 presents the fracture surfaces of the reference unreinforced specimen and

chosen sample with CFRP tape (1S1_R42R3). Both fractures exhibit features characteristic of ductile failure, such as visible dimples and evidence of plastic deformation. However, the surface of the CFRP-reinforced sample also shows localized brittle features – such as sharper edges

and cleavage-like regions – indicating a mixed fracture mode resulting from the constraint effects introduced by the composite reinforcement. These brittle features observed in the CFRP-reinforced specimen arise due to the constraint effect imposed by the high-stiffness composite material. The CFRP tape limits the local plastic deformation of the steel, especially near the fracture zone, which leads to stress concentration and reduced ductility in those regions. As a result, the material is more prone to localized brittle cracking, even though the overall fracture remains predominantly ductile. This mixed-mode failure is observed when a ductile substrate is reinforced with a much stiffer and less deformable material like CFRP.
