Effect of solution heat treatment on mechanical properties of Manaurite XM reformer tubes after long term service at elevated temperatures

Michał Landowski^{1*}, Jerzy Łabanowski¹, Mateusz Jurkowski²

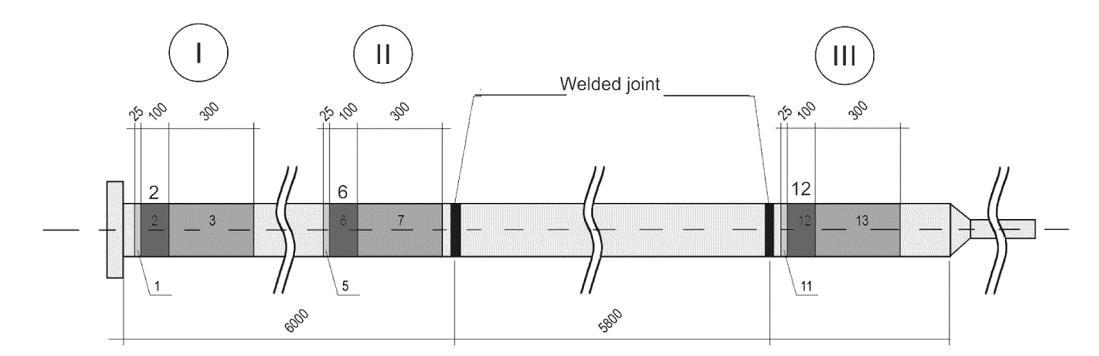
The catalytic tube consisted of three sections connected by circumferential welds. The pipe diagram is shown in Figure 1. Samples were cut from each section (I, II and III) of the catalytic tube for microscopic metallographic examinations, chemical composition analysis and static tensile tests. The microstructure and material properties of the tube from areas I, II and III differed due to different operating temperatures. Area I of the tube – close to the substrate inlet – was operated at the lowest temperature. The further from the flange, the temperature of the tube increased and reached the nominal value at 1/3 of the height counted from the end of the tube.

Figure 1. Diagram of the catalytic tube with marked places where samples were taken for testing

Two sets of samples were prepared for the tests. The samples were taken parallel to the tube axis. The first set of samples was tested in the state after operation – samples from sections I-2, II-6, III-12 (Fig. 1), the second set of samples was subjected to heat treatment by solution heat treatment – samples from sections I-3, II-7, III-13. Both sets of samples for the static tensile test contained three samples from each section. A total of 18 samples with a circular cross-section of \emptyset 5.0 mm and an initial measuring length of Lo = 30 mm were prepared, taken from the central part of the catalytic tube wall material. Static tensile tests were carried out in accordance with the PN-EN ISO 6892-1:2016-09 standard.

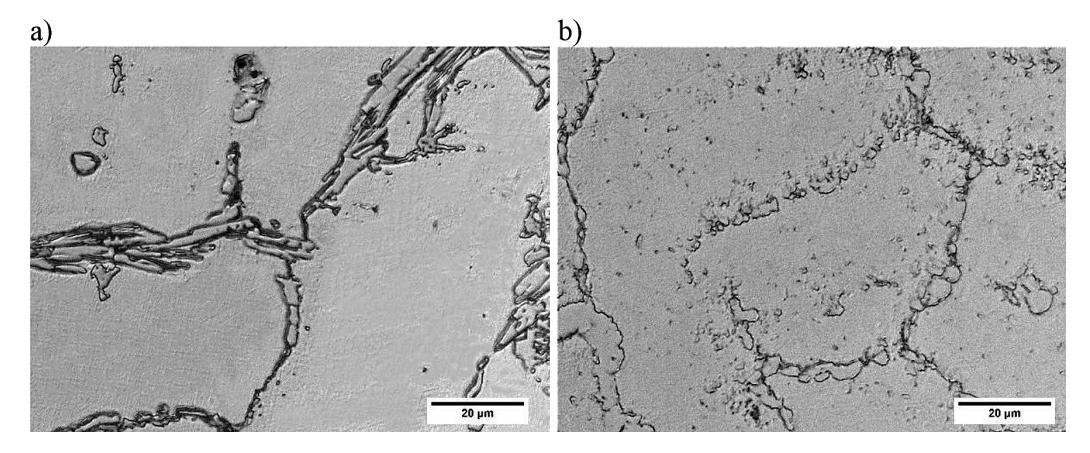
Figures 2–4 show LM microstructures of the catalytic tube in the after-service conditions and in the state after solution heat treatment. In sample I-2 (Fig. 2a) an undegraded structure characteristic for high-carbon austenitic cast steel in the as-cast state was observed. It is composed of austenitic matrix and carbide-austenitic eutectic of characteristic lamellar composition located on the boundaries of austenite grains. Apart from the eutectic structure, there are also elongated primary carbides distributed along the austenite boundaries. Massive primary carbides Nb and Cr occur only within the eutectic

Figure 2. Microstructure of sample: a) I-2 in the post-service state, b) I-3 after solution heat treatment

and along the austenite grain boundaries. The interiors of austenite grains are free of precipitates.

After solution heat treatment, significant changes in the alloy microstructure were observed. In sample I-3 (Figure 2b), the disappearance of the austenitic-carbide eutectic and coagulation of eutectic carbides, which formed compact precipitates along the austenite grain boundaries, were observed. Some of these carbides formed large clusters inside the austenitic matrix. In samples II-7 and III-13, the disappearance of secondary carbide precipitates was observed, which dissolved in the matrix, Figure 3b and 4b. Coalescence of primary carbides and some secondary carbides occurred, which formed a thick network along the austenite grain boundaries.

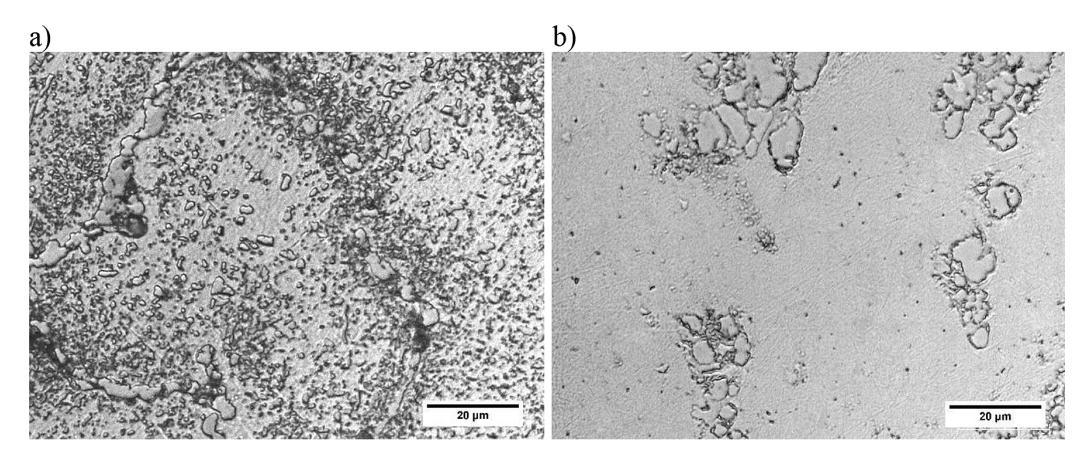
The original morphology of eutectic carbides has been changed during the long time of operation at elevated temperatures during which certain coalescence has taken place. The structure of II-6 (Fig. 3a) and III-12 (Fig. 4a) samples contain still lamellar eutectic of primary carbides, but the coalescence process has formed not completely continuous network of carbides. Secondary carbides in great amount are observed within the austenitic grains. No acicular precipitates were observed within the austenite grains characteristic for the intermetallic sigma phase. The size, shape and distribution of secondary carbides were similar in samples II-6 and III-12.

Figure 3. Microstructure of sample: a) II-6 in the post-service state, b) II-7 after solution heat treatment

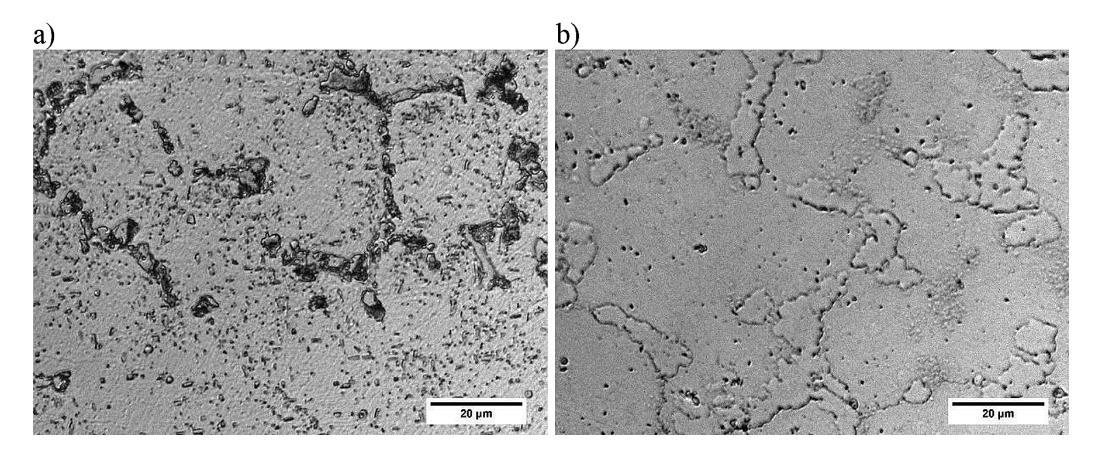
Figure 4. Microstructure of sample: a) III-12 in the post-service state, b) III-13 after solution heat treatment

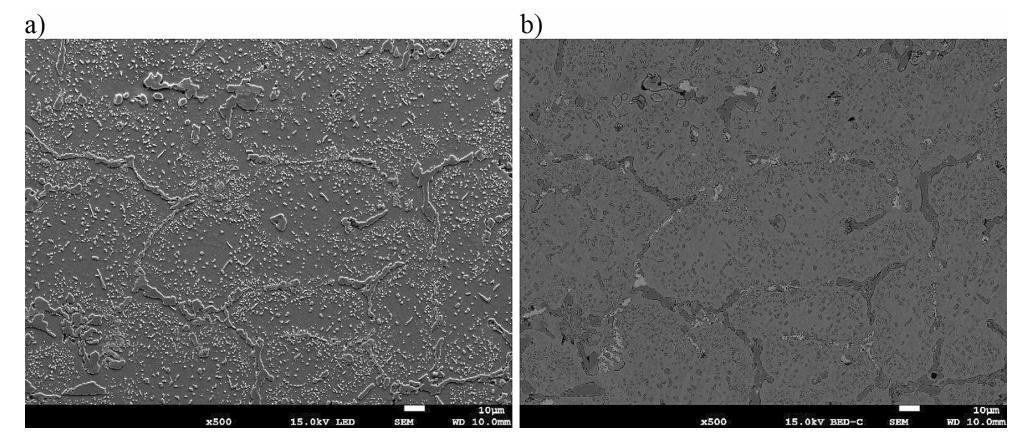
The observations from light microscope were confirmed by examinations using a scanning electron microscope (SEM). Figure 5a shows the microstructure of sample III-12 in the post-service state. A large number of small spherical secondary carbides are visible inside the austenitic matrix. Figure 5b shows the same structure obtained using the backscattered electron technique (BSE), which allows for qualitative differentiation of structural components with various chemical composition. It can be seen that the carbides forming a compact network around the austenite grains are not homogeneous. Some of the compact carbides are light in color, while others are dark.

Figure 5. Microstructure of sample III-12 in the post-service state: a) SEM, b) SEM – BSE mode

5a) are conglomerates of chromium carbides of the M23C6 type, while the adjacent light precipitates are niobium carbides and probably niobium-rich phases of the Nb6Ni16Si7 type. The spherical precipitates inside the austenite grains in sample III-12 in the post-service state (Fig. 6a) are M23C6 carbides containing mainly chromium. The tests did not detect any precipitates with a composition characteristic for the σ type intermetallic phase.

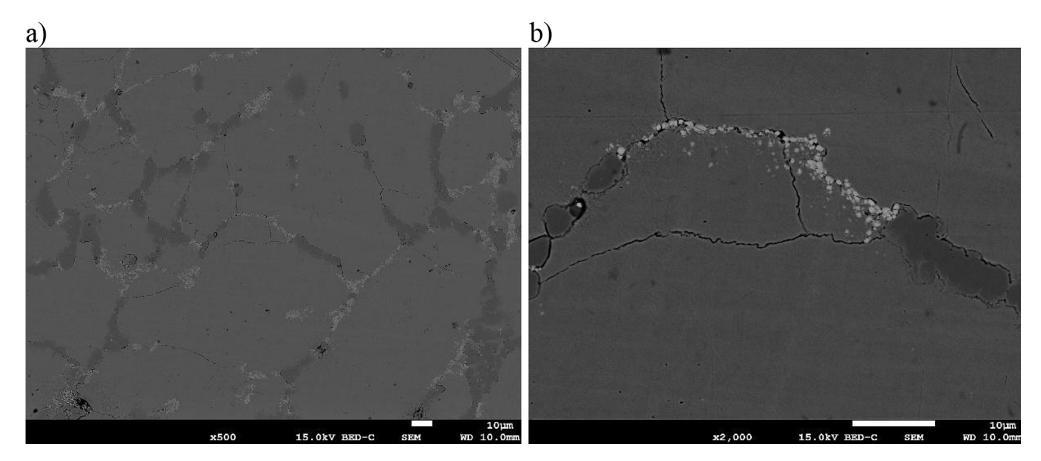
Figure 6a and 6b show the SEM-BSE microstructure of sample III-13 after solution heat treatment. Areas of austenitic matrix without secondary carbide precipitates are visible. The network of coagulated carbides on the austenite grain boundaries shows a structure composed of different types of carbides. Higher magnification in Figure 6b reveals the presence of a network of fine cracks in the austenitic matrix and on the austenite-carbide boundaries. Such cracks were not observed in the microstructure of the tube in the post service state, before solution heat treatment.

Figure 6. Microstructure of sample III-13 after solution heat treatment: a) SEM - BSE, b) SEM – BSE Close-up of the crack network

- 7. After heat treatment, small cracks were observed in the austenitic matrix and at the austenite-carbide boundaries. Therefore, the tubes should be subjected to non-destructive testing (NDT) after solutionizing to exclude the presence of cracks that threaten further safe operation.

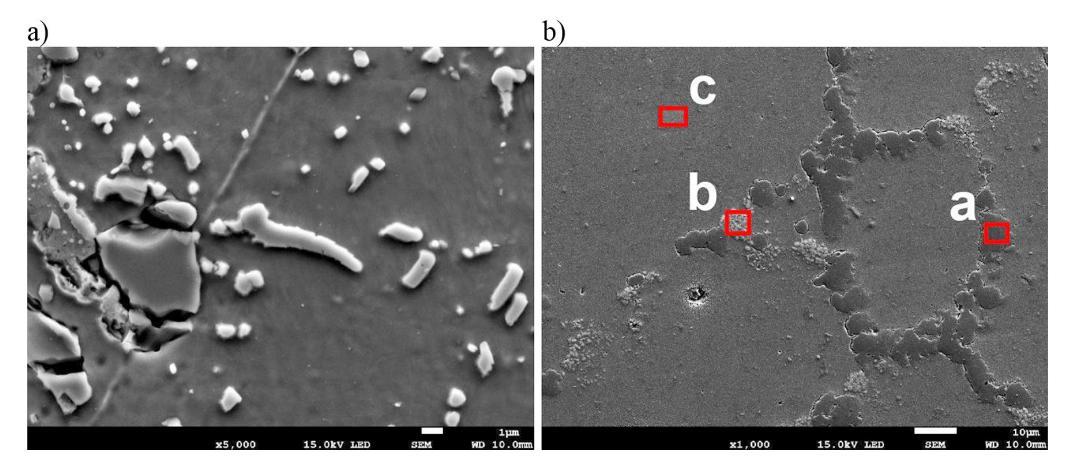
Figure 7a shows the morphology of secondary carbides precipitated in the austenitic matrix in sample III-12 after service. The diameter of globular precipitates or the width of elongated precipitates does not exceed 1 μ m. There are no signs of

Figure 7. Microstructure of sample: a) III-12 in the post-service state, b) III-13 after solution heat treatment

coagulation of secondary precipitates. No acicular precipitates characteristic of the σ phase were found. Figure 7b shows an enlarged SEM image of sample III-13 after solution heat treatment.

Microanalysis of the chemical composition of the austenitic matrix and carbide precipitates was performed using a scanning electron microscope coupled with an energy dispersive X-ray spectrometer (EDS). Examples of the obtained spectra for the analyzed areas are presented in Figure 8 a–c (a – dark precipitates, b – light precipitates and c – austenitic matrix) from the areas as indicated in Figure 7b, respectively.

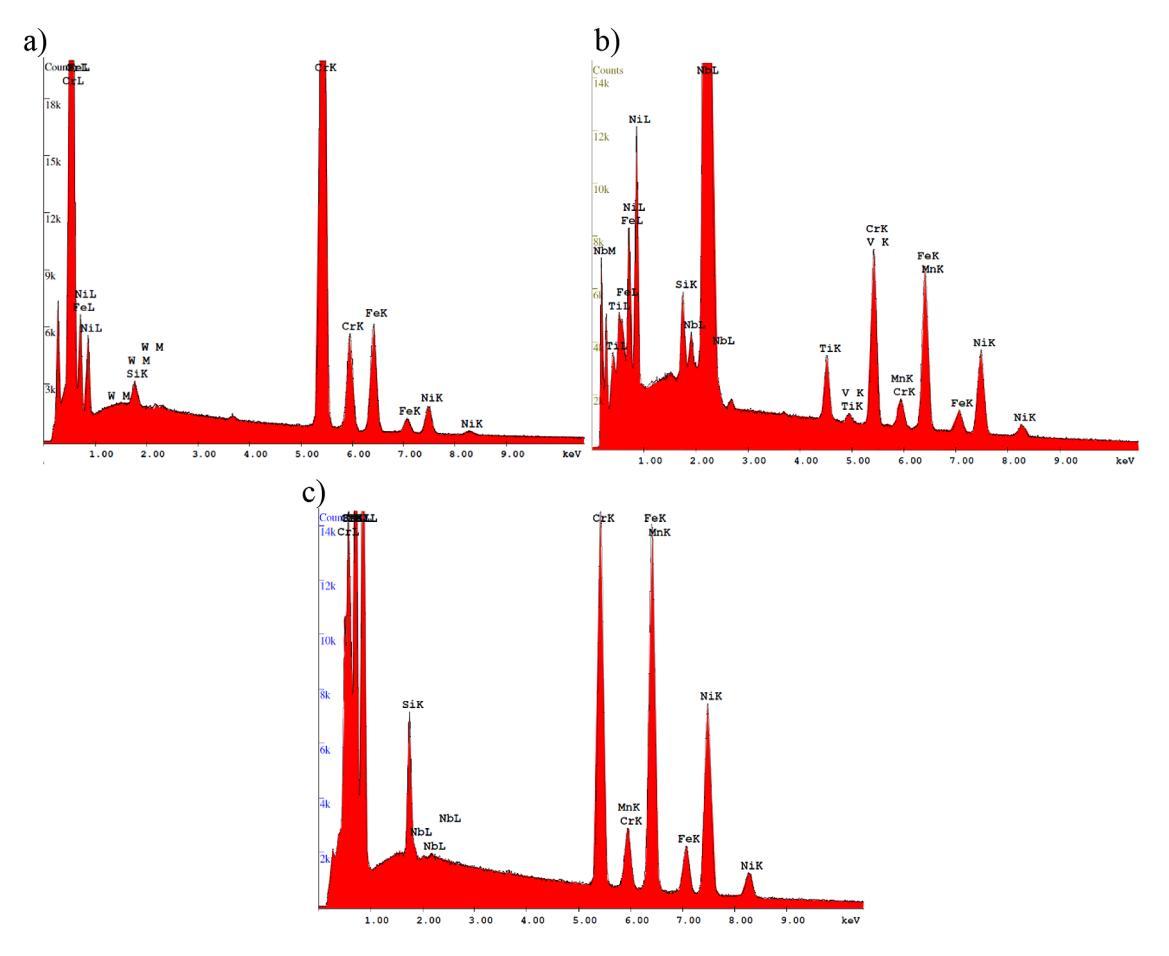
Figure 8. Spectra (EDS) of the areas of sample III-13 after solution heat treatment, a) dark precipitate area, b) light precipitate area, c) austenitic matrix

The results of chemical composition microanalyses are presented in Table 3. The obtained results indicate that the dark precipitates (Fig.

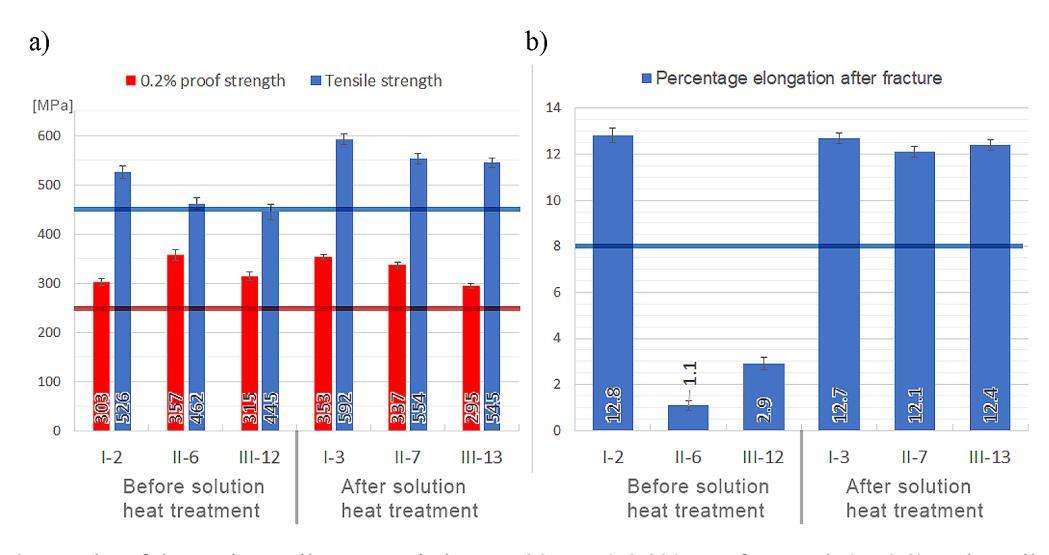
The results of the static tensile test at room temperature are presented in Figure 9. The

minimum values of yield strength ($Rp_{0.2}$), tensile strength (Rm) and percentage elongation after break (A) declared by the manufacturer are marked as horizontal lines on the graphs in the corresponding colors and are 250 MPa, 450 MPa and 8%, respectively. It is noticeable that the strength and plasticity of the tube material from the areas operated at high temperatures (II-6, III-12) are significantly reduced compared to the area of the tube near the flange, where the temperature did not exceed 550 °C (I-2).

Solution heat treatment at temperature of 1220 °C caused structural changes in the microstructure of the cast steel and a significant improvement in the mechanical properties tested at room temperature. An increase in the tensile strength (Rm) and percentage elongation after fracture (A) was observed in all tested areas of the tube (I, II, III). The obtained values of tensile strength and elongation meet the requirements of the cast material declared by the manufacturer.

Figure 9. Results of the static tensile test carried out at 20 °C, a) 0.2% proof strength (Rp0.2) and tensile strength (Rm), b) percentage elongation after fracture

- 6. After solutionizing, the tensile strength (Rm) and percentage elongation after fracture (A) were restored to values that met the manufacturer's requirements.
