Water Absorption and Microbial Corrosion Resistance of Hemp Concrete Modified with the Acid Casein Admixture

Przemysław Brzyski^{1*}, Urszula Gąska-Jędruch²

¹ Faculty of Civil Engineering and Architecture, Lublin University of Technology, ul. Nadbystrzycka 40, Lublin, 20-618, Poland

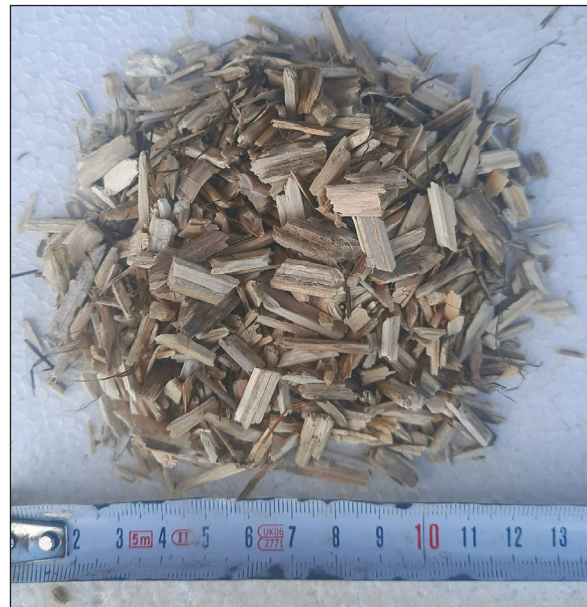
Figure 1. Hemp shives used in the research

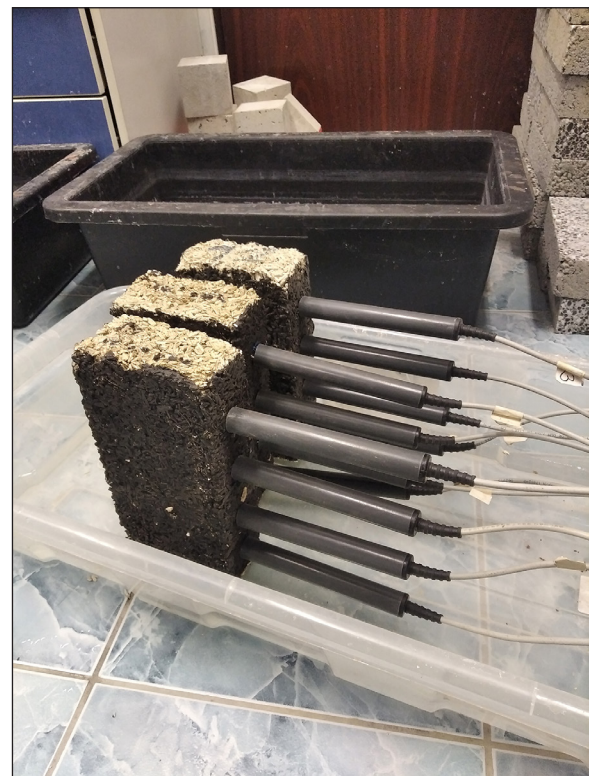
Figure 3. General view of the sample during capillary rise test

The capillary rise test was performed using TDR (Time Domain Reflectometry) probes. This method was used in own previous research on hemp-lime composites [20]. Measuring setup for TDR examination consisted of:

- sample of hemp-lime composite,
- LOM – TDR multimeter (ETest, Lublin, Poland),
- FP/mts – TDR probes (ETest, Lublin, Poland),
- PC computer as control station.

with 100 mm needle length were embedded at four following sample height levels 35, 85, 135, and 185 mm above the bottom edge of the sample. The sample was placed in a bathtub of water, immersing it to a depth of 10 mm (Figure 3). The water level was monitored during the study. The whole experiment lasted 5 days. Time step of the readouts was set to 15 minutes

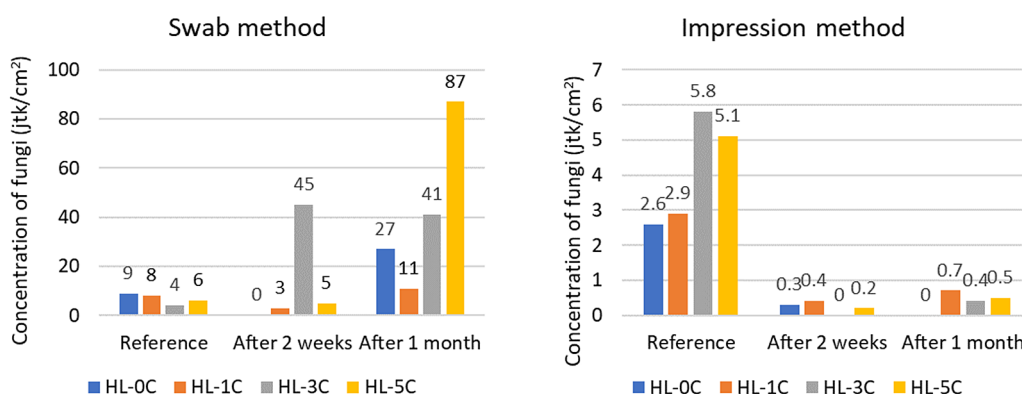
Figure 8. Average values of the results of testing the growth of fungi on the surface of samples

Table 5 and 6 show the numbers in individual composites and Figure 8 shows the average values of the results of testing the growth of fungi on the surface of samples. The swabs method is more accurate comparison to the printing method, especially for the composites tested, where their structure is rough. The impression method in the case of the HL-3C composite failed to download fungal spores of the genus *Chrysosporium* sp., and in the case of the HL-5C composite of the *Aspergillus* sp. spores, which were taken using the swabs method. Individual species and types of fungi on

For composites tested using the impression method, a decrease in fungal growth and presence can be observed after only two weeks. However, the swab method for HL-5C composites shows a similar number of fungi on the surface after two weeks and an increase in their number after a month compared to the control samples. This is due to the presence of spores

from the *Absidia* genus, which are commonly found in nature. However, in the case of the HL-3C composite, higher values were observed after 2 weeks and a month in comparison to the control samples. This is attributed to the presence of spores from the genus *Chrysosporium* sp. The differences in the number of fungi are due to the composition of the composite, which

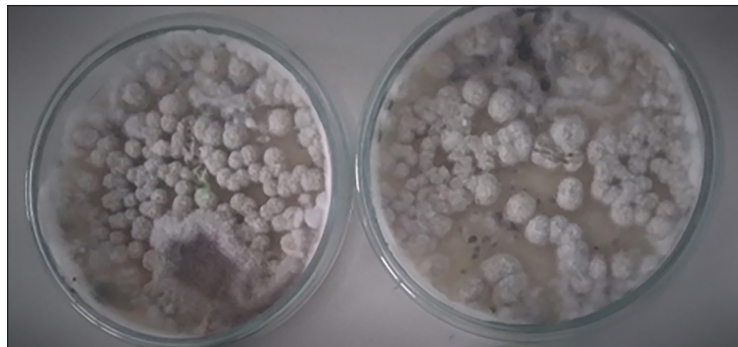
Figure 11. Swab method: HL-5C composite – after 1 month, the predominance of the genus *Absidia* sp.

Figure 11 shows the growth of a fungus of the genus *Absidia* sp. after one month of incubation

obtained using the swab method in duplicate. As in the case of HL-3C, no growth of this genus was detected with respect to the control samples.
